CONCRETE REPAIR BULLETIN

Seismic Retrofit of McKinley Tower

Anchorage, Alaska

Submitted by QuakeWrap, Inc.

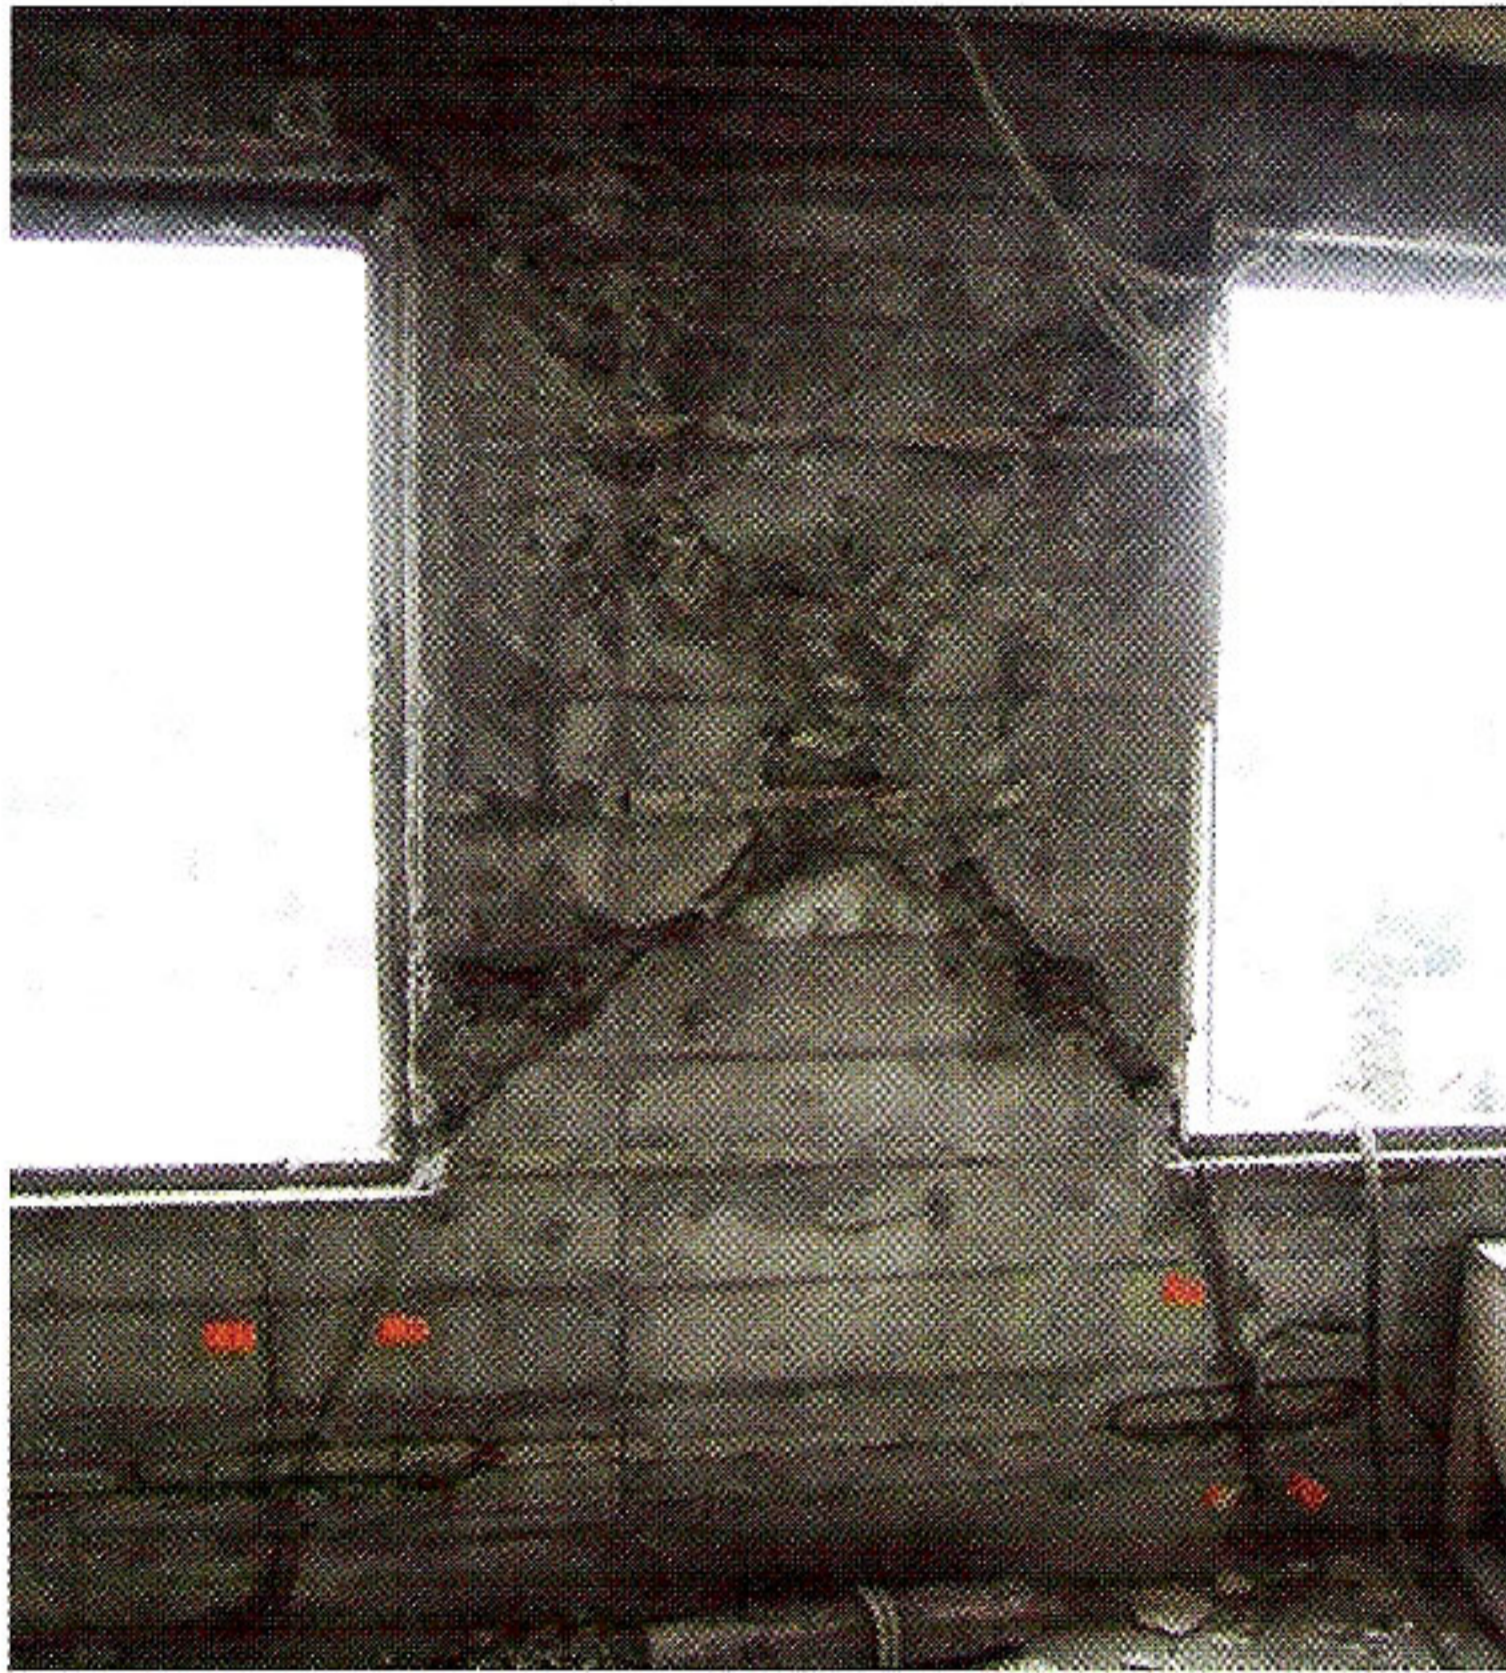
Fig. 1: Damage to walls caused by the earthquake

The building survived the 1964 "Good Friday" Alaska Earthquake, which had a Richter scale magnitude of 9.2, making it the strongest earthquake in North America to date. Damage to the building consisted of shear failure of exterior spandrel beams and extensive diagonal cracking of exterior walls (Fig. 1). The east vertical pier on the north-end wall failed up to the third floor at a construction joint and similar failure was observed on the south-end wall. The walls around the building's core suffered light diagonal and horizontal cracks at construction joints, with damage being more severe from the third to sixth floors.

After the earthquake, the building was vacated and put up for auction. In 1965, some repair work was done, consisting of patching exterior cracks, replacing damaged reinforcement of ornamental spandrel beams, removing loose material, and fixing spalled areas in the stairwell and elevator core.

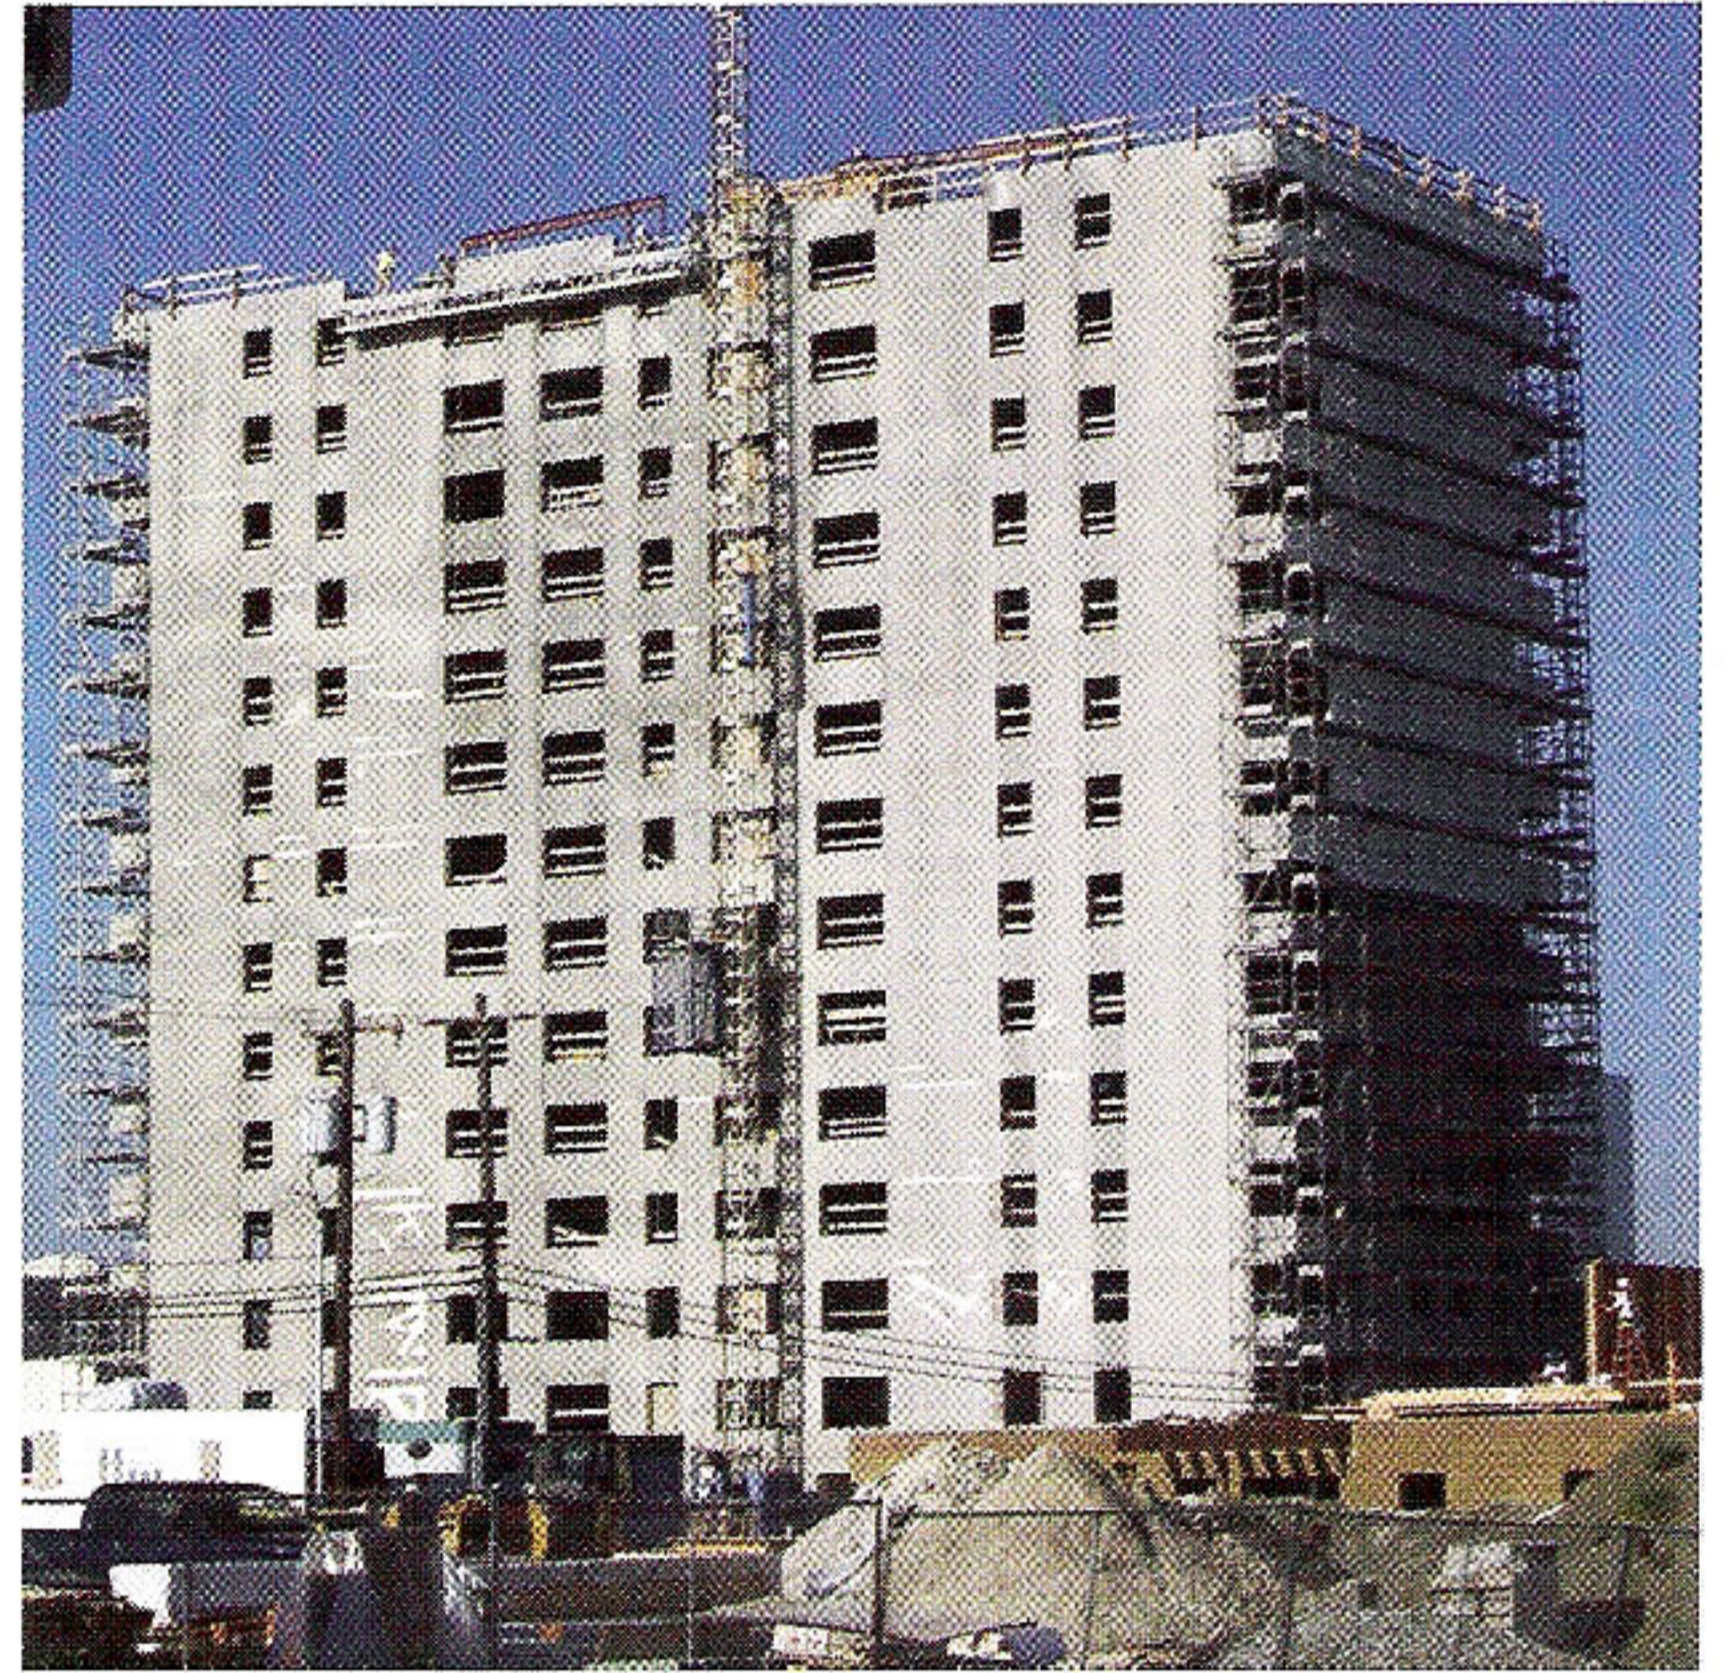
Fig. 2: Stripped building was an eyesore for over 20 years

The current owner acquired the building in 1998. Since then, extensive structural repairs were undertaken to bring the building up to current seismic code requirements. Due to the excessively high costs involved, however, all repair work was stopped. As a consequence, the building remained vacant for more than 20 years, becoming an eyesore in downtown Anchorage (Fig. 2).

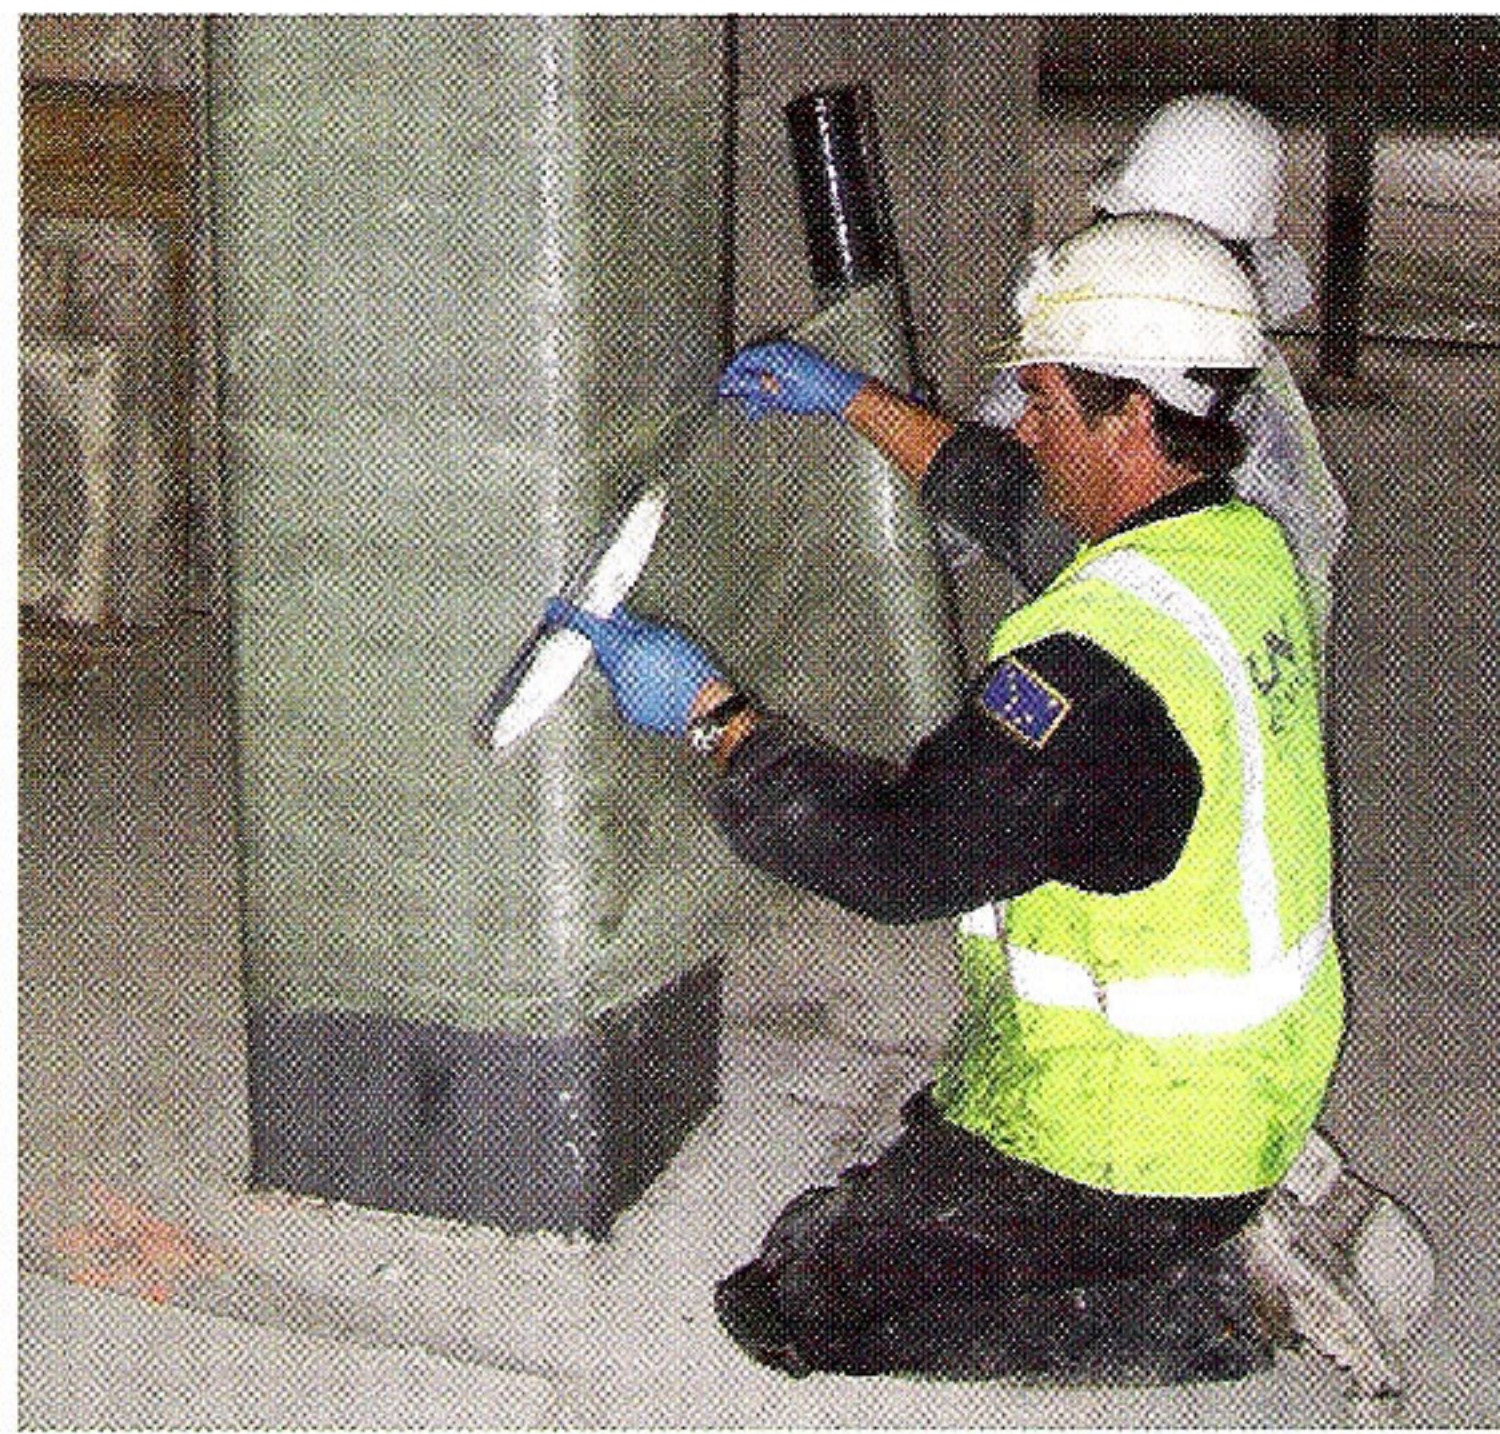
Fig. 3: Wrapping of columns with GFRP

Unidirectional glass FRP (GFRP) fabrics were applied to all columns to provide a confining effect to the concrete, which increased its compressive strength and ductility. This eliminated the need to increase the size and steel reinforcement of all existing columns. The fabric was supplied in 24 in. (61 cm) wide tapes that were wrapped around the column in two or more layers; along the height of the column, the bands of fabric were butt jointed (Fig. 3).

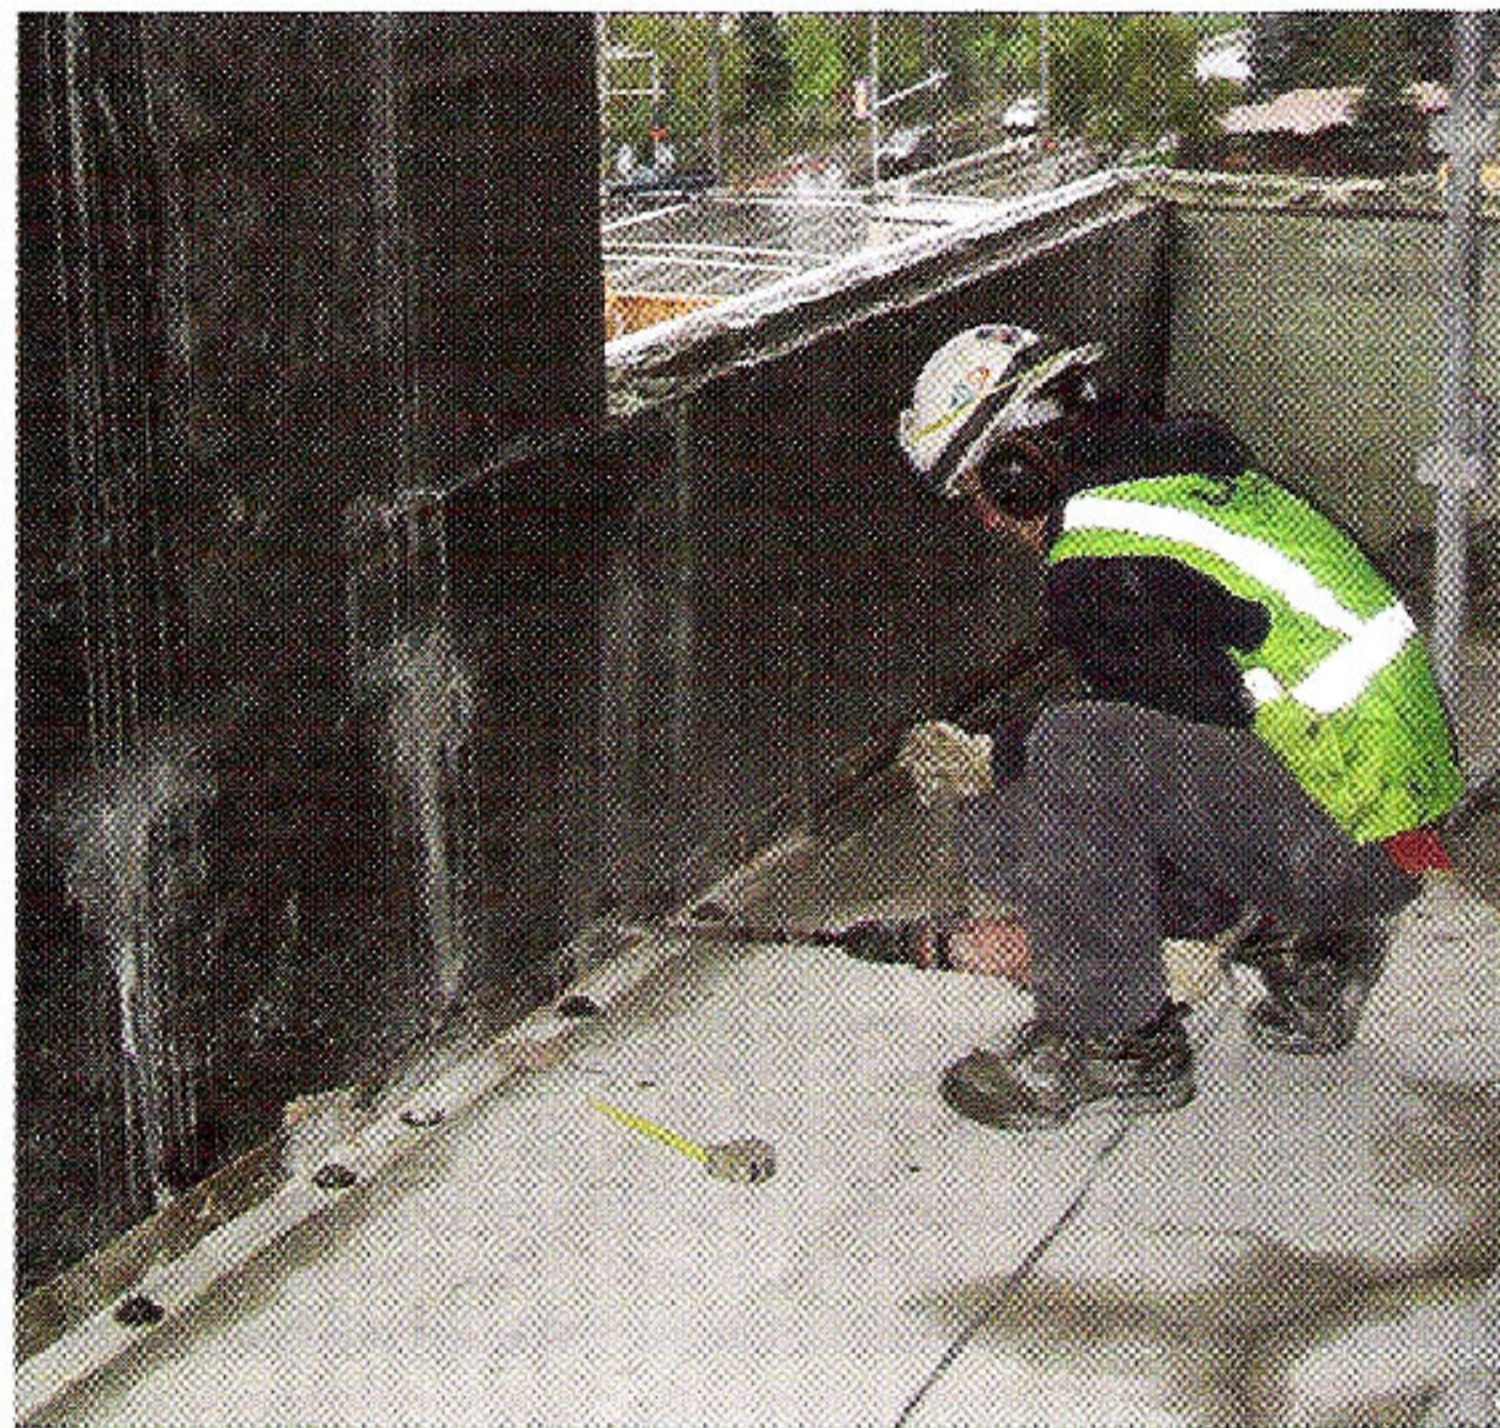
Fig. 4: Steel angles and bolts for transfer of loads from shearwalls to floors

The north- and south-side bearing walls above the 4th floor were converted to shearwalls by applying biaxial carbon FRP on the inside face of the wall up to the 9th floor. Vertically oriented unidirectional glass fabric was placed between the 9th and 10th floor. Additional horizontally oriented unidirectional glass fabric was applied on the end of the new exterior shearwall constructed up to the 4th floor. To assure proper load transfer to the floor system at each level, a special structural detail was developed (Fig. 4).

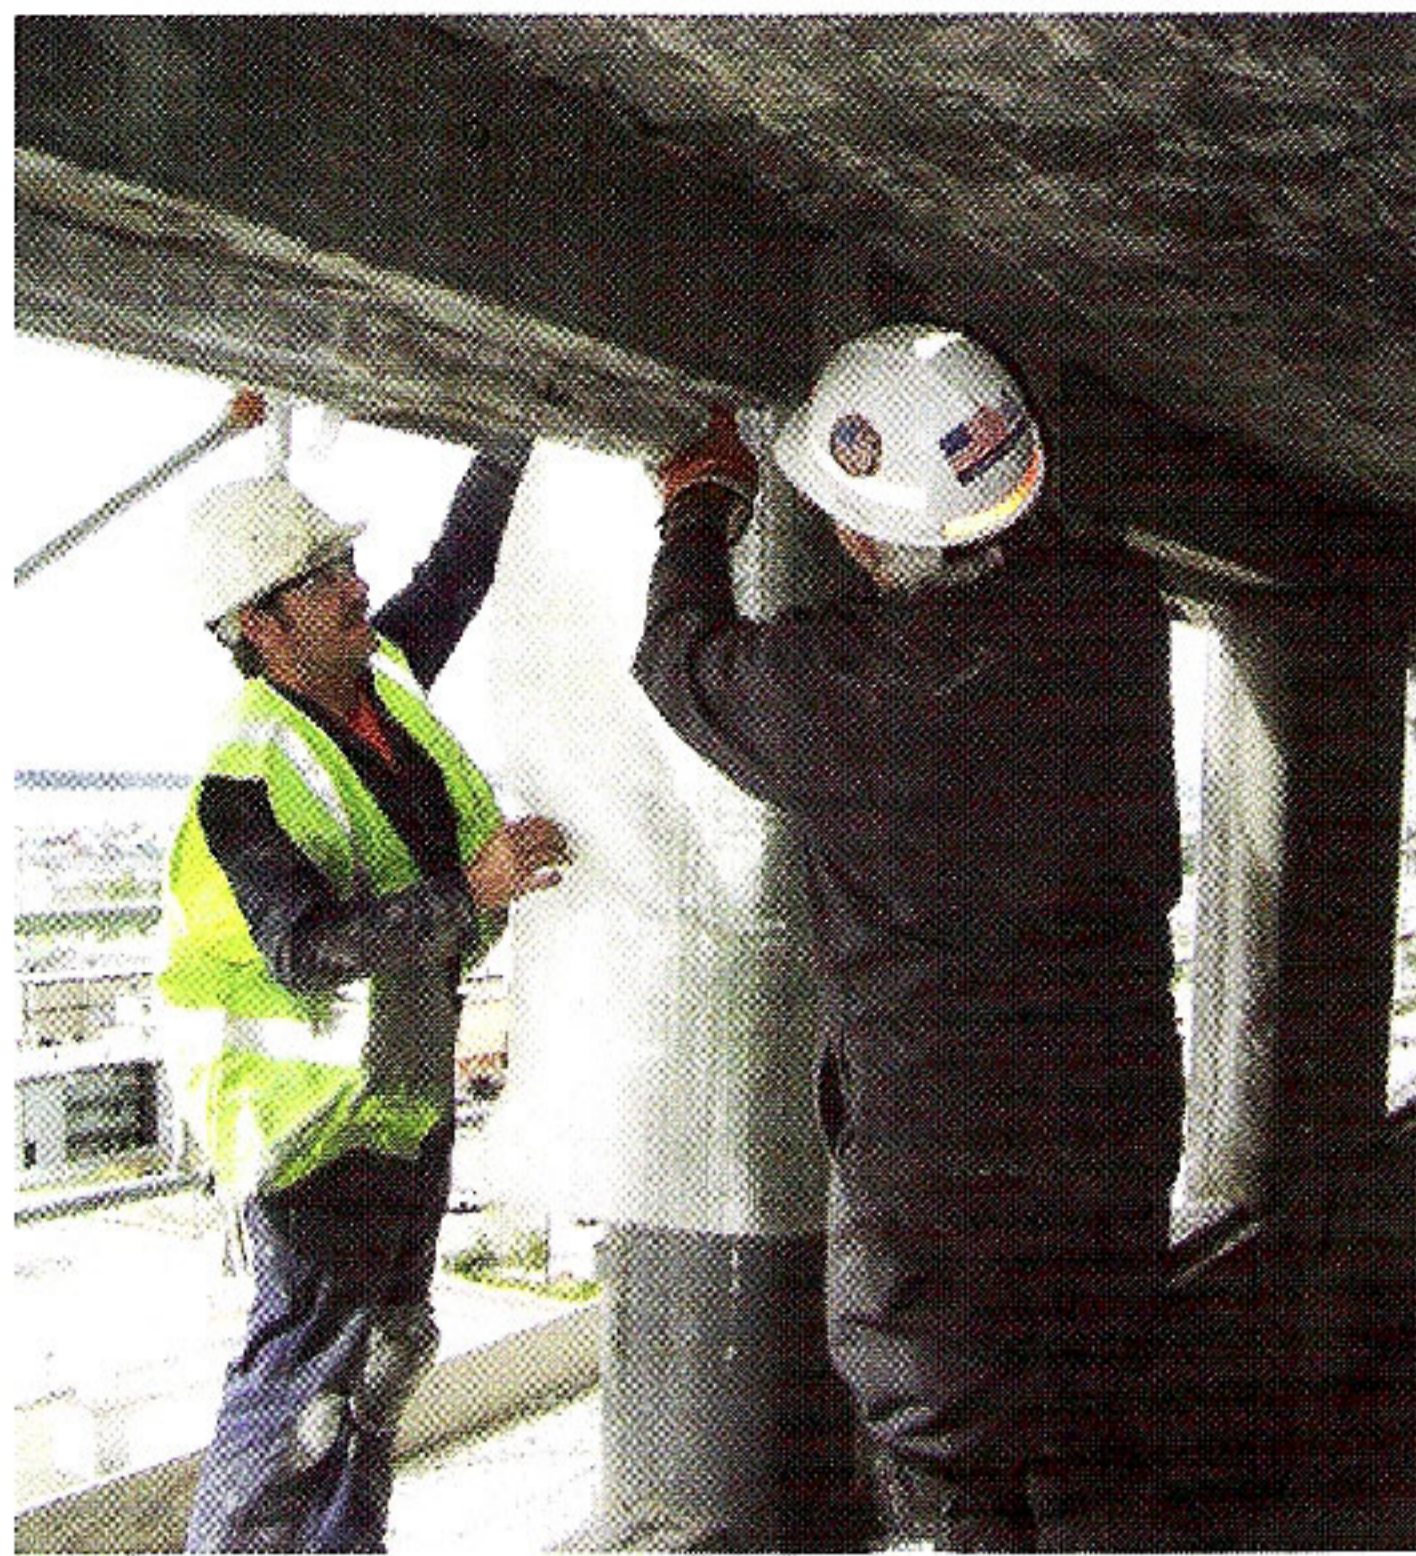
Fig. 5: Reinforcing boundary elements in shearwalls with GFRP

Coupling beams for east and west shearwalls were reinforced for shear by applying biaxial GFRP on the inside face (Fig. 5). The same design was applied on the inside face for shear reinforcement of cantilever beams on the west and east building elevations. For the cantilever beams on the north and south elevations, shear reinforcement was achieved by applying a biaxial carbon fabric on the inside face. Cantilever beams were also reinforced for negative flexural strength by applying unidirectional carbon FRP to the top face.

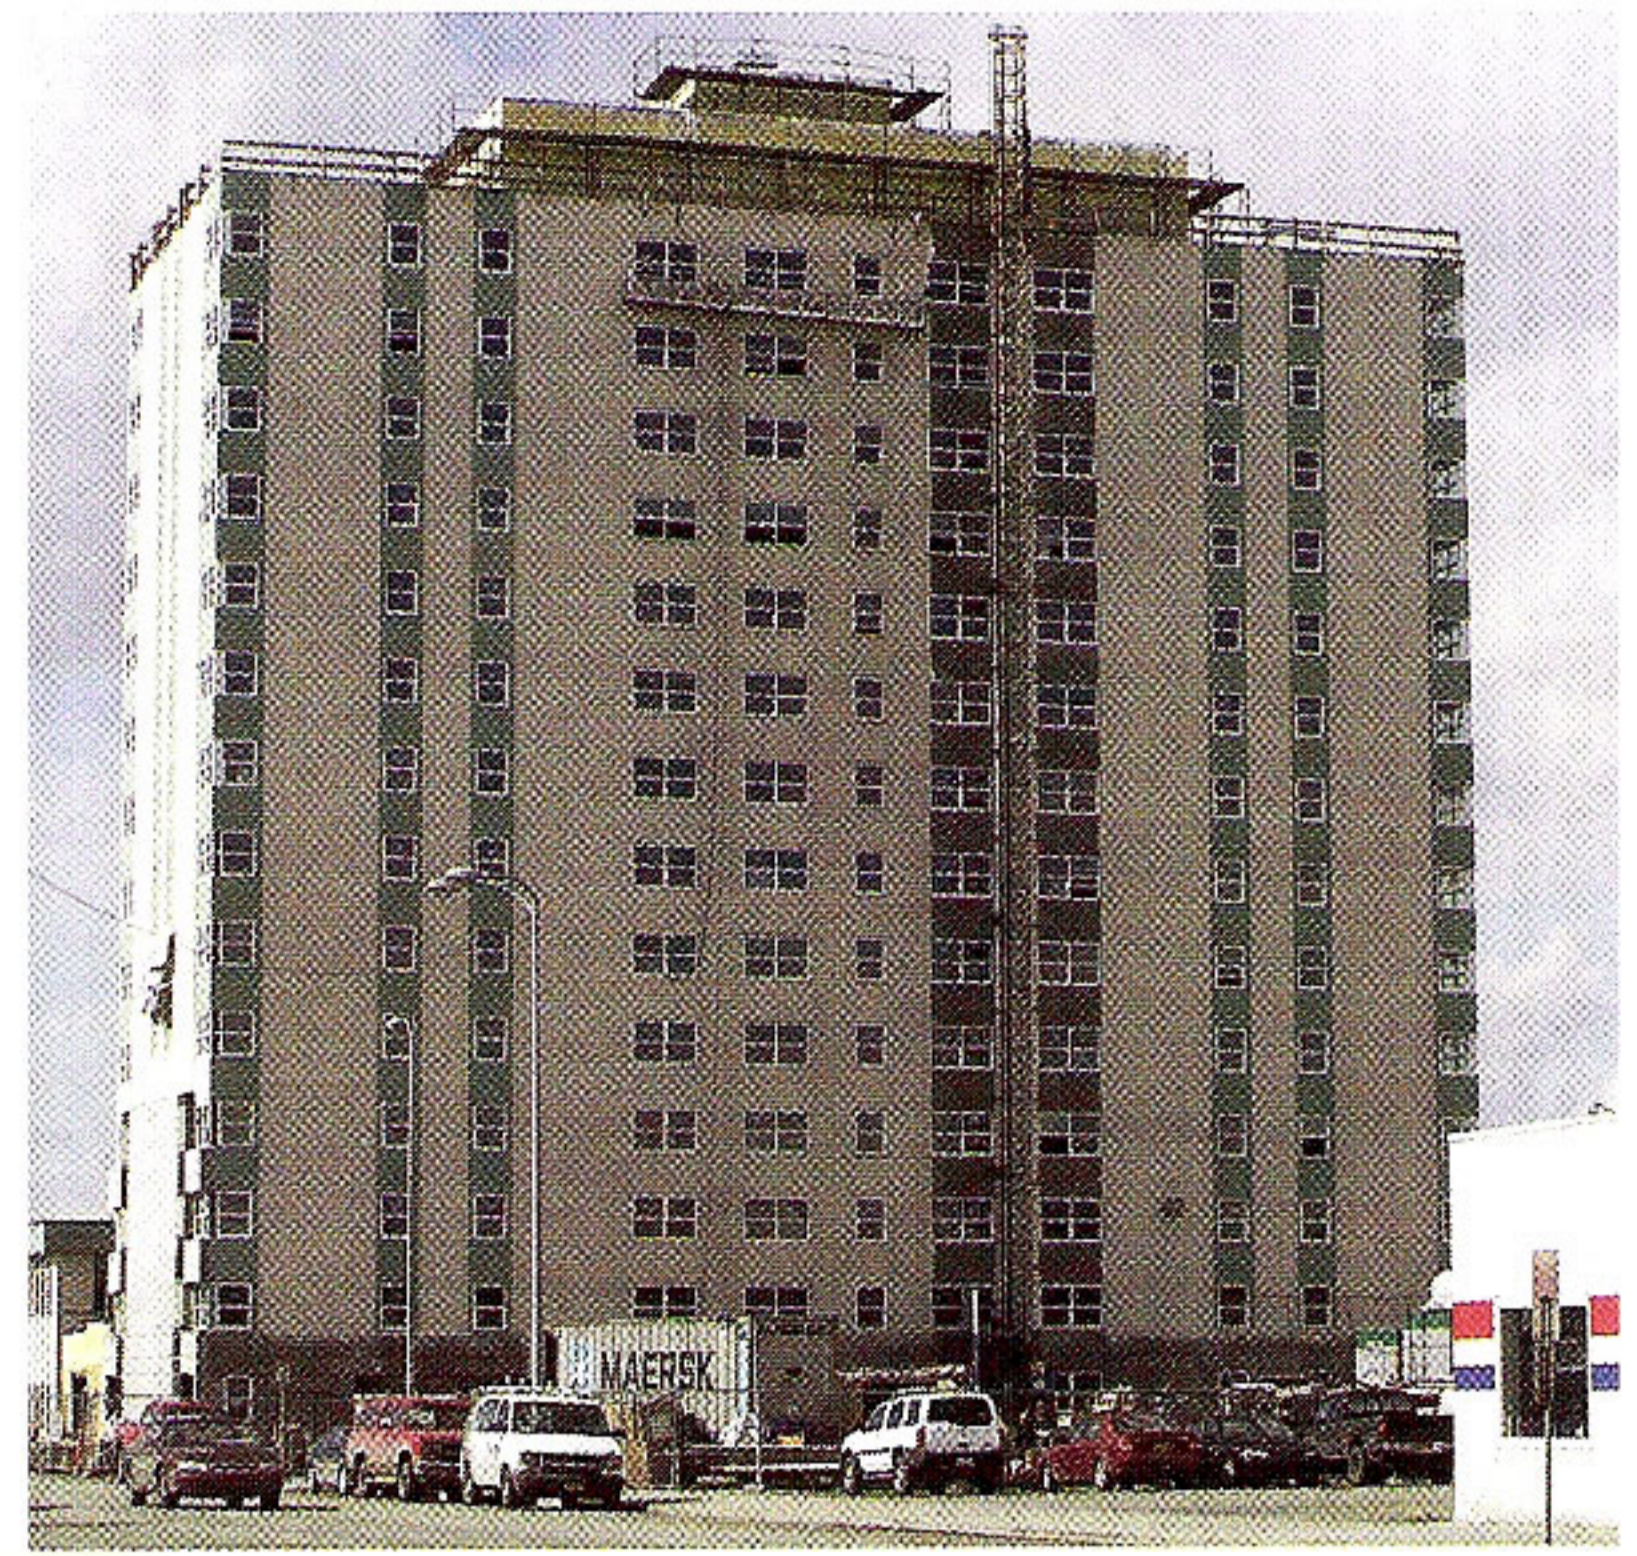
Fig. 6: The building nearly completed and painted
