Fiber Reinforced Polymers

Seismic Retrofit of the McKinley Tower

By Mo Ehsani, Ph.D., P.E., S.E.

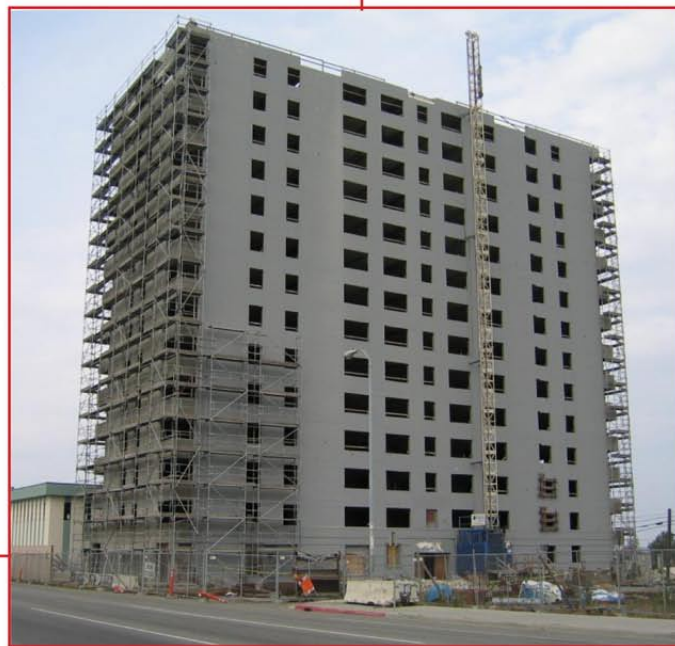
Since its establishment, it has also become an important historical icon. The McKinley towers served as both office and residential space until March 27, 1964, when the magnitude 9.2 'Good Friday' earthquake struck the Prince William Sound area of Alaska. Anchorage, located a mere 100 miles from the epicenter of the earthquake, was severely affected. Among the 150 commercial buildings that were damaged or made unstable by the quake, the McKinley building sustained significant damage. The spandrels were broken beyond recognition, while the bearing and interior walls developed large diagonal cracks. The vertical pier on the north end wall failed up to the third story, as did piers on the south end wall.

Figure 1: Damaged McKinley Tower sat vacant for more than two decades

After the earthquake, the building was vacated and put up for auction. IN 1965 some repair work was done consisting of exterior crack patching, replacement of damaged reinforcement of ornamental spandrel beams, removal of loose material, and fixing spalled areas in stairwell and elevator core (Figure 1).

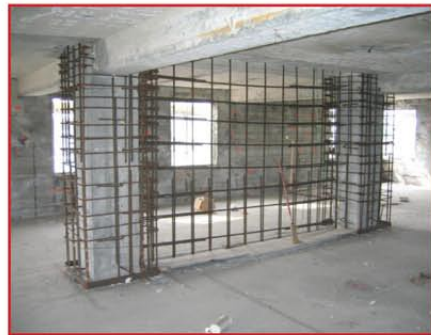
Figure 2: Original retrofit scheme required new shear walls and enlargement of existing columns

building to current seismic design code requirements traditional retrofit measures were undertaken consisting of construction of new exterior and interior concrete shear walls and the placement of structural steel shapes along the entire height of the building. There were several disadvantages to this retrofit design, the most problematic of which was excessively high cost. The foundation system was found to be adequate for the original design, but required significant improvements to resist the loads imposed by the current code, design standards, and the additional seismic mass created by the retrofit. To resist overturning, 88 soil anchors were needed to resist uplift due to seismic forces. Another disadvantage was that the long steel shapes proved to be a construction challenge, in addition to changing the overall profile and appearance of the historic tower.

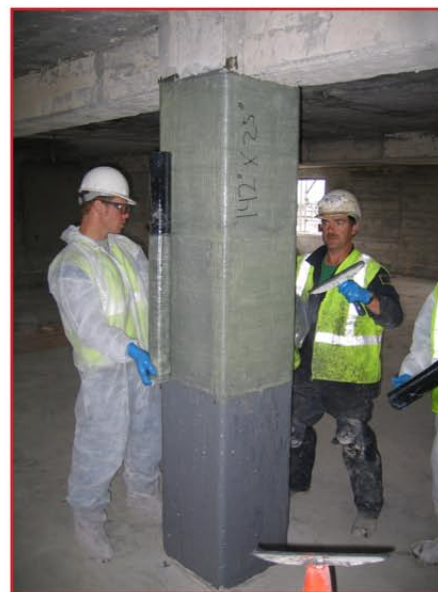
Figure 3: Confinement of a typical interior column with FRP

Unidirectional glass FRP fabrics were applied to all columns to provide a confining effect to the concrete, which increased its effective compressive strength and ductility. This eliminated the need to increase column size or to add steel reinforcement to existing columns. The fabric was supplied in 24-inch wide tapes that were wrapped around the column in at least two layers. Along the height of the column, the bands of fabric were continued by butt joints (Figure 3, see page 35).

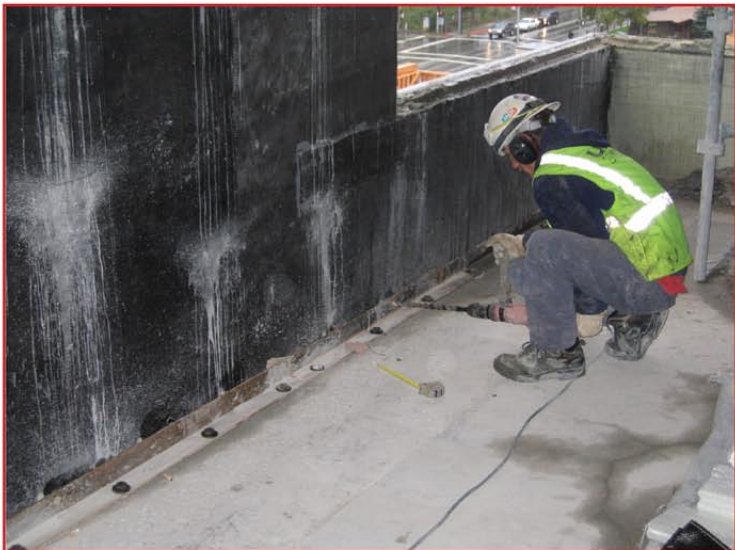
during a seismic event. Both interior and exterior shear walls were identified as over-stressed, with localized high stress

Figure 4: Retrofit of walls with carbon fabric and connection of wall to floor

in the spandrel and cantilevered wall panels. The majority of this retrofit concentrated on floors 5 to 14. A discussion of the FRP design solution for each type of structural element follows:

The north and south side bearing walls above the 4th floor were converted to shear walls by applying biaxial carbon FRP on the inside face of the wall up to the 9th floor. Vertically oriented unidirectional glass fabric was placed between the 9th and 10th floor. Additional horizontally oriented unidirectional glass fabric was applied on the end of the new exterior shear wall constructed up to the 4th floor. Specialized structural details were developed to ensure proper load transfer to the floor system at each level (Figure 4).

For the east and west side shear walls, wall boundary elements were created by wrapping horizontally oriented unidirectional glass fabrics on the three sides of window corner openings. Additional 5/8-inch A307 bolts were installed through the wall to provide confinement of the boundary elements.

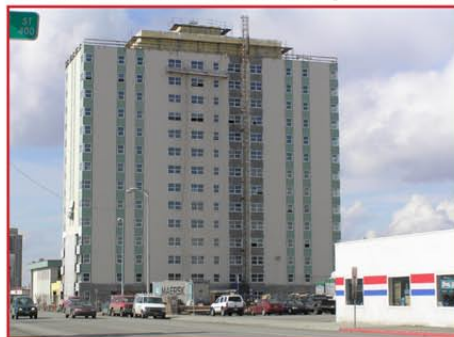
Figure 5: View of nearly-complete and painted building

installed on the interior side of the walls (Figure 5). Also, due its historical landmark status, there was significant public pressure imposed to finish the building retrofit under a tight deadline.
