Durability of GFRP Reinforced Concrete in Field Structures

by **A. Mufti, M. Onofrei, B. Benmokrane, N. Banthia, M. Boulfiza, J. Newhook, B. Bakht, G. Tadros, and P. Brett**

Synopsis: Recently, ISIS Canada studied the durability of GFRP in concrete in several field structures across Canada. The objective of the study was to provide the engineering community with the results of the performance of GFRP materials that have been exposed to the concrete environment in built structures. Cores of GFRP-reinforced concrete were removed from five field structures. Analytical methods, namely optical microscopy, scanning electron microscopy and energy dispersive x-ray, differential scanning calorimetry and infrared spectroscopy, were used to determine the composition of GFRP after being subjected to the alkaline environment of concrete for five to eight years. Three research teams from four Canadian universities performed microanalyses of the GFRP and surrounding concrete independently. Results indicate that no deterioration of GFRP took place in any of the field structures. No chemical degradation processes occurred within the GFRP due to the alkalinity of the concrete. The overall conclusi

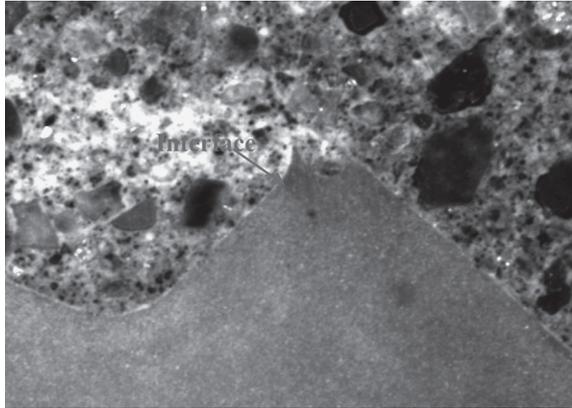
OM examinations of the interface between the GFRP and concrete of the cores from the five field structures exposed to natural environmental conditions show no loss of bond between the GFRP and concrete. Figures 5 and 6, showing OM results for cores from the Crowchild Trail and Chatham bridges, respectively, are typical of all OM observations. It can be seen in these figures that there are no gaps between the GFRP and concrete, thus confirming a good bond between the two materials.

Figure 5 – OM image of cross-section of GFRP from Crowchild Trail Bridge

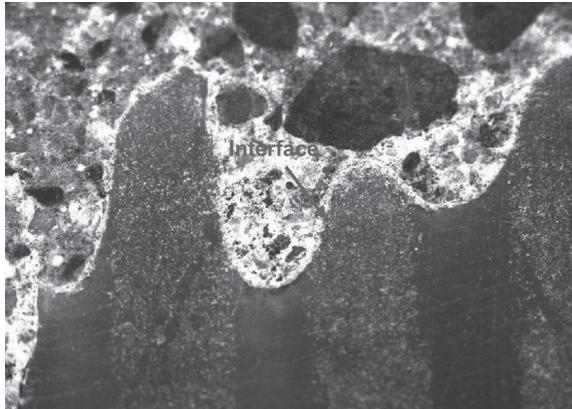
Figure 6 – OM image of cross-section of GFRP from Chatham Bridge.

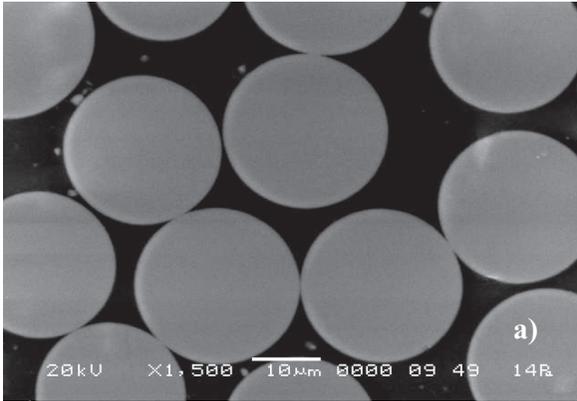
SEM and EDX were used to determine in detail the effect of exposure on the constituent materials of the GFRP. SEM examination of cores from all five structures confirmed that there was no sign of any damage to the FRP. A micrograph of the cross-section of a GFRP bar from the Crowchild Trail Bridge is presented in Fig. 7, in which it can be seen that at the plane under examination, the fibers have not lost any cross-sectional area. Similarly, a micrograph of a longitudinal section of a GFRP sample from the Chatham Bridge, presented in Fig. 8, shows no degradation of the fibers in the direction of the fiber axes. Although the entire surface of each specimen was examined, attention was focused primarily to areas close to the GFRP/concrete interface.

Results from SEM analyses presented in Figs. 7 and 8 are typical of all other SEM analyses, which have shown that the individual fibers are intact with no gaps between fibers and the matrix. There is no evidence of deterioration of the glass/matrix interface. A good contact between individual glass fibers and the matrix, between sand grains and the matrix as well as between concrete and the matrix was observed for all specimens. The SEM analyses confirmed that the GFRP in the five structures did not show any evidence of attack from the alkali in concrete.

Figure 7 – Micrograph of cross-section of GFRP from Crowchild Trail Bridge.

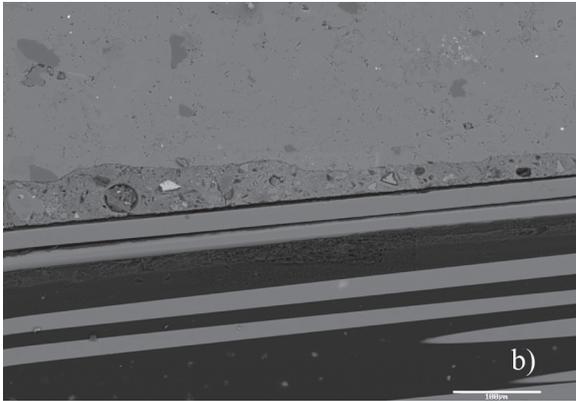
Figure 8 – Micrographs of longitudinal section of GFRP from Chatham Bridge.

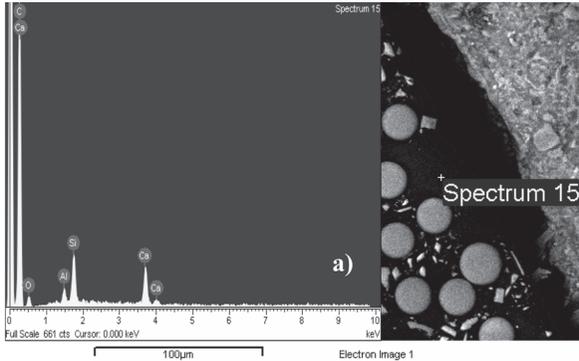
From two of the examined structures, samples of GFRP were saved and kept in storage for possible future investigation. These samples, referred to herein as the control specimens, provide an opportunity to compare the chemical composition of the GFRP extracted from in-service structures; the latter specimens are referred as the 'in-service' specimens. The EDX spectra of the in-service and control GFRP specimens from the Joffre Bridge are presented in Figs. 9 and 10, respectively. It can be seen that the matrix in both specimens contains mainly carbon, as it should. However, some additional elements such as Si, Al, and Ca have also been detected. Since the EDX spectrum of the

in-service specimen is almost identical with that of the control specimen, the presence of elements other than C in the matrix could be attributed to contamination introduced during the preparation of the specimens for the microscopic examination.

Figure 9 – EDX spectra of in-service specimen from Joffre Bridge.

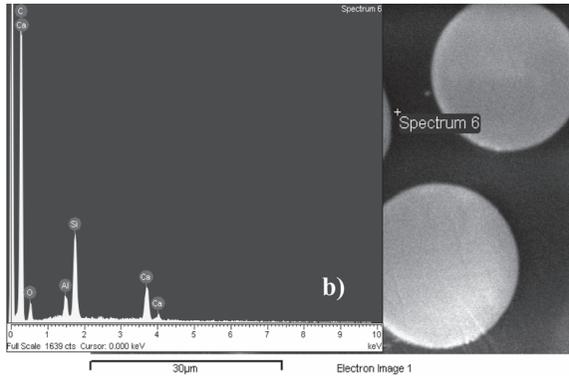
Figure 10 – EDX spectra of control specimen from Joffre Bridge.

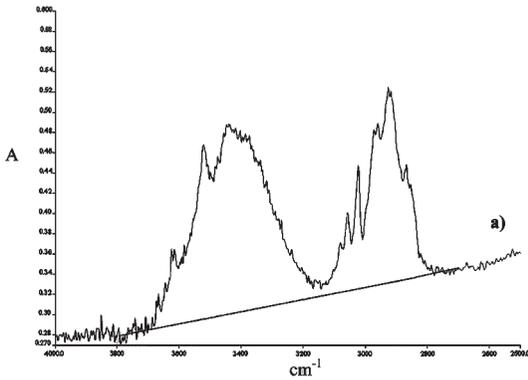
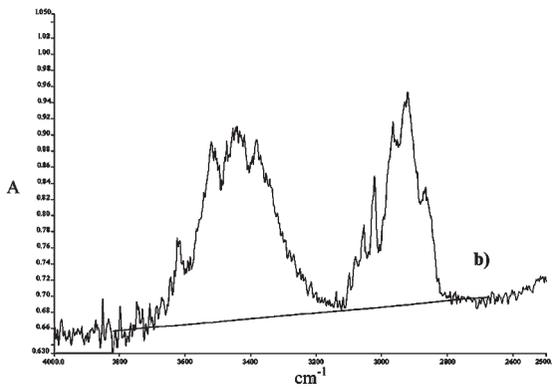
The durability of the matrix is governed to a large extent by the chemical nature of the structure of the polymeric chain. In their structure, all resins have ester bonds, which are the weakest link of the polymer. A possible degradation mechanism of the matrix is the alkali hydrolysis of the ester linkages. Due to the alkaline environment in concrete, alkali hydrolysis is expected to some extent. During the hydrolysis reaction, the OH^- induces ester linkage attack and the resin chain is broken. Consequently, the structure of the resin is disrupted and the material properties are changed. The resin material degrades and eventually will not be able to transfer stresses to the glass fibers and to protect the glass fibers against alkaline attack. Changes in the amount of hydroxyl groups present in the composite material provide insight into the hydrolysis reaction. The relative amount of hydroxyl groups in the specimens were measured by determining the ratio of the maximum of the band corresponding to the hydroxyl groups at 3430 cm^{-1} and the band corresponding to the carbon-hydrogen groups at 2900 cm^{-1} in the FTIR spectra. The C-H content is assumed to be constant. Since the vinyl ester resins naturally contain hydroxyl groups, all the spectra present a strong absorption band in this region. Typical results of the FTIR analysis of control and in-service GFRP samples from Hall's Harbor Wharf are presented in Figs. 11 (a) and (b), respectively. It can be seen that there is no significant change in the spectra of the two specimens. Table 1 lists the content ratio of OH/CH for the control and in-service specimens from the Joffre Bridge and the Hall's Harbor Wharf. The results show very little changes in hydroxyl content in the in-service specimens. In effect, the OH/CH ratio decreases in the in-service sample indicating that the hydrolysis reaction did not occur in the specimens during the exposure to natural environmental conditions.

Figure 11 – FTIR spectra of GFRP from Hall's Harbor Wharf: (a) control specimen, and (b) in-service specimen.

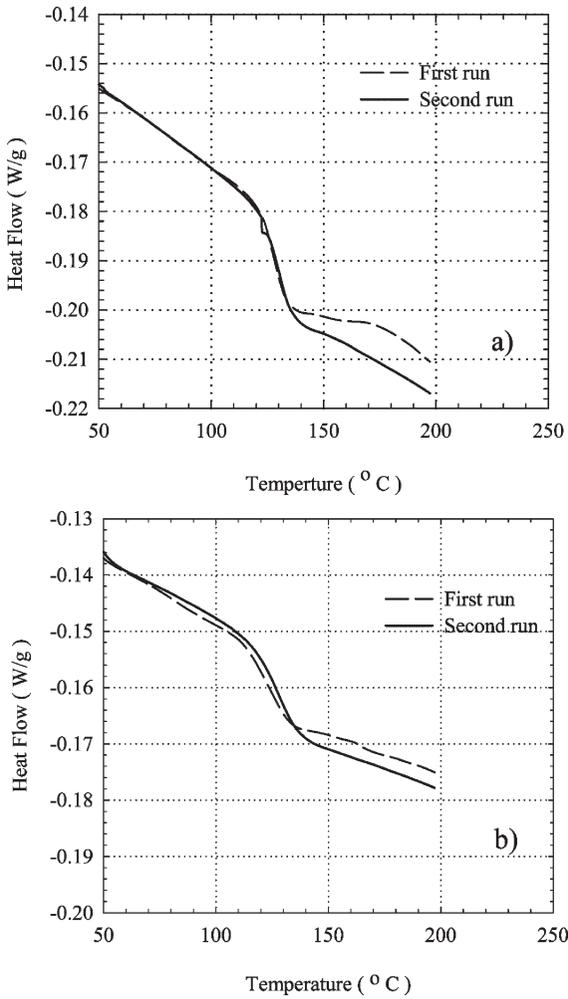
The results for the Hall's Harbor Wharf control specimen indicated a difference between the values of the T_g in the two heating runs indicating that the matrix in the GFRP ISOROD rod was not fully cured. In the 2nd heating run the resin was fully crosslinked and the T_g value increased from 105°C in the 1st run to 125°C. However, the T_g value for the exposed specimens did not show any significant change between the two heating runs, suggesting that the post-cure of the matrix occurred in the concrete structure. It is quite likely that the completion of the crosslinking process was due to structure exposure to high temperature during summers. The control samples on the other hand were stored at room temperature that did not initiate the post-curing process. Overall, the T_g results indicate that the structure of the matrix has been not disrupted by the exposure conditions at the Hall's Harbor Wharf. Similarly, no significant differences in the T_g values were observed for the control and in-service specimens for the Joffre Bridge. However, it should be noted that the T_g value for the 16 mm diameter GFRP C-Bar was 108°C which, even fully cured, was low compared with the T_g value for other GFRPs used in the Hall's Harbor Wharf and Crowchild Trail Bridge. The low value is attributed to manufacture formulation. High T_g values, ranging between 123 and 128°C, were measured for the 9 mm diameter GFRP C-bar. The T_g values for both types of GFRPs suggest no structural disruption of the matrix due to exposure to natural conditions at the Joffre Bridge. The thermographs for 9mm control and in-service specimens from the Joffre Bridge are presented in Figs. 15 (a) and (b). The results indicate that GFRP material was fully cured and the thermograph for the in-service specimen (Fig. 12a) was very similar to the thermograph for the control specimen (Fig. 12b).

Figure 12 — Thermographs for GFRP from Joffre Bridge: (a) in-service specimen, and (b) control specimen.
