FRP Application in Underwater Repair of Corroded Piles

by R. Sen, G. Mullins, K. Suh, and D. Winters

Keywords: corrosion; FRP; instrumentation; piles; repair; underwater

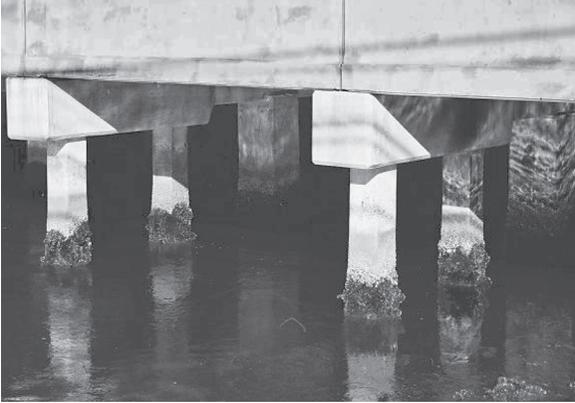
Preparatory work -- Pile surfaces were covered with marine growth (Fig. 2) that had to be scraped off. Additionally, two of the four corners that were not rounded but chamfered had to be ground using an air-powered grinder. This was a difficult operation particularly for sections that were below the water line. A quick-setting hydraulic cement was used to fill any depression, discontinuities and provide a smooth surface. Just prior to wrapping the entire surface was pressure washed using freshwater to remove all dust and marine algae.

Figure 2 — Marine Growth, Allen Creek Bridge, Clearwater

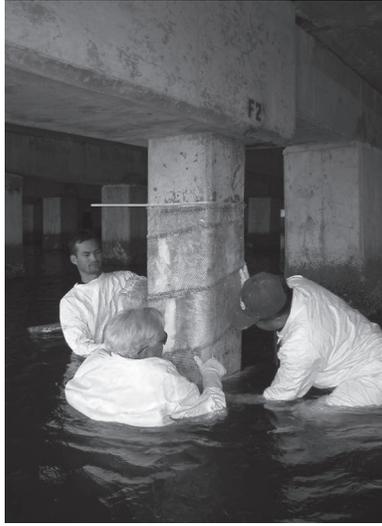
FRP wrapping -- Two different schemes using two different materials were evaluated. In each scheme four piles were wrapped with two other instrumented piles serving as controls. In the first scheme, cofferdam construction was used and the piles wrapped using a bi-directional FRP in a wet lay up under dry conditions. As this was wrapped under ‘perfect’ conditions, its performance provided a means for evaluating piles that were directly wrapped in water using a new water activated resin (Fig. 3). The latter scheme was a pre-preg system developed by Air Logistics.

Figure 3 — Underwater Wrapping, Allen Creek Bridge, Clearwater

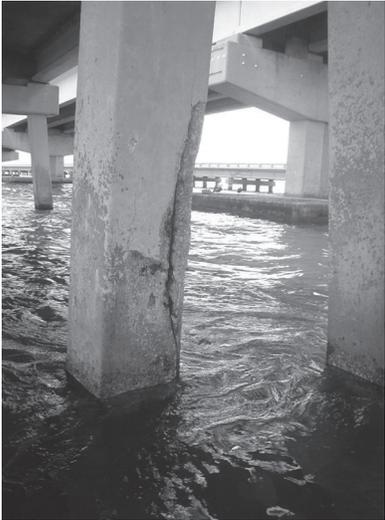
Figure 8 — Heavily Corroded Pile, Gandy Bridge, Tampa

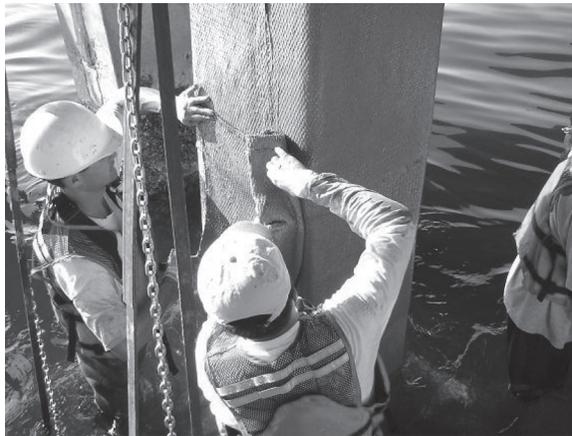
FRP wrapping -- The same two systems used in the Friendship Trails Bridge were also used in the Gandy Bridge. The operation was identical excepting that the system used for saturating the fibers for the Fyfe system was modified. Instead of using the saturating machine, hand methods were used as they were found to be speedier and equally effective. The entire operation went smoothly and the wraps were installed in about an hour each (Fig. 11).

Figure 11 — Underwater Wrapping, Gandy Bridge, Tampa

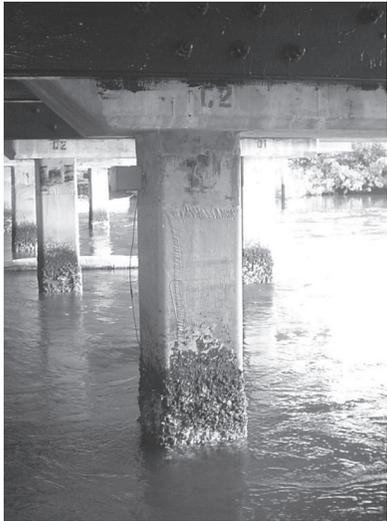
Fig. 12 shows the condition of the wrapped piles in the Allen Creek Bridge after almost two years. The FRP appears to be in reasonable condition although marine growth has formed on the surface of the wrap. This is borne out by corrosion rate measurements shown in Fig. 13. These cover a period of nearly two years from the time the piles were first wrapped in March 2003.

Figure 12 — View of Wrapped Piles, Allen Creek Bridge, Clearwater after Two Years

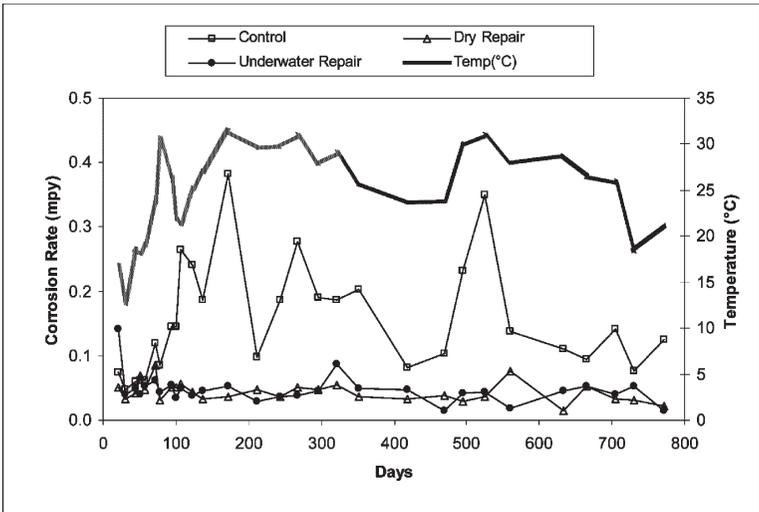
Fig. 13 shows the average corrosion rate measurements in unwrapped controls, and piles wrapped under dry (cofferdam) and wet conditions. The variation in temperature is also shown. Inspection of Fig. 13 shows that the corrosion rate in the wrapped piles is low and stable while that of the unwrapped piles showed continual fluctuation possibly due to environmental factors such as temperature and tide change. According to criteria proposed by Clear¹⁷, corrosion is not expected in the wrapped piles and it may occur in 10–15 years in the unwrapped piles.

Fig. 13 also shows that the corrosion rates for the piles wrapped under dry or wet conditions are quite similar. This suggests the underwater epoxies performed well and the piles are being provided comparable protection. Since strengthening is a bond critical

Figure 13 — Results of Corrosion Rate Measurement at Allen Creek Bridge, Clearwater
