Seismic Retrofit of McKinley Tower

Anchorage, Alaska

Submitted by QuakeWrap, Inc.

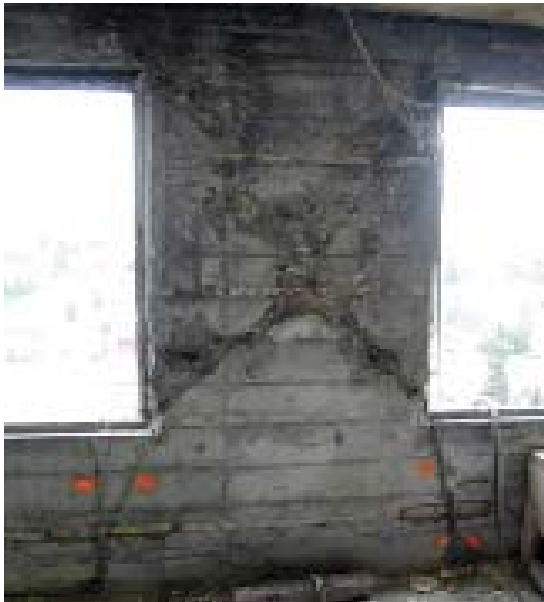
Fig. 1: Damage to walls caused by the earthquake

The building survived the 1964 “Good Friday” Alaska Earthquake, which had a Richter scale magnitude of 9.2, making it the strongest earthquake in North America to date. Damage to the building consisted of shear failure of exterior spandrel beams and extensive diagonal cracking of exterior walls (Fig. 1). The east vertical pier on the north-end wall failed up to the third floor at a construction joint and similar failure was observed on the south-end wall. The walls around the building’s core suffered light diagonal and horizontal cracks at construction joints, with damage being more severe from the third to sixth floors.

After the earthquake, the building was vacated and put up for auction. In 1965, some repair work was done, consisting of patching exterior cracks, replacing damaged reinforcement of ornamental spandrel beams, removing loose material, and fixing spalled areas in the stairwell and elevator core.

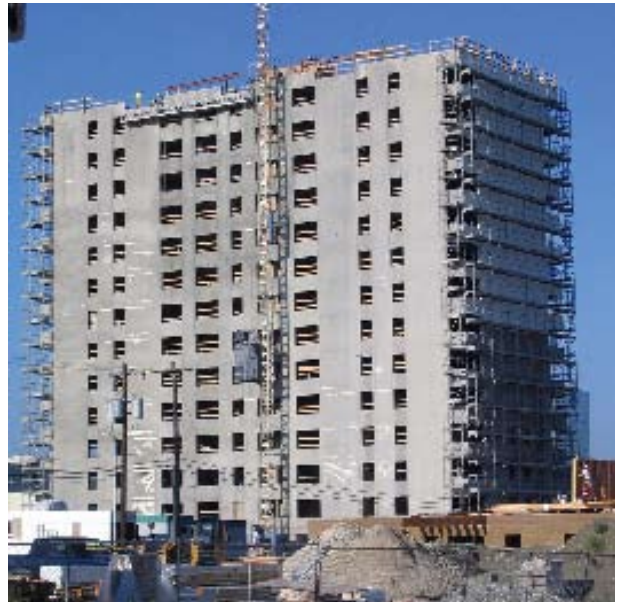
Fig. 2: Stripped building was an eyesore for over 20 years

The current owner acquired the building in 1998. Since then, extensive structural repairs were undertaken to bring the building up to current seismic code requirements. Due to the excessively high costs involved, however, all repair work was stopped. As a consequence, the building remained vacant for more than 20 years, becoming an eyesore in downtown Anchorage (Fig. 2).

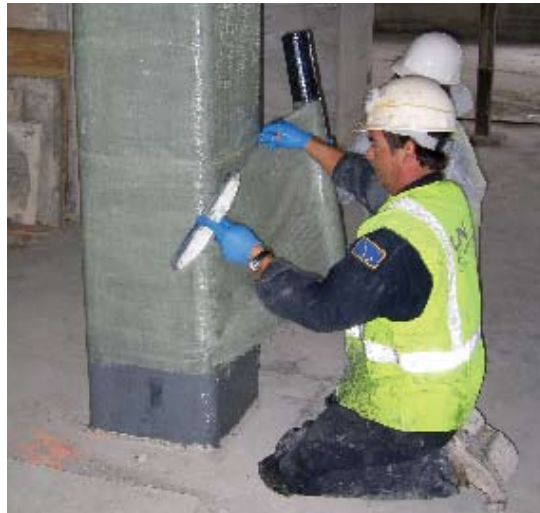
Fig. 3: Wrapping of columns with GFRP

Unidirectional glass FRP (GFRP) fabrics were applied to all columns to provide a confining effect to the concrete, which increased its compressive strength and ductility. This eliminated the need to increase the size and steel reinforcement of all existing columns. The fabric was supplied in 24 in. (61 cm) wide tapes that were wrapped around the column in two or more layers; along the height of the column, the bands of fabric were butt jointed (Fig. 3).

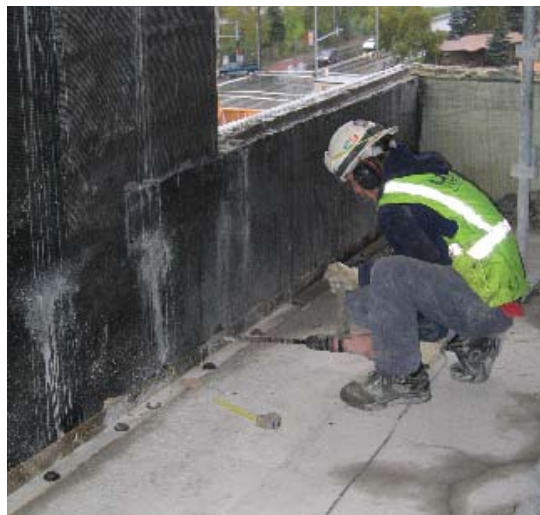
Fig. 4: Steel angles and bolts for transfer of loads from shearwalls to floors

The north- and south-side bearing walls above the 4th floor were converted to shearwalls by applying biaxial carbon FRP on the inside face of the wall up to the 9th floor. Vertically oriented unidirectional glass fabric was placed between the 9th and 10th floor. Additional horizontally oriented unidirectional glass fabric was applied on the end of the new exterior shearwall constructed up to the 4th floor. To assure proper load transfer to the floor system at each level, a special structural detail was developed (Fig. 4).

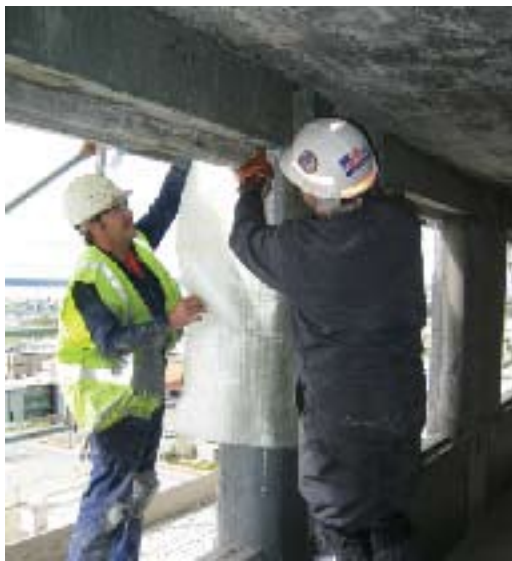
Fig. 5: Reinforcing boundary elements in shearwalls with GFRP

Coupling beams for east and west shearwalls were reinforced for shear by applying biaxial GFRP on the inside face (Fig. 5). The same design was applied on the inside face for shear reinforcement of cantilever beams on the west and east building elevations. For the cantilever beams on the north and south elevations, shear reinforcement was achieved by applying a biaxial carbon fabric on the inside face. Cantilever beams were also reinforced for negative flexural strength by applying unidirectional carbon FRP to the top face.
