SEISMIC RETROFIT OF THE LOS ANGELES COUNTY MUSEUM OF NATURAL HISTORY

BY MO EHSANI

SEISMIC UPGRADE OF THE ROOF SLAB WITH CFRP

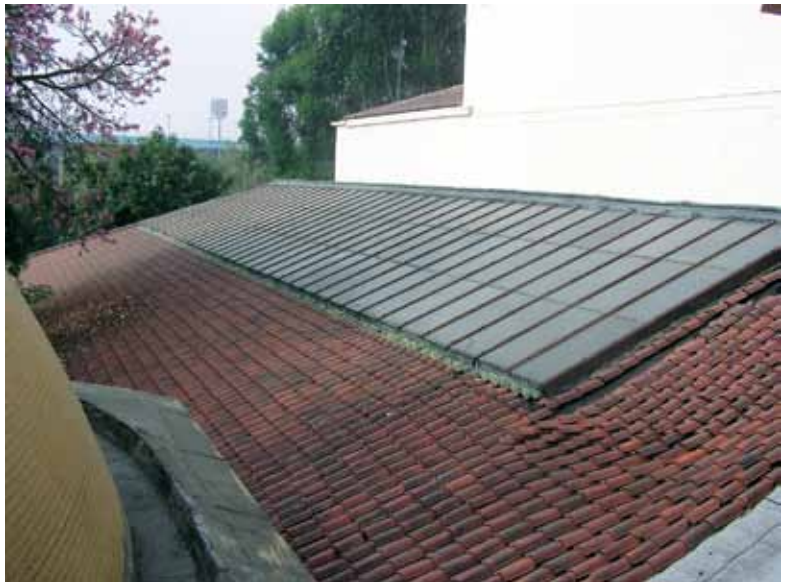
Fig. 3: View of roof and shingles before seismic upgrade

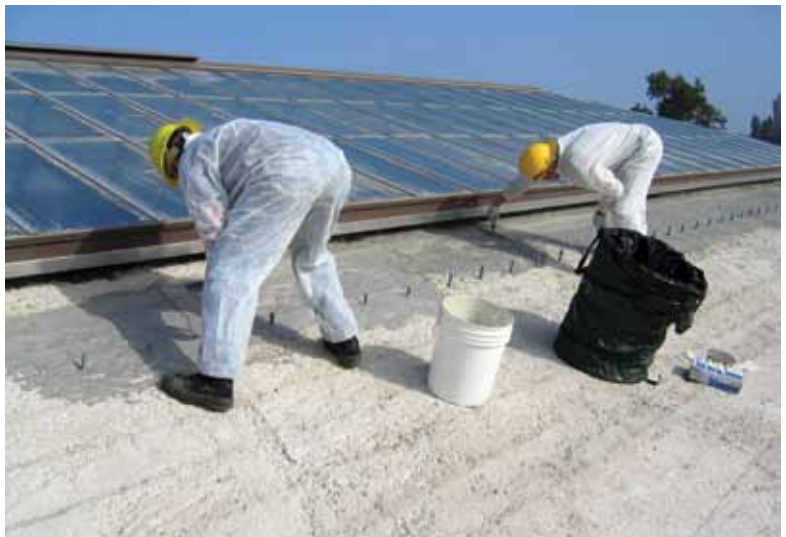
- **Roof surface preparation:** Once the shingles and tile nailers were removed, it was found that the surface of the deck was extremely rough and weak. A number of products were tested to see if the sloping roof surface could be made smooth. Most of these products were cost-prohibitive. A special non-sagging thixotropic two-component epoxy was selected that could be troweled on the surface of the roof. Pull tests were conducted in the field to ensure that the material was suitable for developing the full strength of the system. This activity added nearly 3 weeks of additional work that was not originally planned.

Fig. 4: Smoothing the rough concrete deck

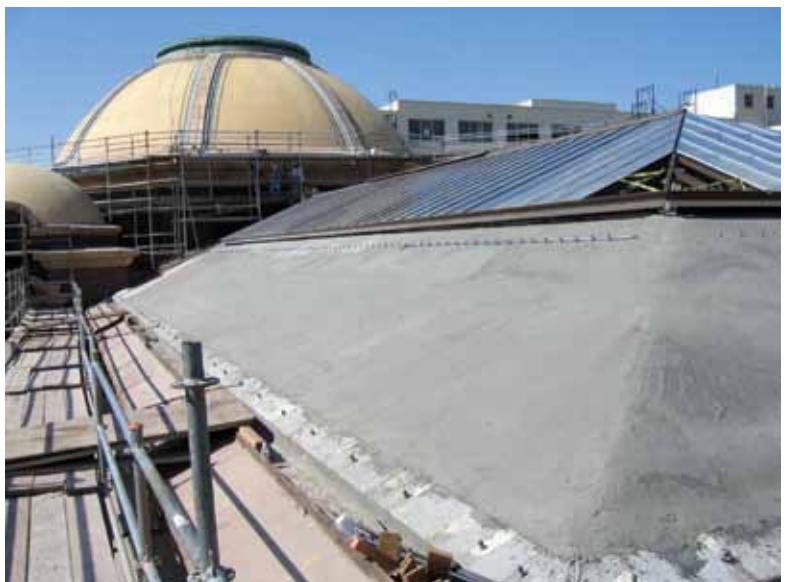
Fig. 5: Roof deck after it has been prepared for CFRP installation

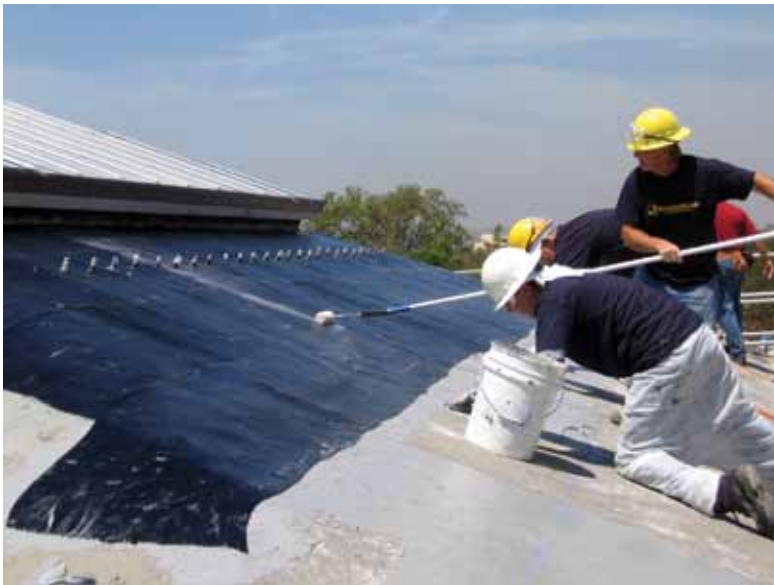
Fig. 6: Installation of CFRP strips over protected steel bolts

- Protection of steel bolts:** As part of the connection of the newly added steel frame, steel bolts were penetrating through the slab. Direct contact between steel and carbon may lead to galvanic corrosion of the steel. To prevent this, the threaded heads and protruding shanks of the bolts were protected during the installation and the carbon fabric was cut in a circular area around the shank. In addition, because long steel plates were going to be laced over the bolts, a 12 in. (305 mm) wide strip of glass fabric was installed along the bolt lines to prevent direct contact between the steel plate and the CFRP.

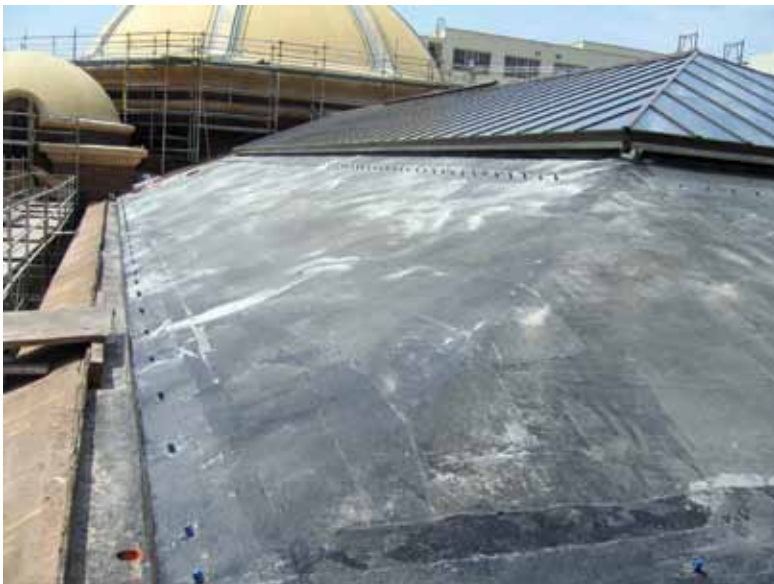
Fig. 7: Retrofitted slab after broadcasting of sand on top of CFRP

- Slippery slope:** Once the FRP is cured, it leaves a fairly smooth and slippery surface. Considering the steep 25-degree slope of the roof, there was concern for the safety of the workers from other crafts that would have to walk on such a smooth surface. Consequently, immediately following the installation of CFRP, a thin film of resin was applied as a top coat and sand was broadcast on top of that. Upon curing of the epoxy, this resulted in a non-slippery surface.

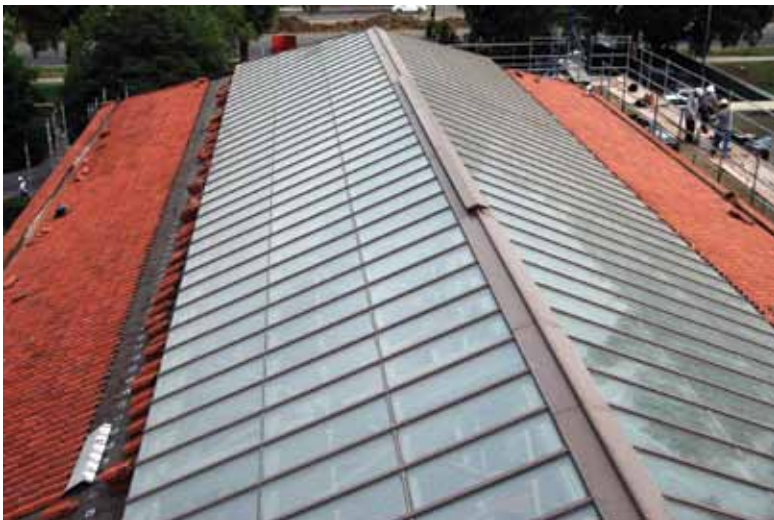
Fig. 8: Restored shingles replaced on the roof with new skylights

- **Maintaining the historic appearance:** The application of thin layers of CFRP kept the overall appearance of the roof structure virtually unchanged. Upon completion of the project, the shingles that were salvaged and restored were placed on the roof, giving back the historic building its original beauty. As a result, the owner commented, “seismically upgrading and structurally improving a building listed on the National Historic Record without impacting its appearance was a tall order and without your critical work would have been virtually impossible.”
