# Restoration of Large Diameter Prestressed Concrete Cylinder Pipelines

Water Flow, New Mexico  
Submitted by QuakeWrap, Inc.

*San Juan Generating Station, New Mexico*

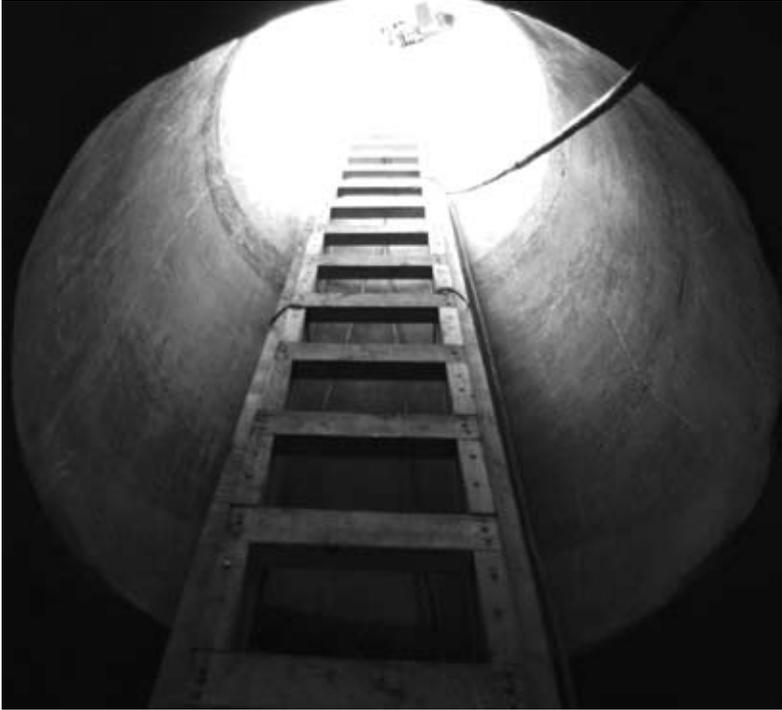
*The only access to pipe was through 30 in. (760 mm) diameter manholes*

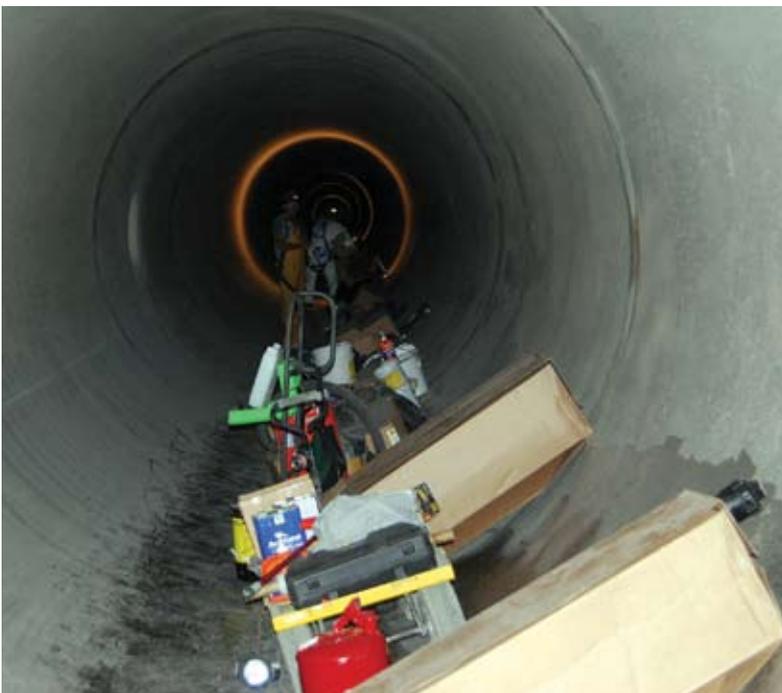
*Materials were spaced out throughout the 840 ft (256 m) long section of pipe*

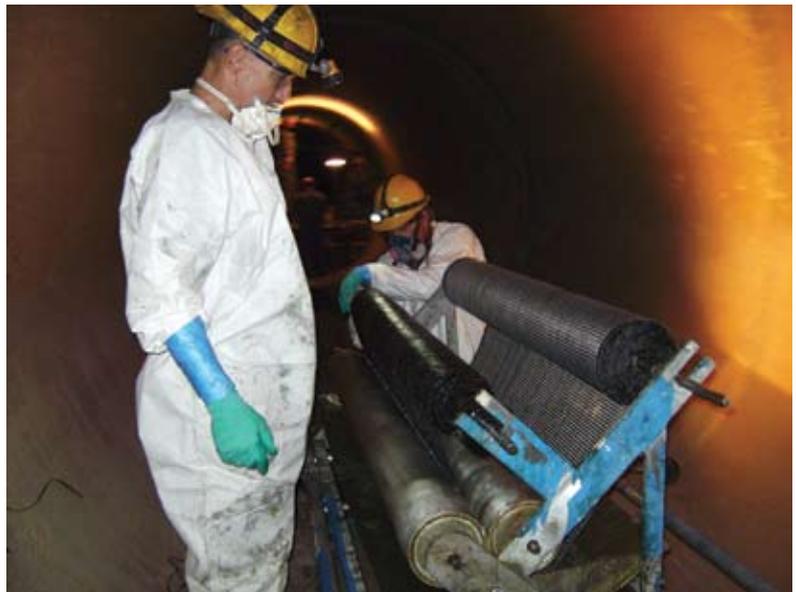
*Saturating machine reassembled inside the pipe*

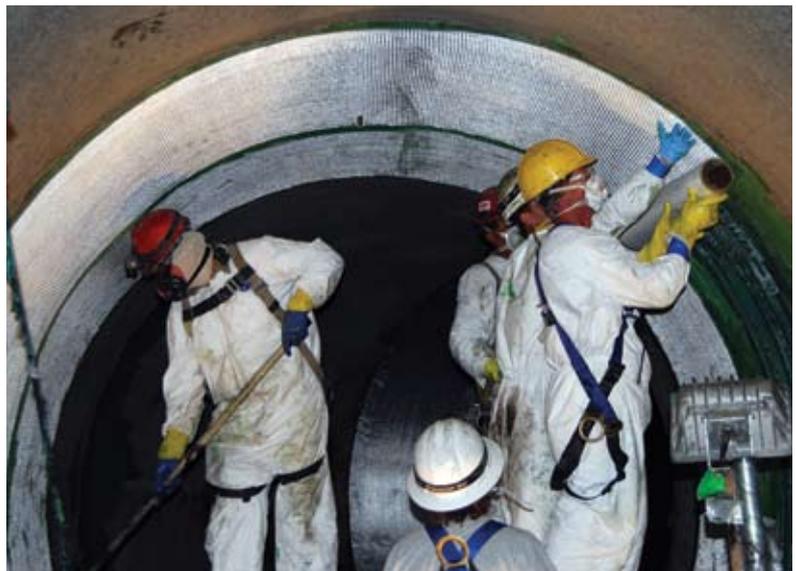
*Installation of glass fabric on pipe*

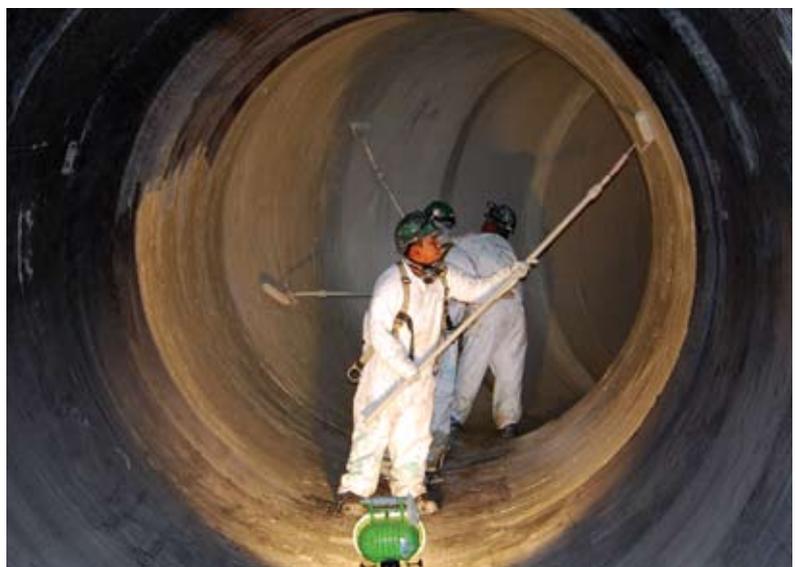
*Application of final finish coating over installed FRP*

A final top coating of epoxy was applied for improved abrasion resistance and to minimize friction losses. Because the shutdown units could not be placed back into service without flooding the PCCP pipes, the CFRP liner had to be installed and fully cured within a 4-week period to avoid service delays. Therefore, the CFRP liner installation was in the critical path of the maintenance program. Even with the complex geometries encountered, the liner was installed in a 3-week period—1 week ahead of schedule.
