CARBON FRP REPAIR OF UTILITY PULL BOXES

Name: Tucson Electric Power Pull Box
Type: Utility Pull Box
Location: Tucson, Arizona
Completed: May 2007

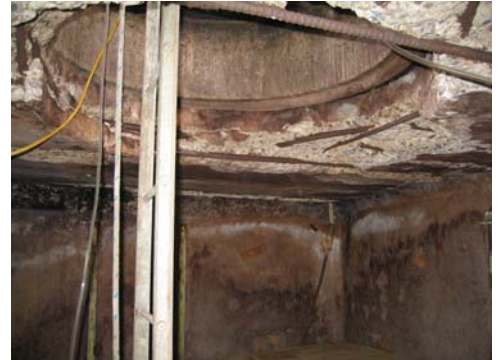
Tucson Electric Power Company (TEP) had several underground pull boxes that exhibited severe corrosion problems in the top slab (ceiling). The degree of concrete and steel reinforcement deterioration compromised the structural integrity of the box and the value of the power cables servicing important industrial facilities in the area.
