FRP REPAIR OF CONCRETE BEAMS IN CONDOMINIUM BUILDING

Name: Oceans One Condominium
Type: Condominium Building
Location: Daytona, Florida
Completed: May 2006

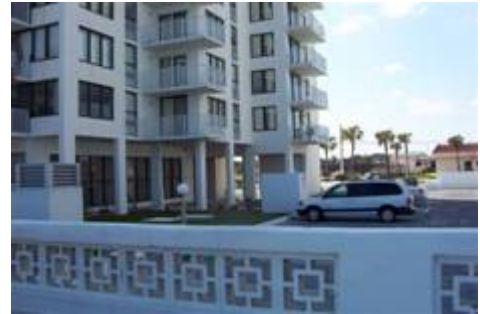
The parking structure of the Oceans One Condominium in Daytona, Florida was experiencing corrosion damage and shear cracking in many of its beams.

Corrosion had worn away at the structure, and was threatening its integrity. In addition, shear cracks had appeared and the building needed to be strengthened. To complicate the repair, several bolted steel plates were protruding from the beam, making a smooth wrap more difficult.
