## FRP REPAIR OF CORRODED PEDESTALS OF A COOLING TOWER

**Name:** Tucson Main Library  
**Type:** Office Building  
**Location:** Tucson, Arizona  
**Completed:** June 2005

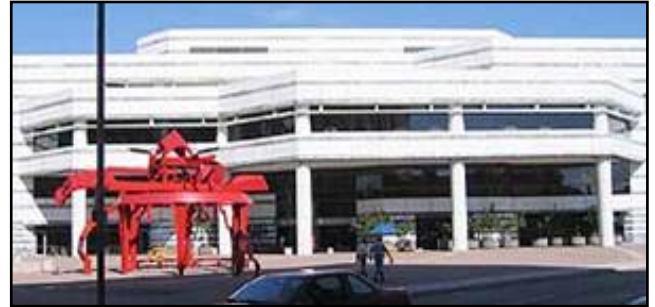
Leaking of water from the cooling tower located on the roof had resulted in severe corrosion damage to the four concrete pedestals that supported the tower.

As part of the replacement of the cooling tower with a new one, the pedestals required to be repaired and protected against future damage by corrosion.
