Field Evaluation of Masonry Walls Strengthened with

FRP Composites at the Malcolm Bliss Hospital

Department of Civil Engineering

CIES 99-12

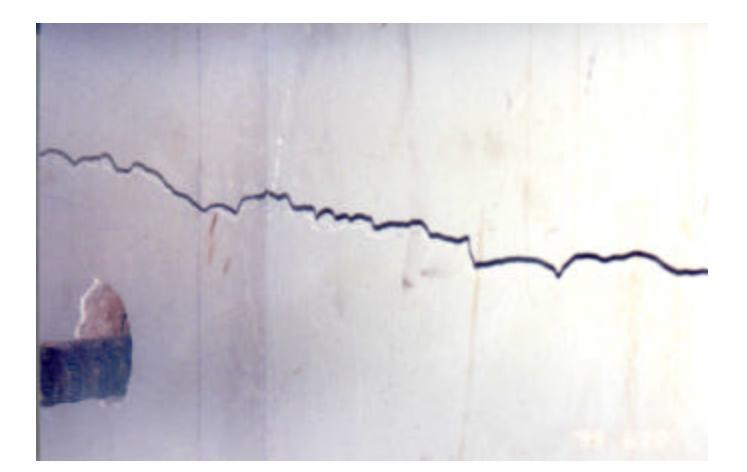
This wall was tested as a control specimen to determine the load-carrying capacity with the inclusion of the cementitious plaster. At 12 kips a first major horizontal crack was visible at mid-height, along the full bed joint (see Figure 5.1). At an applied load of 26 kips a second horizontal crack is formed, measured at a quarter height from the top of the wall. The peak load was reached at 30 kips for a mid-height deflection of 0.16 in as can be observed in Figure 5.2. The final failure is produced by a shear-compression combination effect, which ended with the fracture of the tiles placed at the bottom region of the wall. At the final stage part of the plaster, located at the bottom region of the wall is delaminated. It is important to highlight that in this specimen as well as in the remaining ones, no damage was observed on the exterior face of the veneer wall.

Figure 5.1. Horizontal crack in Wall 1

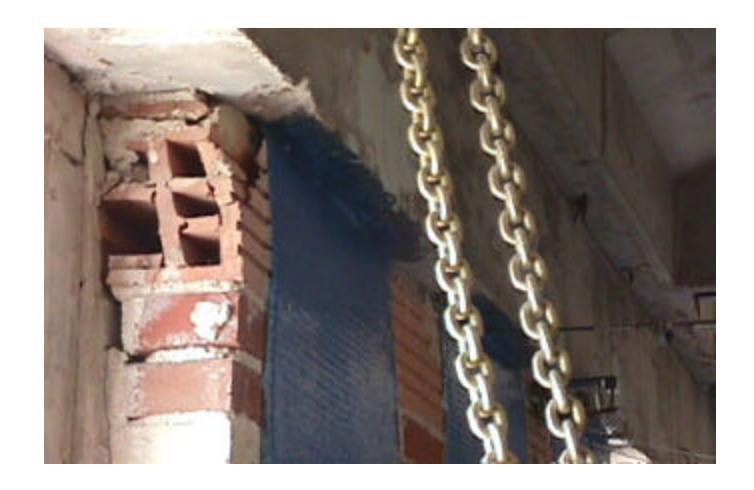
This wall had a similar strengthening scheme to Wall 3. The significant difference was that the glass fibers were applied directly on the masonry, meaning the plaster was previously removed. It was observed that the FRP reinforcement performed in a better fashion than the previous wall due to this alteration in the FRP installation procedure. The failure was caused by fracture of the masonry units located at the to of the wall (see Figure 5.5). However, the fact that the FRP was attached to the masonry made possible to observe a behavior more ductile than that observed in the previous wall, as can be observed in Figure 5.6. The maximum load recorded was 34 kips with a corresponding mid-height deflection of 0.2 in.

Figure 5.5. Fracture of Tile Unit

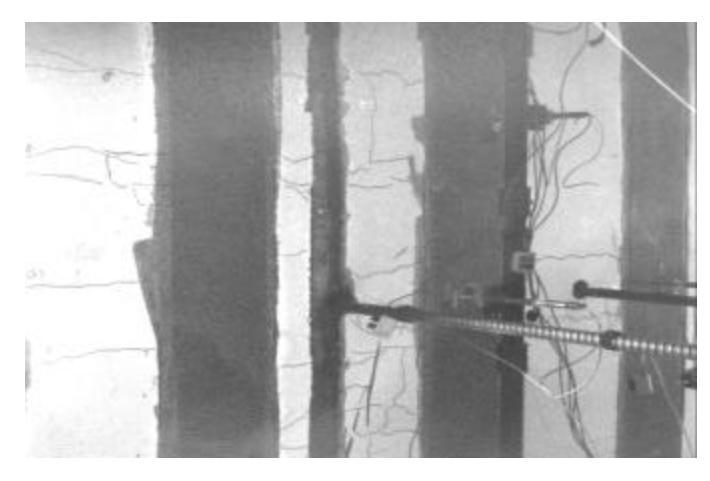
This wall was strengthened with half of the reinforcement used in Walls 3 and 4, meaning three strips 10 in. wide of GFRP fibers were attached to the wall surface. A horizontal crack above the mid-height course was observed at a load of 13 kips. Similarly to the previous walls, the failure was caused by a shear-compression combination effect at the lower region of the wall. The failure occurred at a load of 33 kips for a corresponding mid-height deflection of 0.12 in (see Figure 5.7). By comparing this wall to Wall 3, a larger presence of cracks spread for almost 50% of the area was observed (see Figure 5.8).

Figure 5.8. Cracking in Wall 5

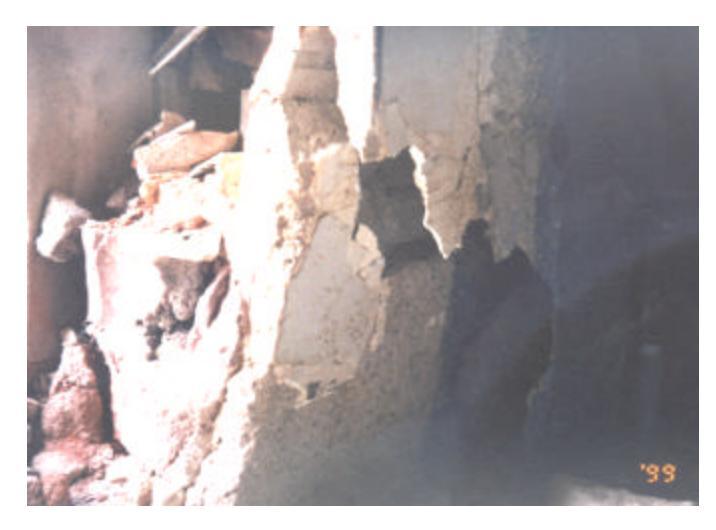
This wall was strengthened with three strips 20 in. wide of CFRP sheets. A major horizontal crack was observed at a load of 24 kips, running along the bed joint located above the mid-height course. The maximum registered load was 30 kips, for 0.06 in mid-height deflection, as observed in Figure 5.9. The failure, brittle and without warning, was caused by a shear-compression combination effect, which fractured some tile units located at the bottom of the wall. As a consequence, with the deflection increasing the plaster layer delaminated from the adjacent tiles as can be observed in Figure 5.10. This wall showed an atypical behavior compared to the other walls. As can be observed in the corresponding Height vs. Displacement curve in Appendix 2, the upper region of the wall displaced in opposite direction to the applied load.

Figure 5.10. Fracture of units at the bottom of Wall 6

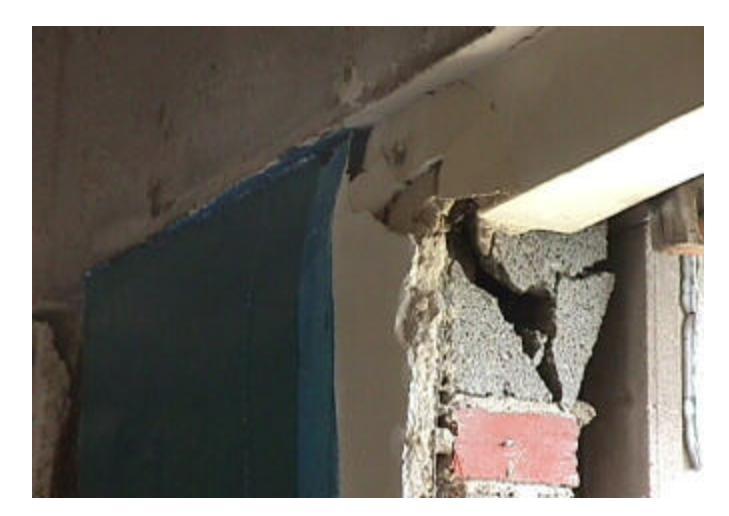
The strengthening geometry of this wall was similar to the previous wall, only that in this case AFRP sheets were used. This wall did not show large areas of cracking, only a major horizontal crack running along the mid-height was detected at a load of 24 kips. The peak load was 36 kips with a corresponding mid-height deflection of 0.12 in. (see Figure 5.11). Delamination of the plaster on the top region of the wall was observed as a consequence of the fracture of the tiles, as shown in Figure 5.12

Figure 5.12. Plaster Delamination

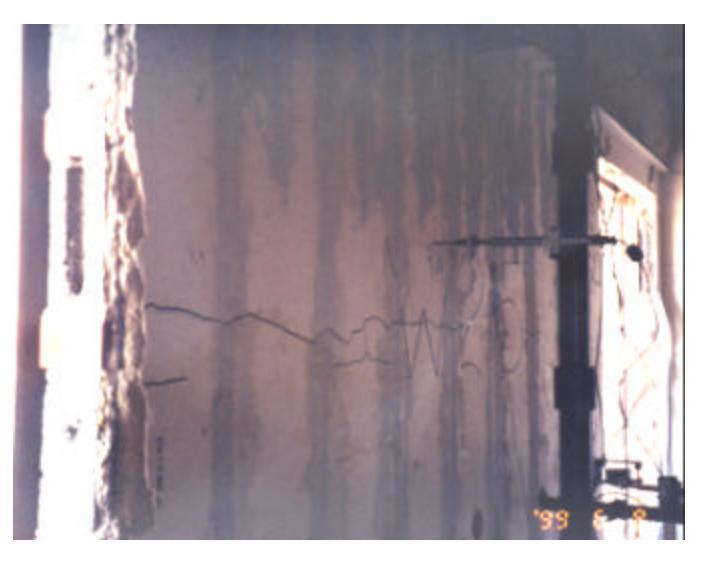
This wall was strengthened with eight #3 glass rods. The first visible crack was observed at 22 kips running along the upper joint of the mid-height course (see Figure 5.14). The wall failed at 24 kips for a mid-height displacement of 0.06 in (see Figure 5.15). The lower capacity may be caused by pre-existing cracking formed during the installation of the rods. The installation procedure weakened the by themselves already fragile clay tiles facilitating the failure. The failure was originated by a shear-compression combination effect, which fractured some tiles at the lower part of the wall.

Figure 5.14. Horizontal crack in Wall 9

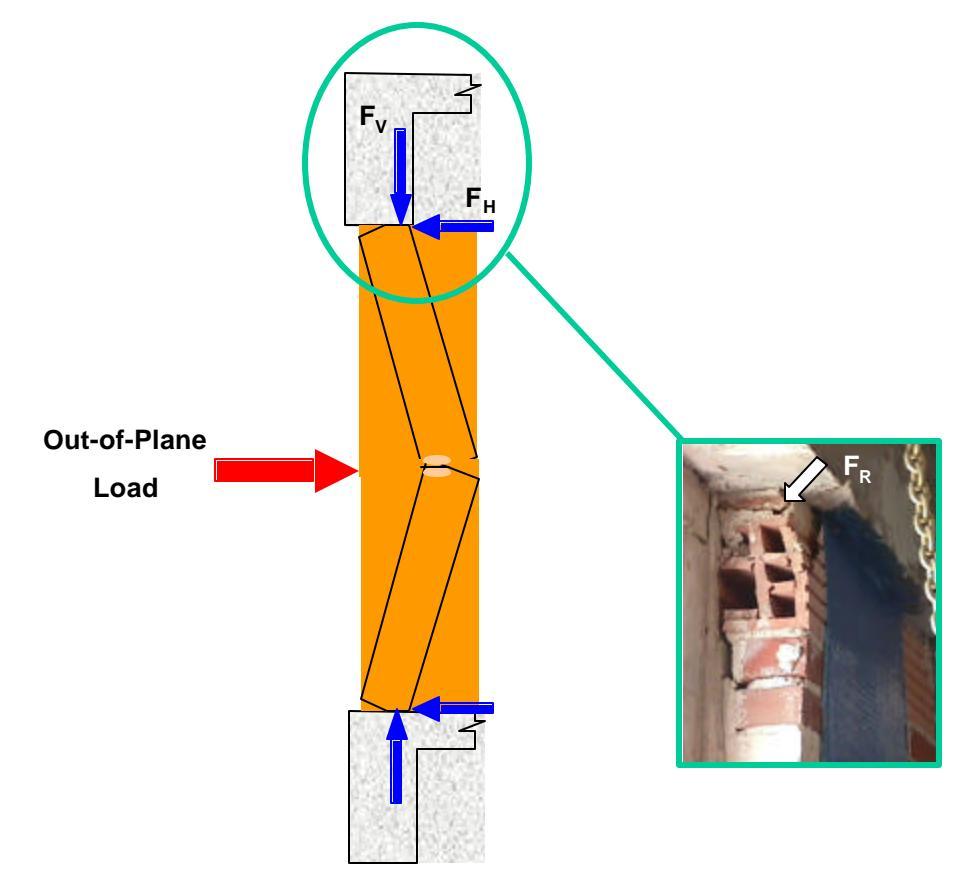
The failure of the URM walls was caused by the fracture of the tile units placed on the uppermost or bottommost courses. The fracture of these tiles is caused by angular distortion due to out-of-plane rotation, and mainly by a force generated by a shearcompression combination effect. Flexural cracking occurs at the supports due to negative moments followed by cracking at mid-height due to positive moments, as a result a threehinged arch is formed. When the deflection increases due to out-of-plane bending the wall is restrained against the supports, in this case the upper and lower beams. This action induces an in-plane compressive force (F_V in Figure 5.23), which accompanied by the shear force (F_H in Figure 5.23) in the support create a resultant force that causes the fracture of the tile (F_R in Figure 5.23). It is important to mention that normally the crushing is associated to the mortar joint; however, due to the brittle characteristics of the tile, the failure here was æsociated with the tiles. Once the fracture of the tiles was initiated, the adjacent plaster layer began to delaminate from the masonry surface. At this stage, since the FRP adhered to the plaster surface was not able of engaging the flexural cracks, the wall capacity degraded. In contrast where the externally bonded FRP strips were attached directly to the masonry, the failure was delayed because the FRP were able to engage the flexural cracks running through the bed joints. Consequently, the wall capacity was improved but the mechanism of failure did not change.

Figure 5.23. Out-of-Plane Mechanism of Failure

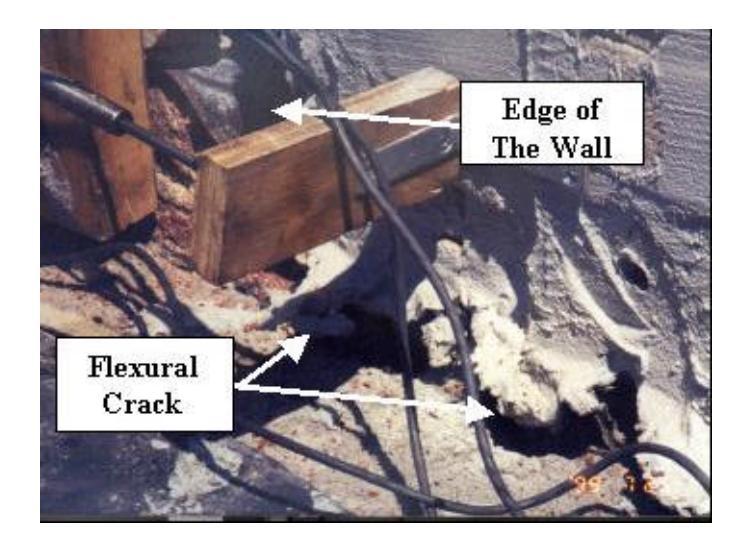
Wall 1 was used as control specimen to determine the flexural capacity of the walls subjected to in-plane loading prior to being strengthened. A flexural crack was visible at the base of the wall for a load of 2 kips. A maximum force of 10 kips occurred for a displacement of about 0.3 in. The wall lost carrying capacity due to the crack growth. The crack length when the test was stopped covered approximately two-thirds of the base length (see Figure 5.25). Base sliding was not observed at this final stage. Compared to the expected moment capacity of 122.6 ft-kips, which is associated to an inplane load of 22.3 kips, the wall exhibited a lower value. This can be attributed to a deficient anchorage of the vertical steel reinforcement, which could have been pulled out from the wall. As it was mentioned in Section 4, the steel reinforcement was placed in the space between the whytes, which was filled with mortar.

Figure 5.25. Flexural Crack at the bottom of Wall 1

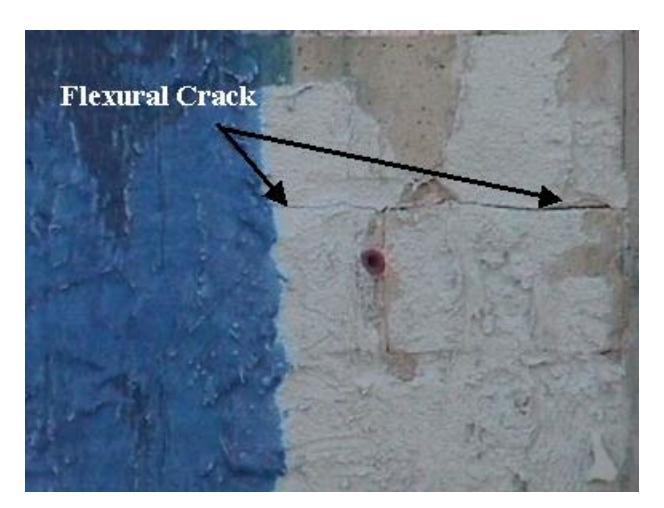
Wall 2 was strengthened with GFRP sheets vertically oriented and GFRP rods horizontally oriented. Similarly to Wall 1, a flexural crack was observed at the base of the wall for a load of 3.5 kips. Flexural failure was observed at 14 kips for a displacement of 0.04 in. Owing to the fact that the GFRP sheets bridged some horizontal cracks (see Figure 5.26), close to the bottom of the wall, an increase of 40% in capacity was observed. However, the main crack, which caused the failure was observed at the bottom of the wall, in similar way as compared to Wall 1.

Figure 5.26. Flexural Crack in Wall 2

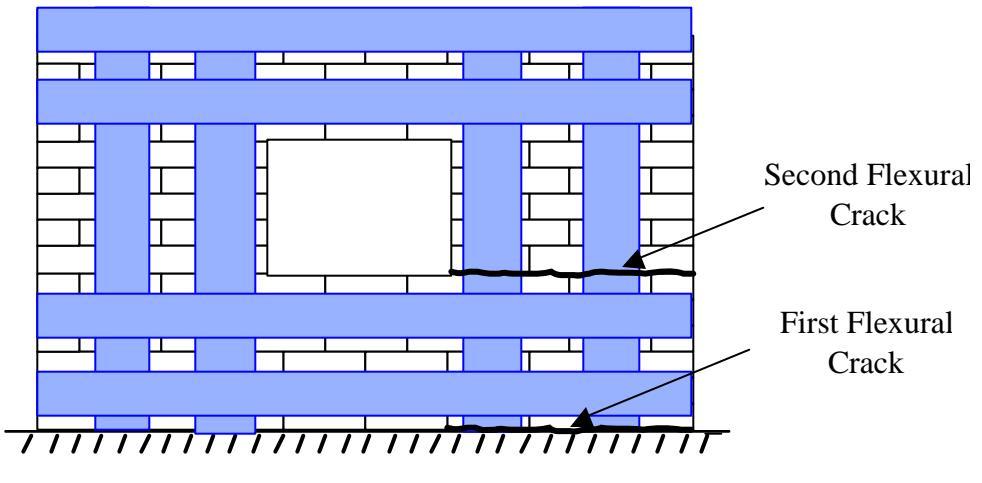
Wall 4 was also strengthened with GFRP sheets and near surface mounted GFRP rods. The purpose of testing this wall was to observe the influence of openings in the wall behavior. Two main flexural cracks were observed; one along the base of the wall, and the other at a height of 2.5 ft., at the cut point of the GFRP rods. The latter flexural crack ended up in the border of the opening, as observed in Figure 5.27.

Figure 5.28. Cracking Pattern in Wall 4.
