Rehabilitation Honorable Mentions

Madison Avenue Water Main Rehabilitation

Emergency Structural Rehabilitation of a Mile-Long 7-ft Diameter Pipeline

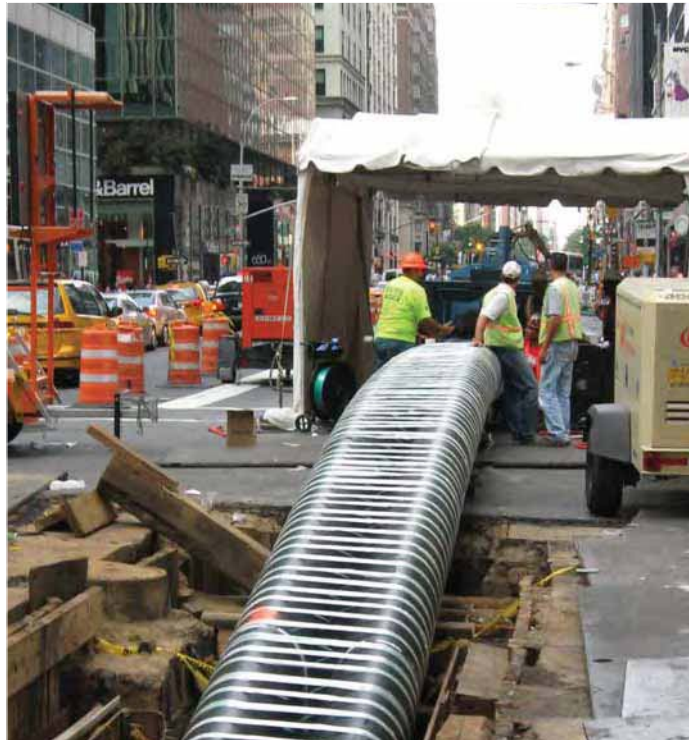
To date, more than 5,200 ft of water main has been renewed.

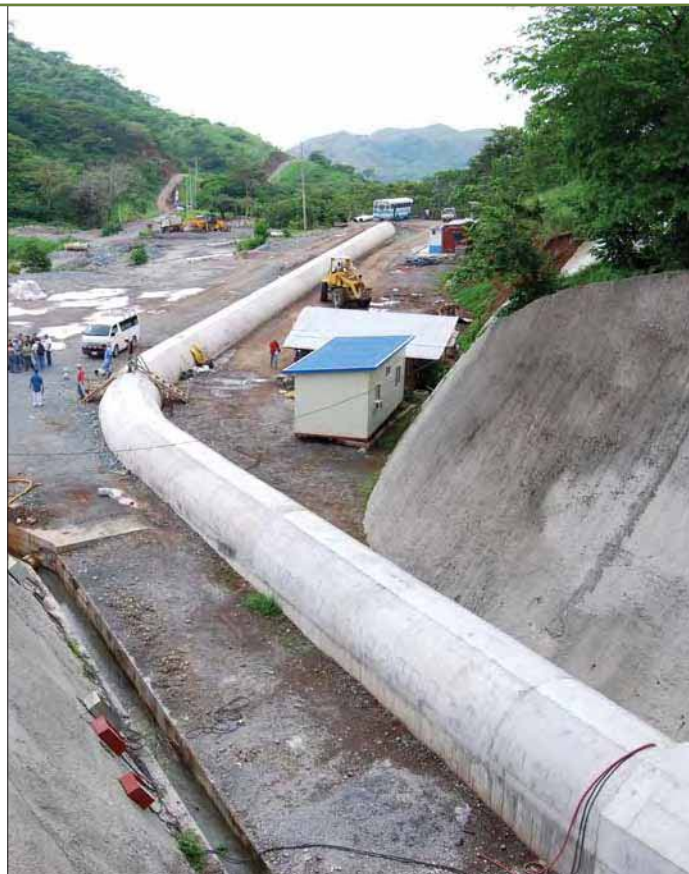
The repair involved using a fiber-reinforced polymer.
