Blast Loading Retrofit of Unreinforced Masonry Walls

With Carbon Fiber Reinforced Polymer (CFRP) Fabrics

Mo Ehsani, Ph.D., P.E., S.E. and Carlos Peña, M.S., P.E.

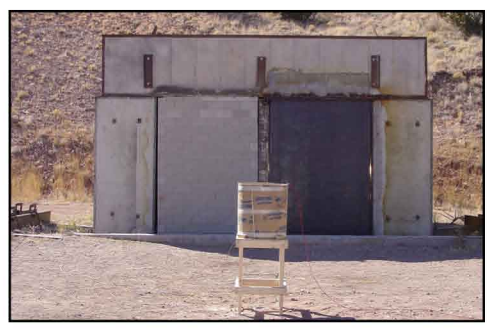
Figure 2: URM wall test specimens ready for blast test

walls. This blast source was intended to reproduce the effects of a car bomb explosion occurring on a side street in front of the wall. Figure 2 shows both test wall specimens and the blast source.

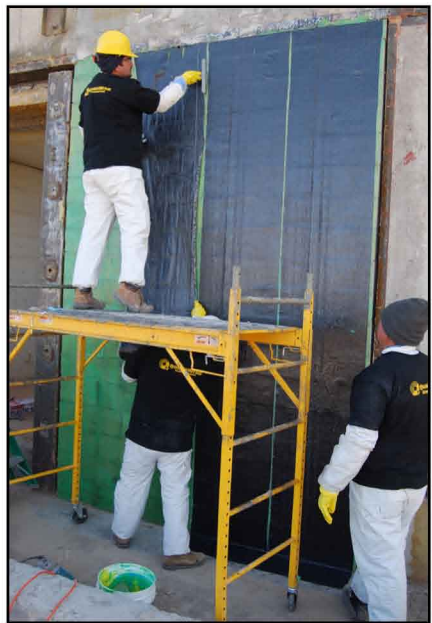
Figure 1: CFRP fabric installation on URM wall

One of the URM walls was retrofitted on both faces with carbon fiber fabric (CFRP), considering the following construction sequence: first, a layer of tack coat was applied to the wall surface. The purpose of the tack coat was to seal the wall surface, smooth out small imperfections and hold up the weight of the saturated CFRP strips; second, the CFRP strips were saturated in epoxy resin and placed on the tack coated surface. Figure 1 shows the installation of the CFRP fabric over the tack coated surface.

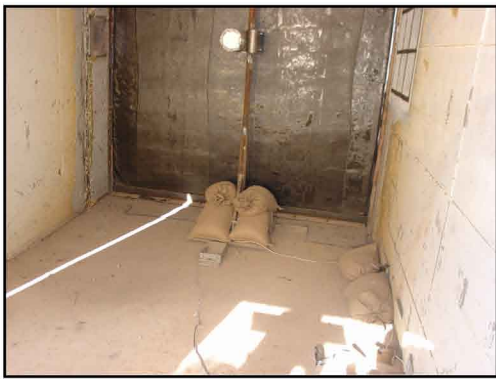
Figure 3: Instrumentation on the interior of the reaction building room

Figure 3 illustrates some of the instrumentation installed on the inside of the room. Visible in the figure is the laser gage mounted on the steel post, the interior pressure gage on the floor (inside the aluminum casing behind the laser stand) and the interior lateral high speed camera window on the left wall. Also visible in this figure is the interior bottom steel angle used as mechanical anchor for the CFRP fabric.

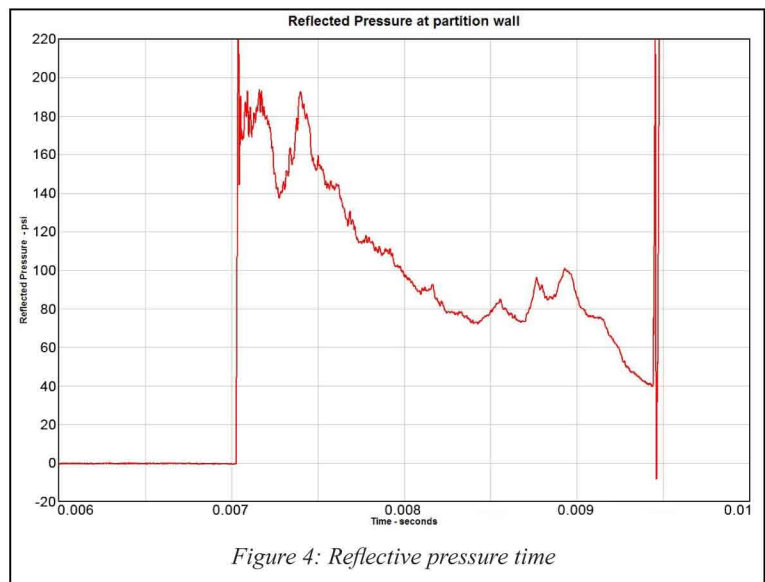
4% lower than the retrofit design value of 200 psi. *Figure 4* shows the reflective pressure time history.

Figure 4: Reflective pressure time

1) Peak reflective pressure: The maximum value was measured at 192 psi, which was just

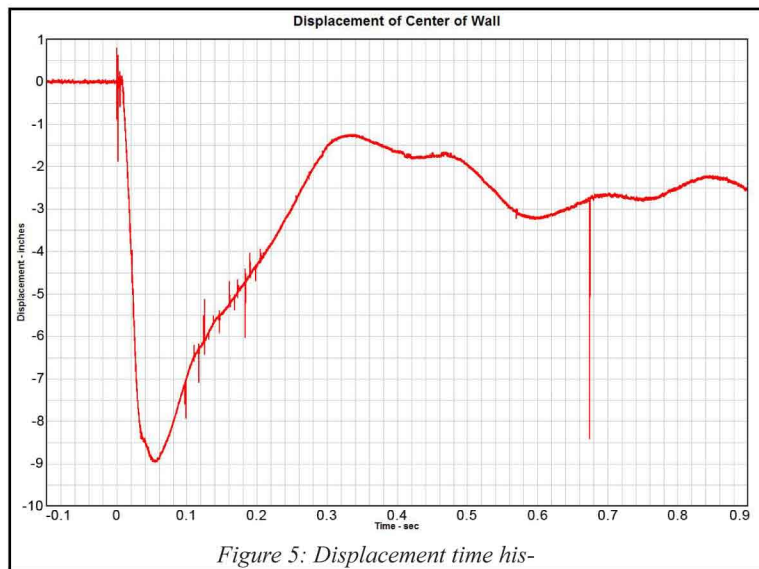
2) Peak lateral deformation: The maximum deformation was measured at approximately 9 inches. The deformation time history plot is given in *Figure 5* (negative values indicate wall movement towards the inside of the room). From *Figure 5*, it can be observed that there is no elastic rebound deformation due to the inertial forces. This was most likely caused by the crushing failure of the masonry, which generated an over-damping effect that eliminated the oscillations about the zero deformation line. As a result of the crushing failure of the masonry, a permanent deformation of about 2.5 inches was measured after the blast event. The figure also shows that oscillations of about 0.25 inch in amplitude with periods of 0.15 to 0.2 seconds occur after the first motion. These appear to be due to vibration of the instrument stand, and are unlikely to represent true motion of the wall.

Figure 5: Displacement time his-

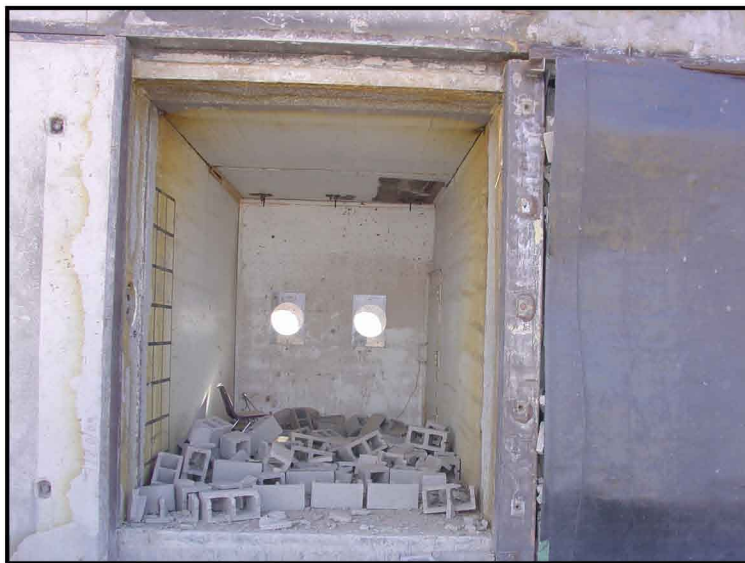
lations. Also, CFRP anchorage failure occurred on the top edge of the outside face of the wall due to insufficient development length. Under static conditions, a simply supported wall would have very little tensile force demands at the edges, so CFRP anchorage failure is usually not a concern. However, under dynamic conditions, the inertial forces of the disintegrated mass of crushed masonry forced the CFRP to act as a membrane, placing significant tensile demands on the edges. The use of a proper development length would have meant extending the CFRP beyond the steel angle anchoring system and into the parapet of reaction building, which was avoided to minimize residual CFRP fabric adhered to the building exterior. *Figure 7* (See page 20) shows CFRP anchorage failure occurring at the upper left corner of the wall.

Figure 7 also shows the state of the retrofitted and un-retrofitted URM walls after the blast test. The un-retrofitted URM wall suffered catastrophic failure, with masonry debris scattered all the way to the back of the room. Although the internal pressure was not measured on the room enclosed by the un-retrofitted wall, it would be safe to assume that it exceeded 45 psi, considering that the shock

It can be observed from *Figure 7* that the CFRP retrofitted wall remained standing, even though the masonry inside was practically reduced to debris. It can also be seen that all the debris was contained by the CFRP. The high speed camera video taken from the inside shows evidence that no masonry debris projectiles were present in the room enclosed by the retrofitted wall and that all the debris was contained by the CFRP fabric. The inside lateral video camera clearly captured the deformation behavior of the wall during the blast event, including the effects of the crushing failure of the masonry. The lateral exterior video camera illustrated the effect of the arrival of the shock wave on both URM walls.

Figure 7: Un-retrofitted and CFRP retrofitted URM walls after the blast test

wave entered the room with minimal energy dissipation due to the collapse of the wall. The 45 psi value represents the threshold for less than 1% survival rate, which means that massive loss of life and property would have occurred in the room with the un-retrofitted URM wall due to the combination of high pressure and masonry projectiles.
