Dynamic In-Plane Behavior of URM Wall Upgraded with Composites

Mohamed A. Elgwady¹, Pierino Lestuzzi², Marc Badoux³
1,2,3 Swiss Federal Institute of Technology, Lausanne, Switzerland.

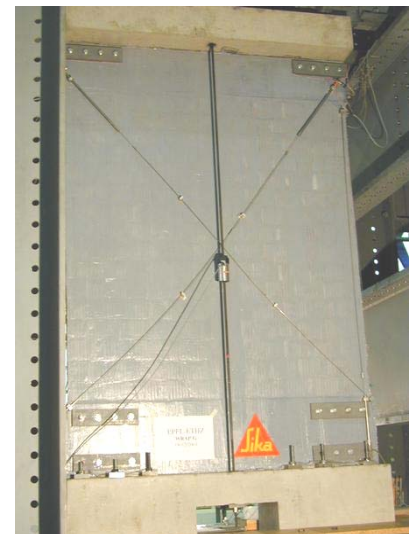
Figure 7. Wall Specimen WRAP-G Upgraded On One Side (West Side) Using GFRP.

The anchorage of externally bonded reinforcement is a common weak point. It is not the goal of the test to test the anchorage of the upgrading system. To ensure that anchorage failure did not occur, steel plates were used to anchor the GFRP to the walls using steel bolts as shown in *Figure 7*.

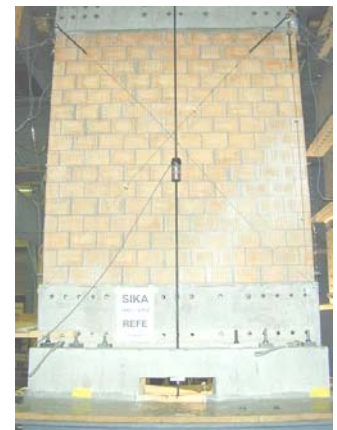
Figure 10. Specimen REFE After Testing

- At the end of the test, wall REFE showed little damage. As shown in *Figure 10* no visible damage or crushing to the brick units or mortar was observed. The test was interrupted in order to preserve the specimen for the subsequent upgraded wall test.

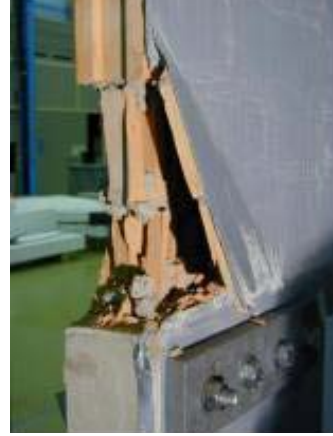
Figure 12. (a) Failure Of The GFRP Fabric At The Base Of The Masonry Wall And (b) Crushing Of The Masonry At The Wall Toe.

- Test runs 1 to 18 produced no visible damage to WRAP-G.
- The delamination process began in a few points during test run 14. This delamination was visible in the form of white spots on the wrap.
- During test run 19, both the horizontal force and the prestressing force decreased slightly. No visible damage was noticed.
- During test runs 20 to 23 both of the horizontal force and the prestressing force increased rapidly.
- During test run 24 the wall started to rock at the base. This rocking was accompanied with crushing of the masonry at the wall corners. The wall failed under a combination of “local buckling” and tear at the wall corner as shown in *Figure 12*.

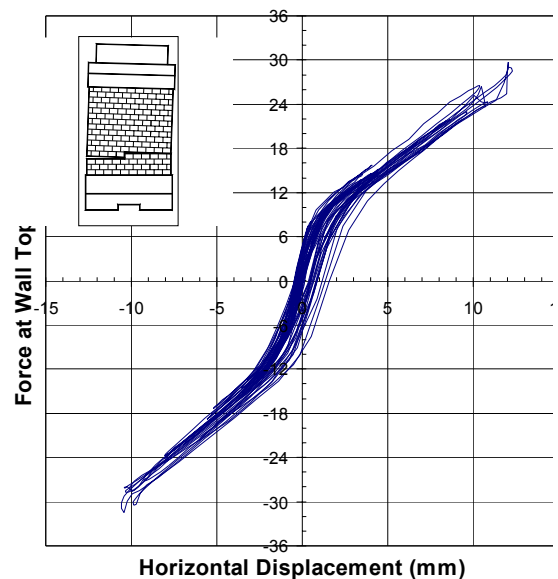
Figure 13. Load Versus Horizontal Deflection At Wall Top During Test Run 11 For Wall REFE.

- *Figure 13* shows the horizontal force versus the wall top deflection during test run 11. The hysteretic curves show a clear bilinear behavior with a soften part when the rocking crack is open. The hysteretic loops show noticeable pinching and indicate limited energy dissipation.

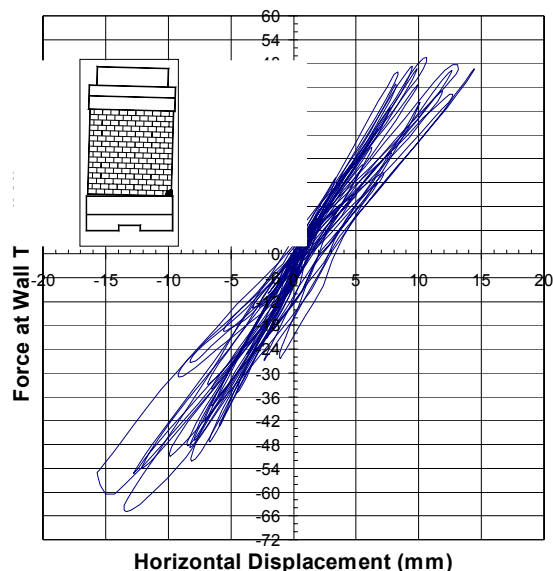
Figure 14. Load Versus Horizontal Deflection At Wall Top During Test Run 24 For Wall WRAP-G.

- As was expected no out-of-plane deformations of the upgraded wall was observed. Even though it was upgraded on one side only.
- Wall WRAP-G exhibited a stable hysteretic force displacement relationship as shown in *Figure 14*.

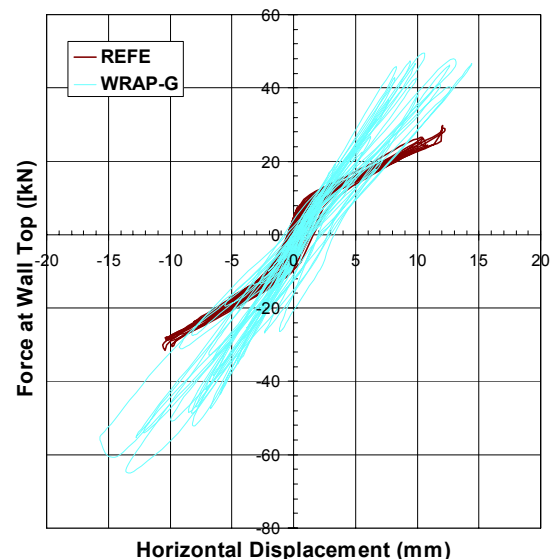
Figure 15. Load Versus Horizontal Deflection At Wall Top At The Test End For Wall REFE And Wall WRAP-G.

- The hysteretic force displacement relationship for both walls at the test end is shown in *Figure 15*. An improved performance was observed in the upgraded specimen. The lateral resistance is doubled from 31.5 to 65 kN. Energy dissipation remain small in both cases.
- The stiffness of specimen WRAP-G, beyond 2mm lateral displacement was superior to that of specimen REFE.
