SEISMIC UPGRADE OF BEAM- COLUMN SUBASSEMBLAGES WITH COMPOSITES

**CIES
02-29**

A THESIS

MASTER OF SCIENCE IN CIVIL ENGINEERING

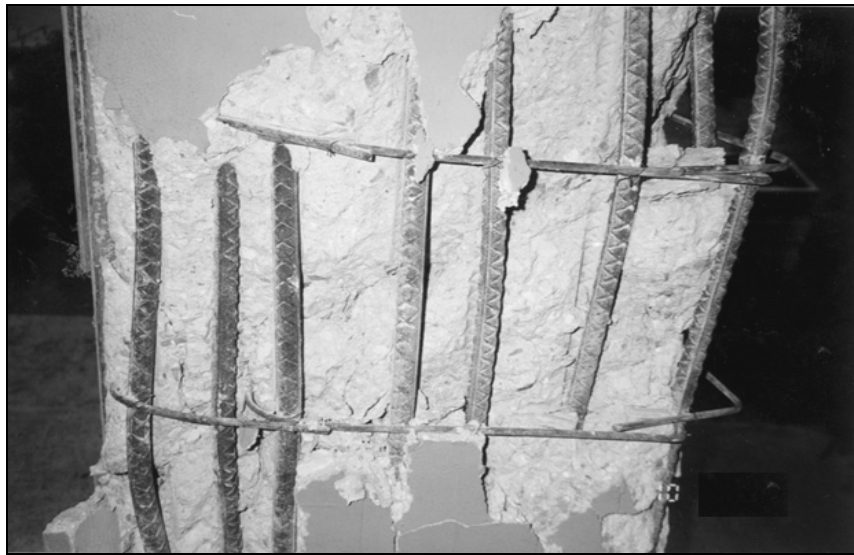
Figure 1. 1 Concrete crushing and buckling of steel rebars

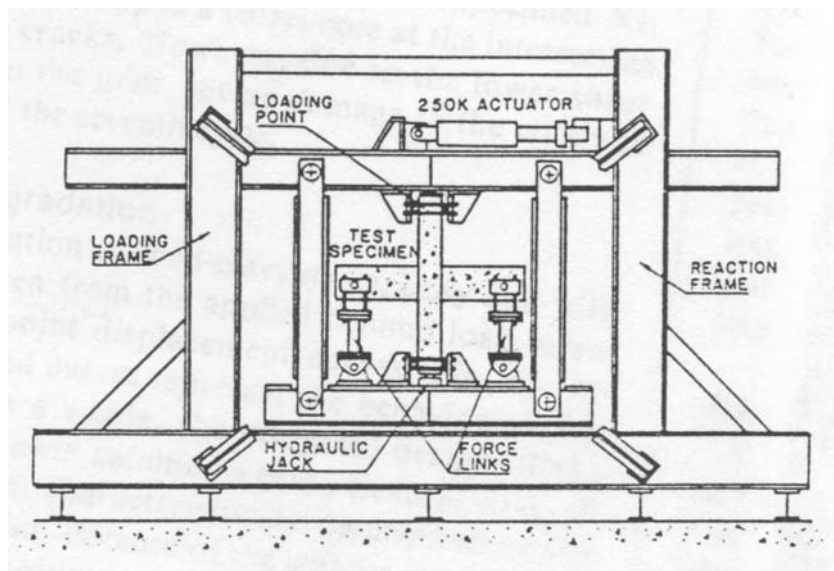
Figure 2. 3 Test setup used by Durrani and Wight (1985)

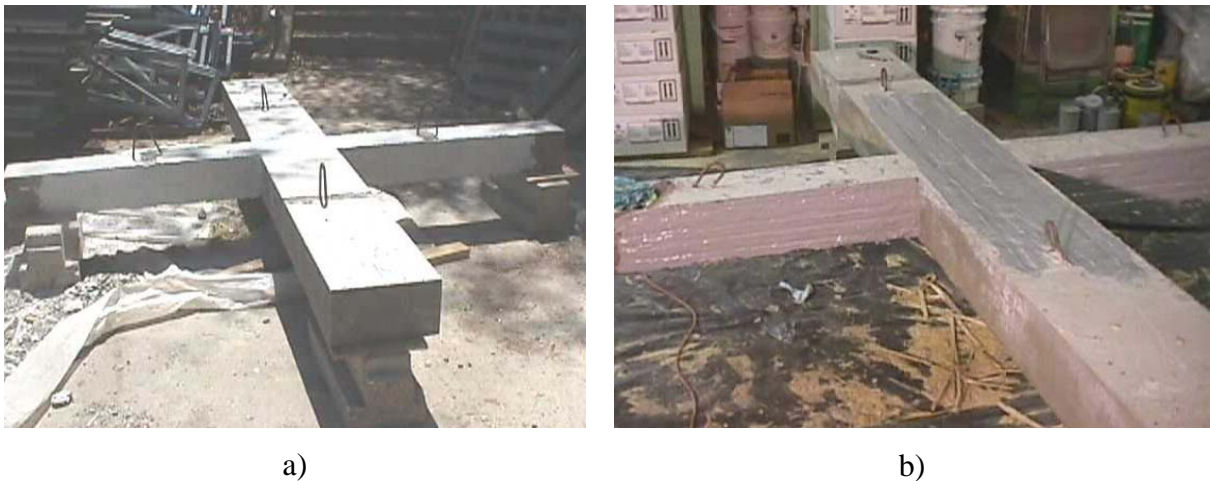
Figure 3. 2 NSM rods in the columns (a) and joint (b)

FRP NSM rods are installed in epoxy filled grooves. Two conditions are possible: (1) Figure 3.2-a depicts their use as additional non-metallic reinforcement of the column, passing through the joint region; (2) Figure 3.2-b shows the application of NSM FRP rods by externally reinforcing the joint region in the beam direction.

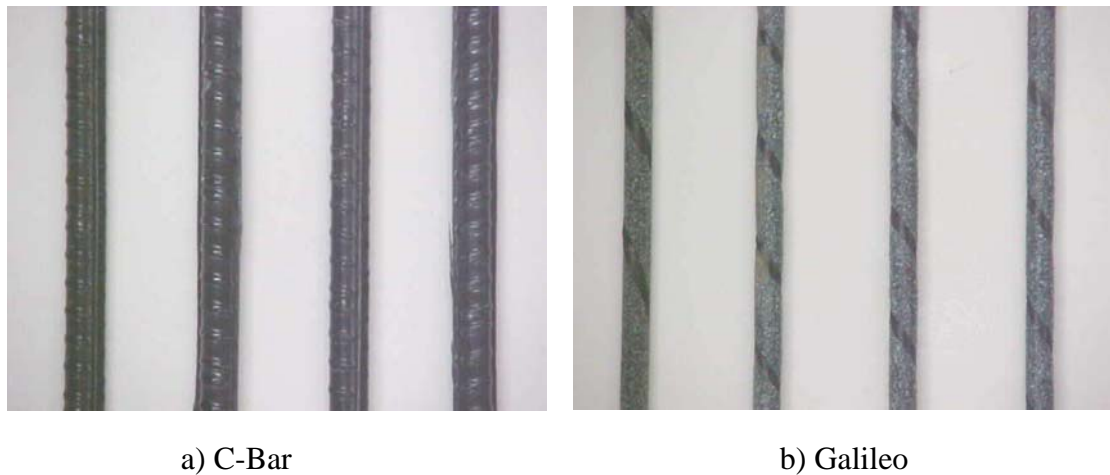
Figure 3. 4 Carbon FRP rods.

3.4.3 CFRP bars. Two different types of carbon FRP rods were used for strength the connections. The former is a CFRP deformed rod commercially known as C-Bar and it was supplied by Marshall Industries Composites Inc., Ohio. The latter is a smooth CFRP rod, commercially known as Galileo rod; it was supplied by MAC Spa, Treviso, Italy. Both are depicted in Figure 3.4, where it can be noticed the difference between the non perfectly circular cross section of C-Bars compared to that circular of the Galileo rods. For both types of FRP bars, tensile characterization was conducted in the laboratory.

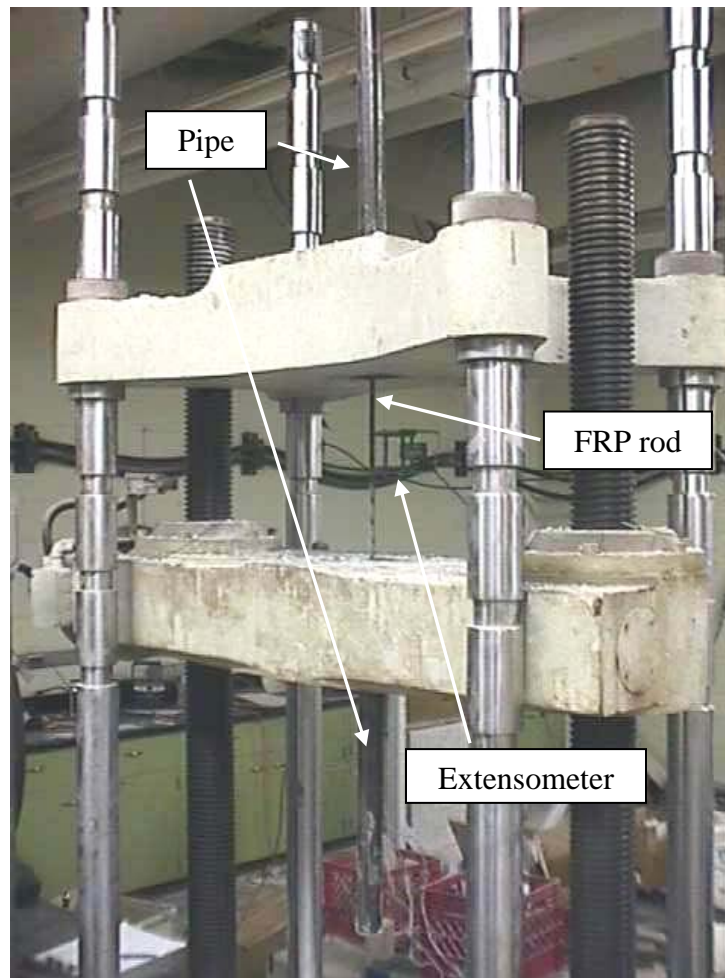
Figure 3. 6 Typical test setup

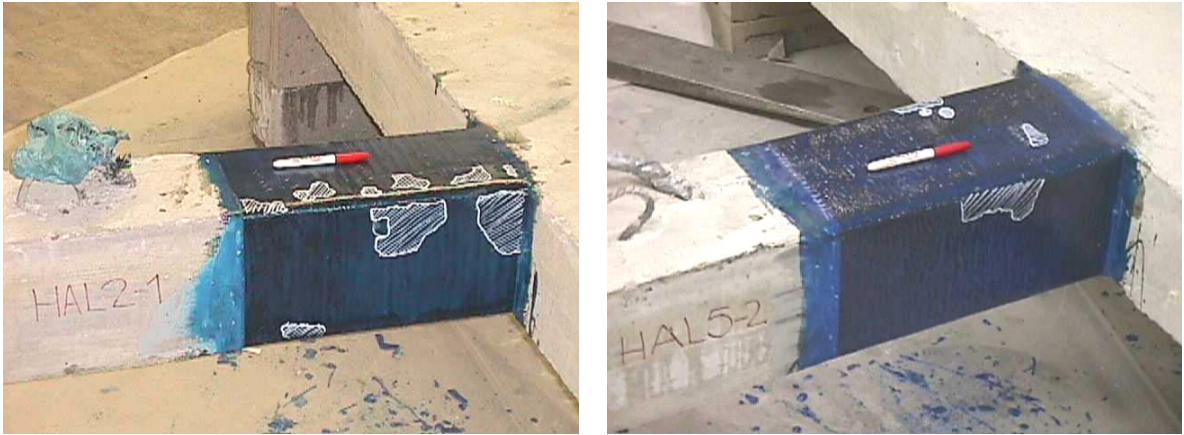
Figure 3. 9 Monitored debonding zones on specimens H2 and H2U

An accurate investigation was then conducted in order to monitor the surface and mark the unbonded zones, as depicted in Figure 3.9. For those zones with area bigger than 645 mm^2 (1 sq in.), defects were injected with primer using a syringe, as Figure 3.10 represents. Primer injection was preferred due to the high viscosity of this resin compared to that of saturant. The behavior of these two specimens observed during testing will be discussed in section 6.2; here it is only anticipated that the adopted remedy allowed them to perform satisfactorily.

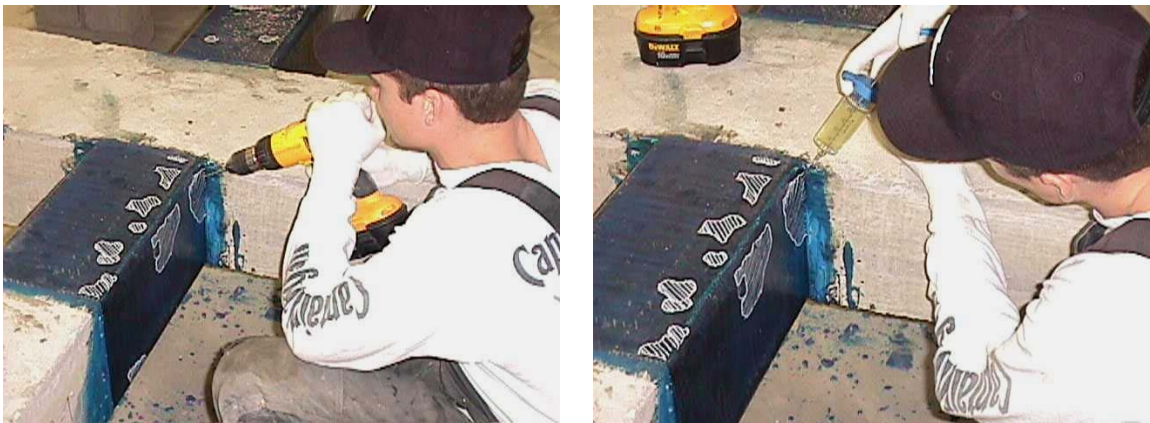
Figure 3. 10 Primer injection of bubbles by a syringe

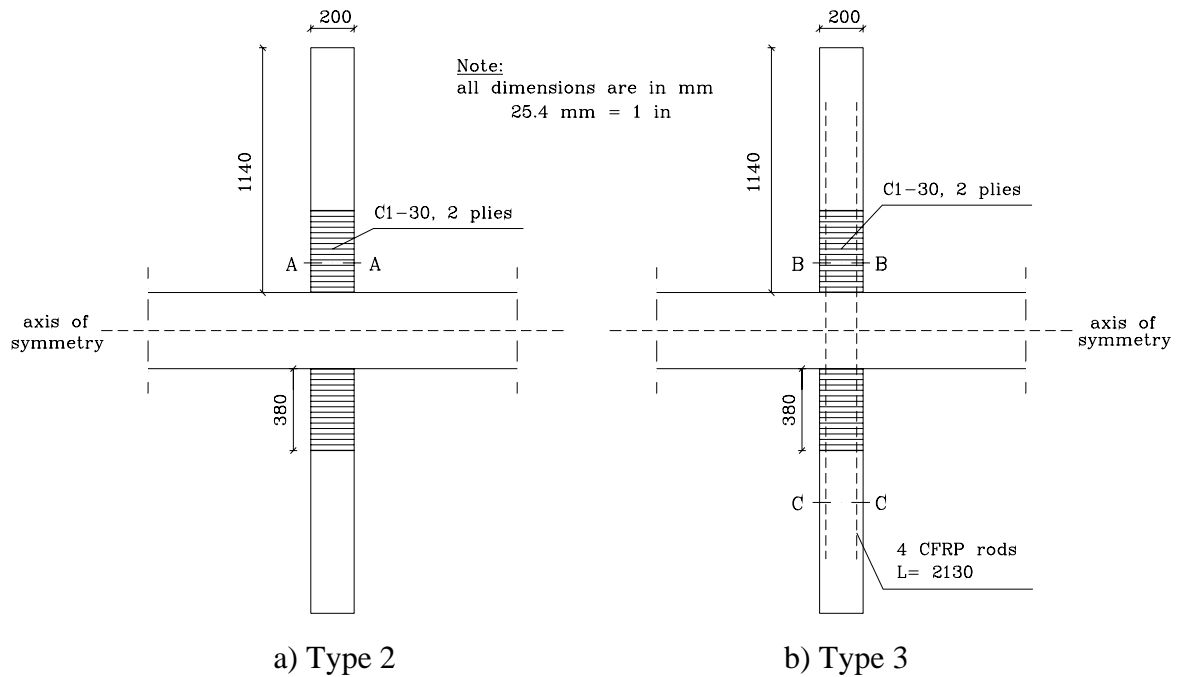
Figure 3. 11 Front view of upgraded subassemblages

Figure 3.11-b depicts a typical subassemblage. It can be observed that four $\Phi 8$ or $\Phi 10$ NSM rods, each 2130 mm (7 ft.) long, were installed on each side of the column.

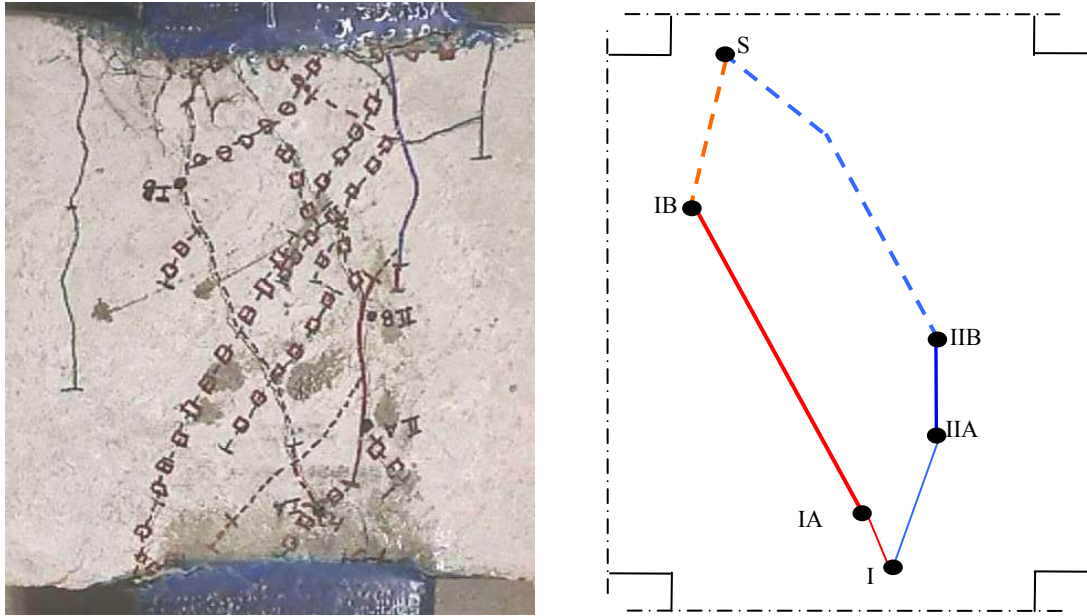
Figure 4. 8 Cracks at failure in the panel of subassemblage H2U

Locally a maximum crack width under load of 1 mm (0.04 in) was recorded along portion IA-IB; cracks at column ends (Figure B.35) were found to have a width equal to about 6 mm (1/4 in) with no major size reduction after load removal.

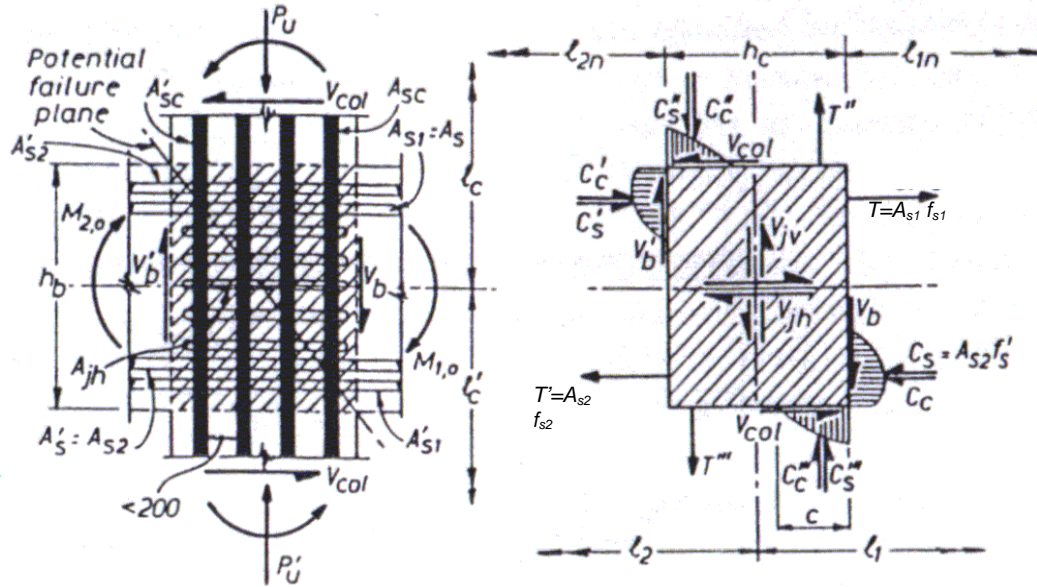
Figure 5. 1 Equilibrium of interior joint (Paulay and Priestley, 1992)

understand and eventually limit the level of shear acting on the joint. Paulay and Priestley [1992] suggested that, for one-way frames, v_j is limited at $0.25f'_c$ in order to avoid brittle failure of the joint due to diagonal compression.

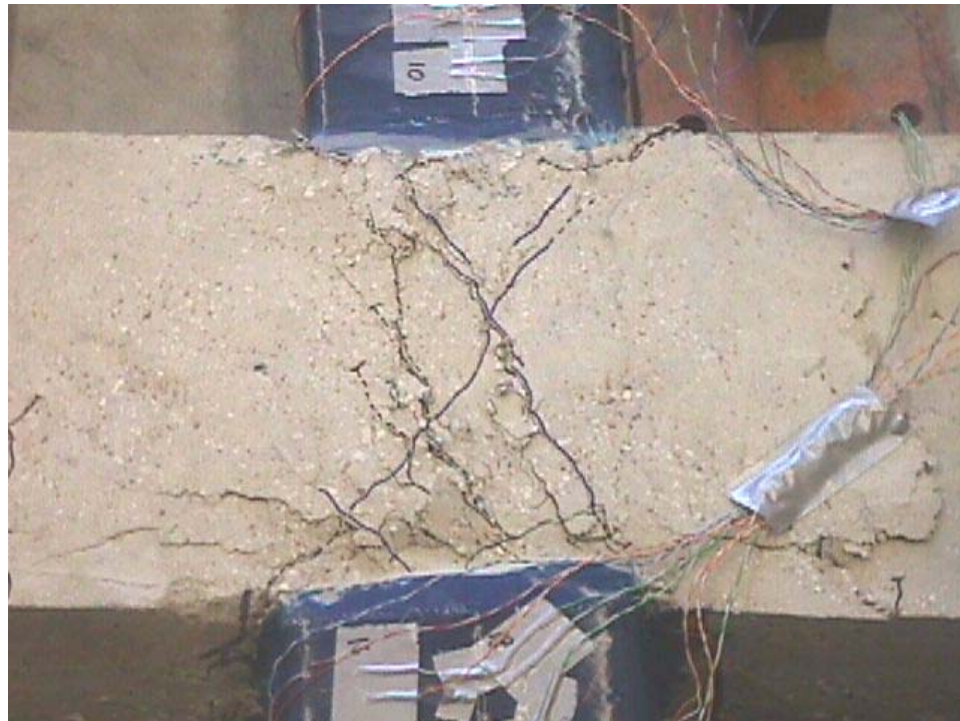
Figure 5. 2 Crushing of the diagonal strut at failure of specimen L3

The nominal shear stress is just an index that can be used in the design; since the crisis of the joint is due to the crushing of the diagonal strut (Figure 5.2), it appears more appropriate to give a direct limitation to the principal compression stress; this would allow to take into account also the axial load levels on both column and beam.

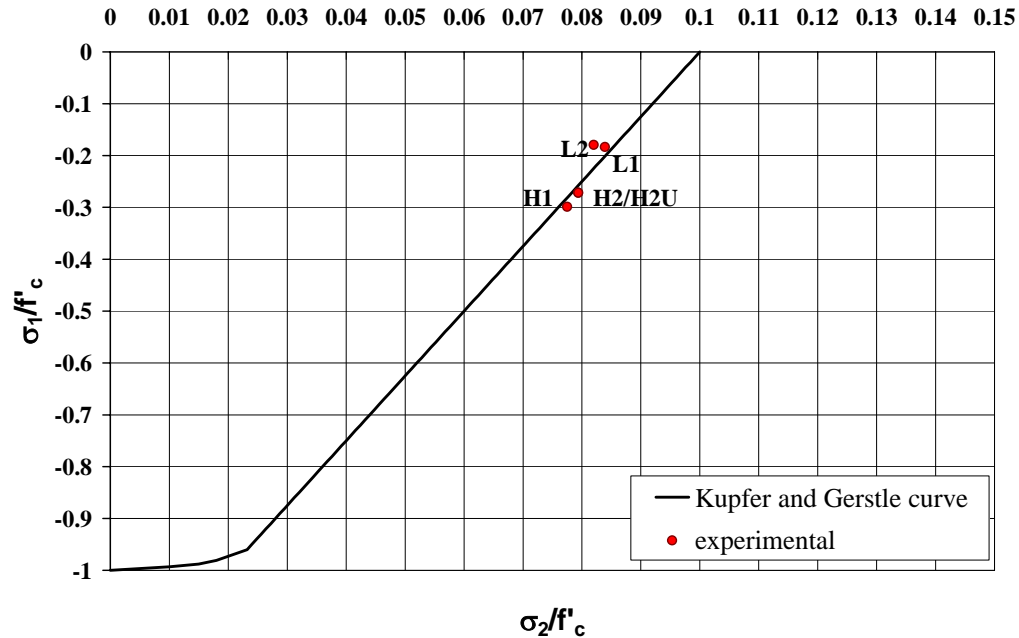
Figure 5.3 Kupfer and Gerstle curve : theoretical vs. experimental

- the Kupfer and Gerstle approach appears to provide more reliable predictions of the column shear corresponding to the first cracking of the joint. The extension of the theory to the case of FRP reinforced joint will allow for computations on a wider number of cases;
- a comparison with experimental outcomes highlights that the limit of $0.3f'_c$ for the principal compression stress at failure of the joint could be a reasonable design criterion, even though it is conservative for high axial load ratios (i.e. type H and M specimens). As Table 4 shows, such limit is conservative in all three cases (i.e., L3, H3 and M3) where failure of the joint was observed; only for specimens L1 and L2 (i.e., column failure), the column shear at failure of the connection corresponded to

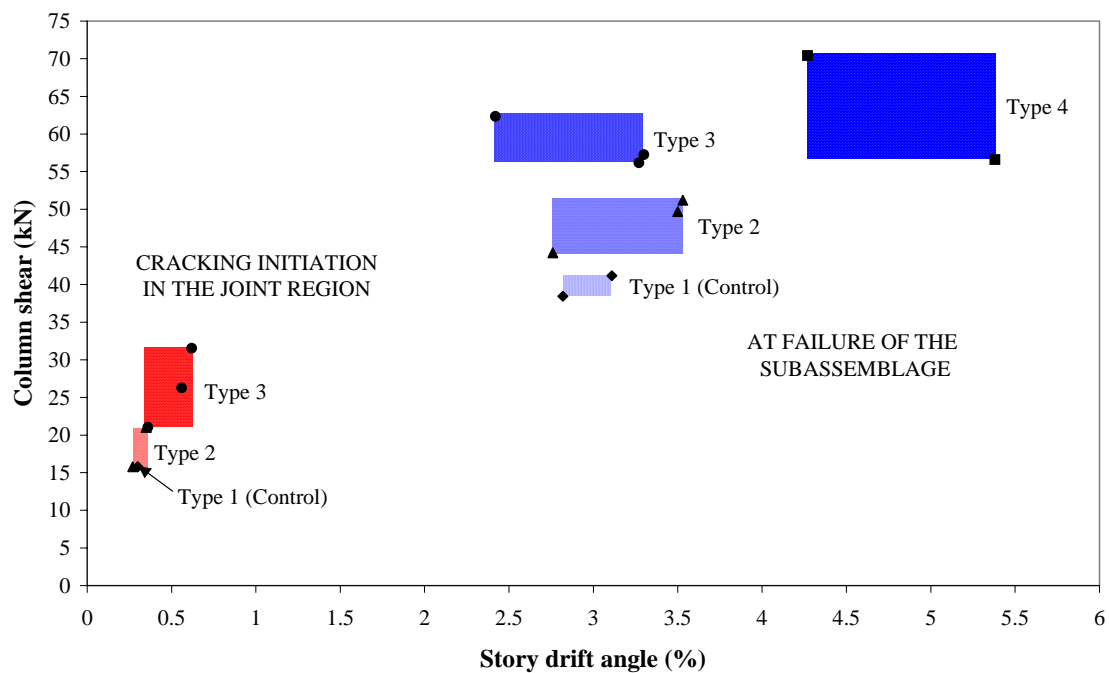
Figure 5. 5 Column shear vs. story drift angle at cracking of the joint (left hand side) and at failure of the subassembly (right hand side)

At cracking initiation of the joint, both control connections reached the same story drift for the same cracking shear in the column (i.e., point indicated by the arrow). The

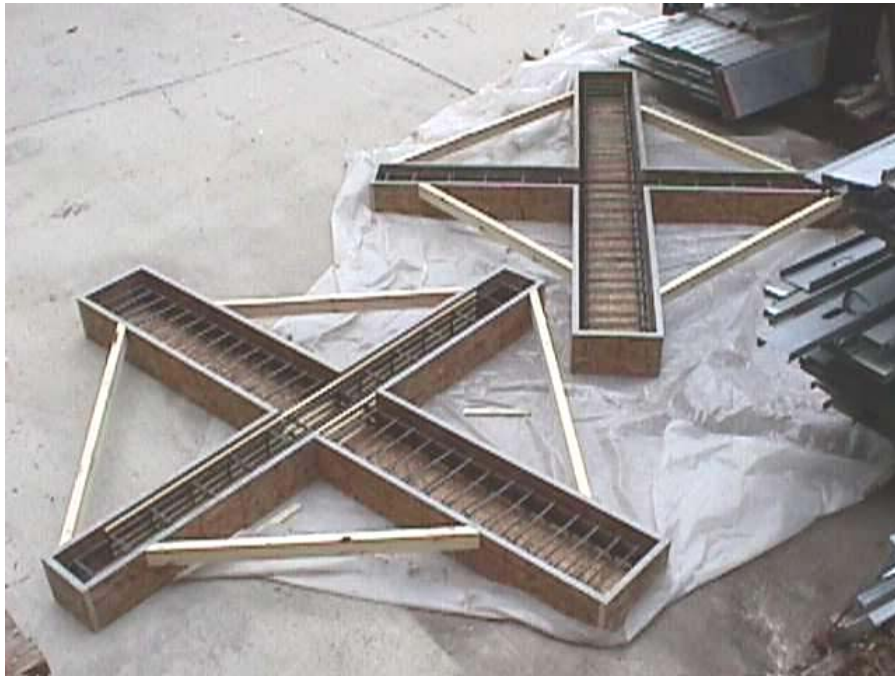
Figure A. 1 Typical formworks: on the left H3, on the right H1

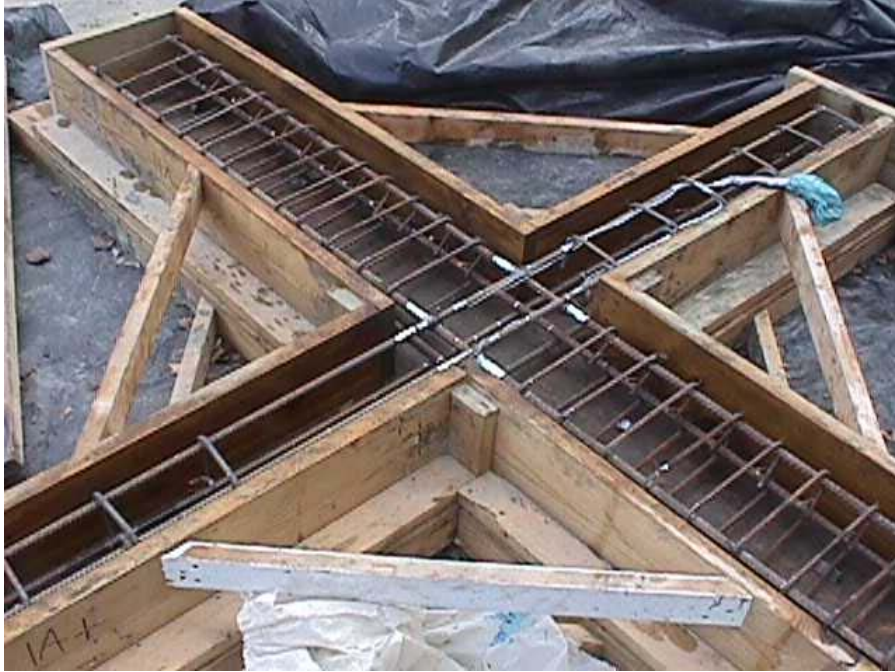
Figure A. 7 Induced confinement defect in the column: H2U

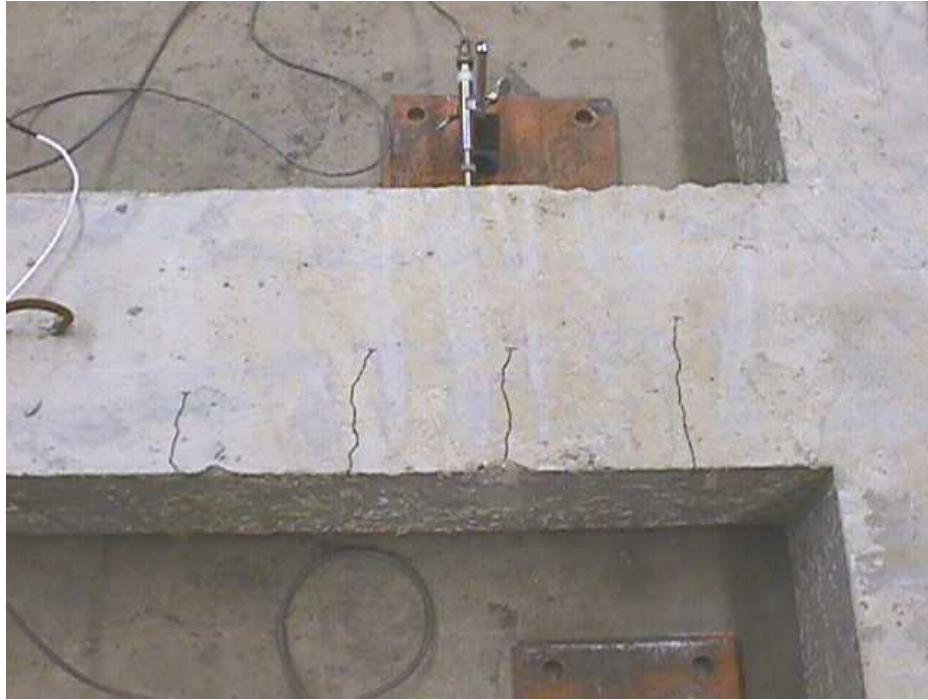
Figure B. 5 Initiation of flexural cracks in the beam: joint L1

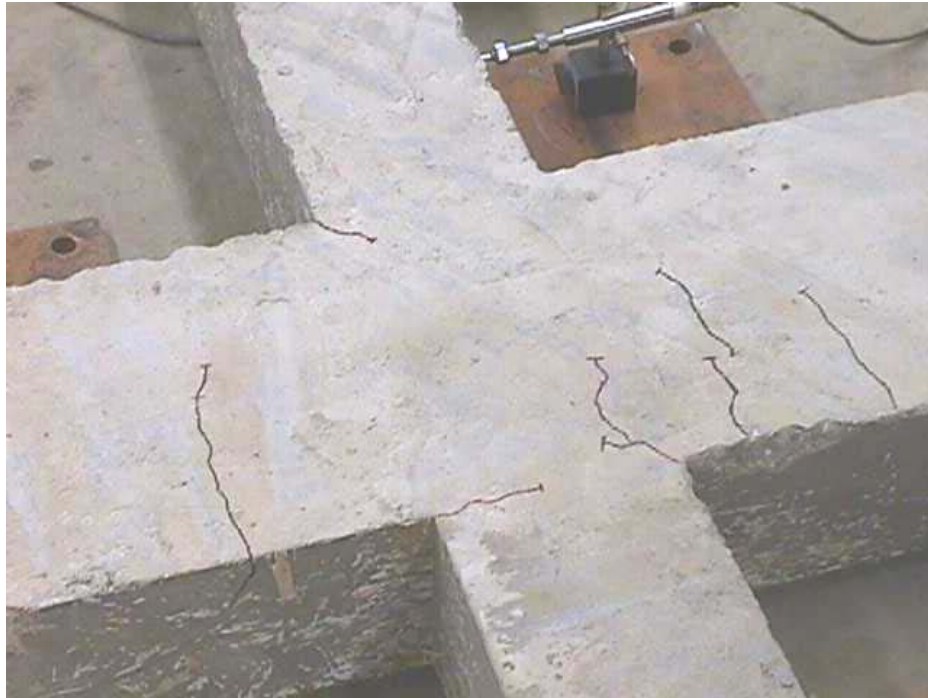
Figure B. 7 Initiation of shear cracks in the panel: joint L1

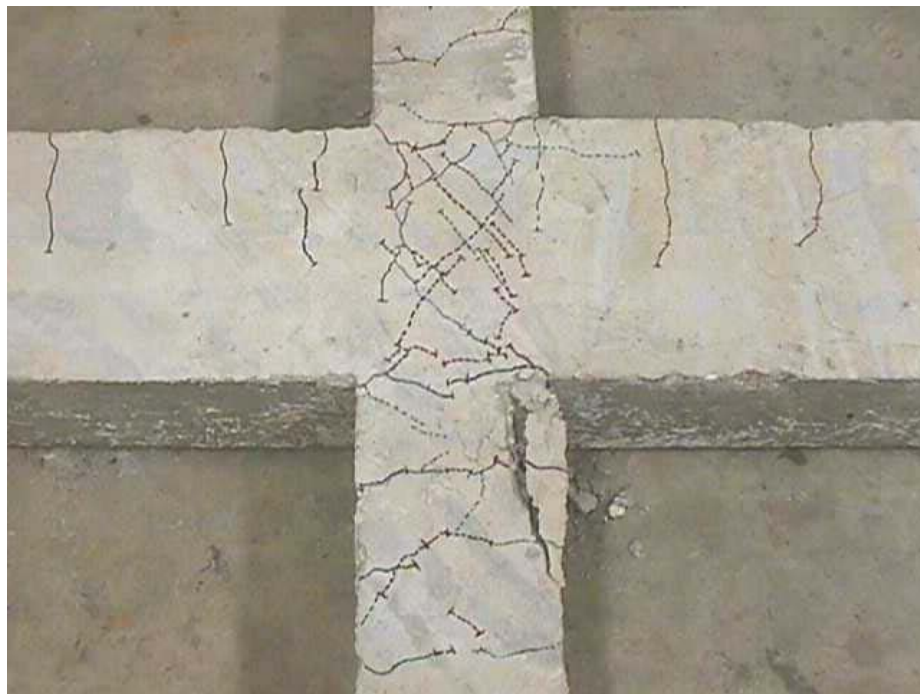
Figure B. 10 Column failure: joint L1

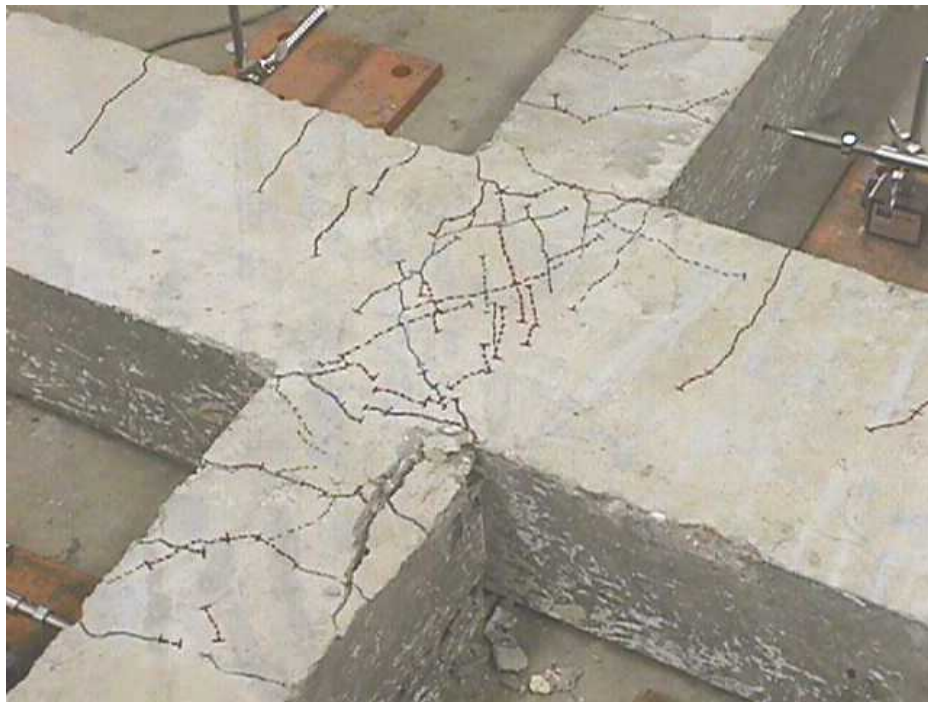
Figure B. 12 Crack pattern at failure: joint L1

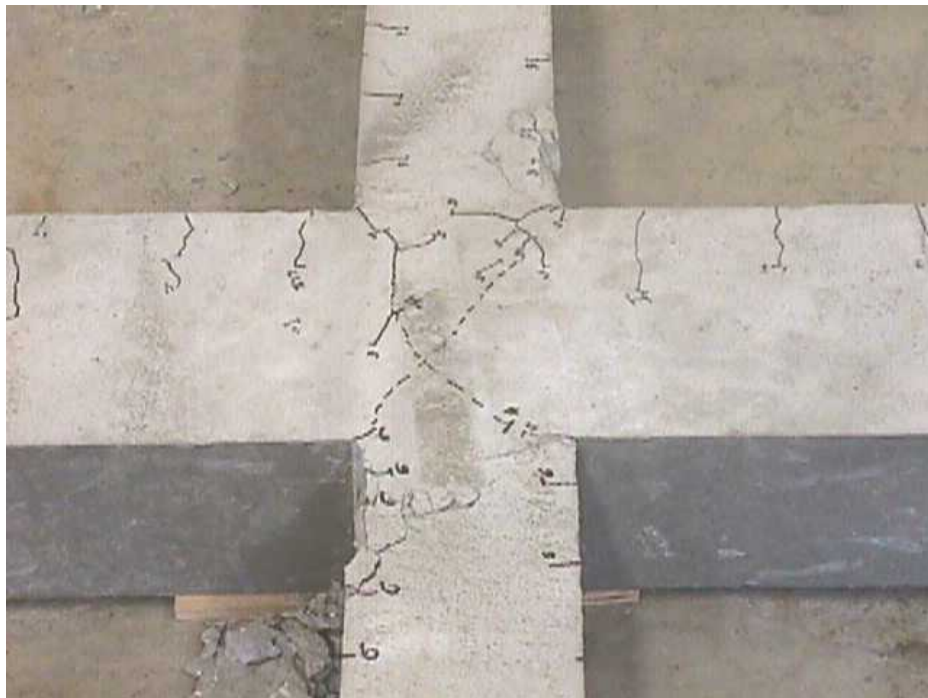
Figure B. 18 Crack pattern at failure: joint H1

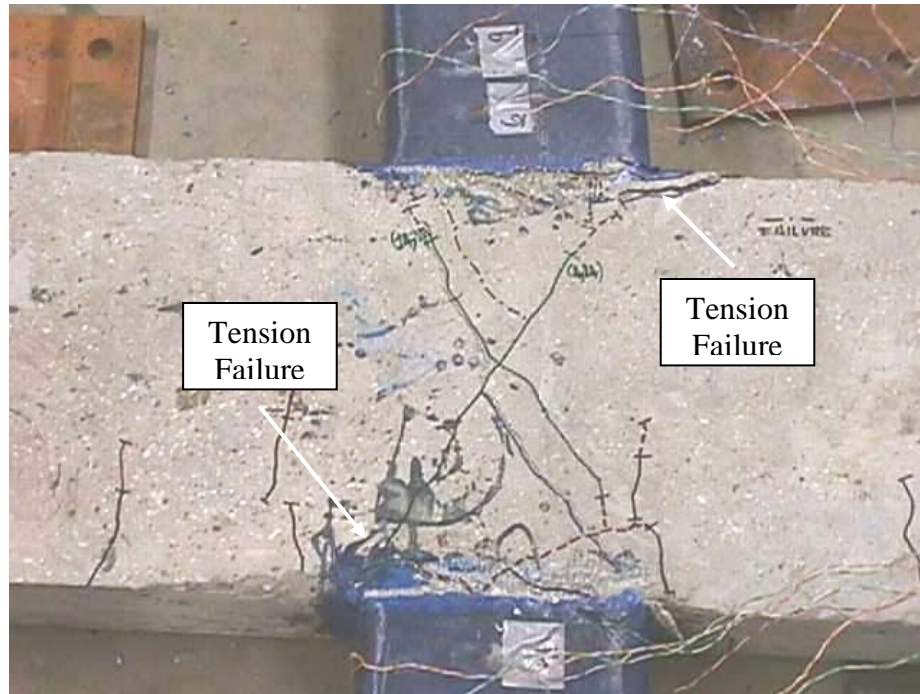
Figure B. 21 Tension failure of the columns: joint L2

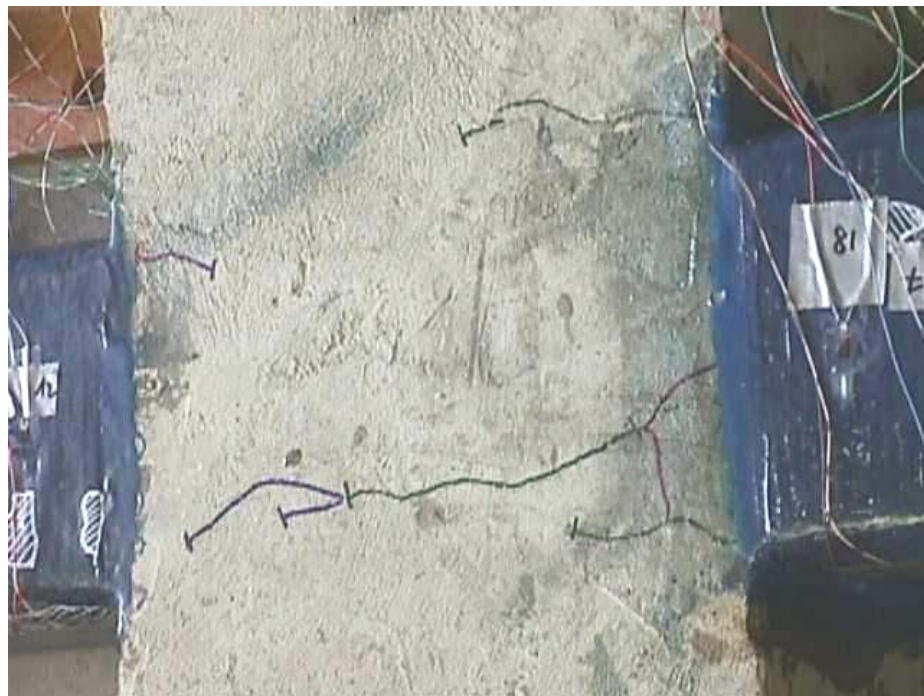
Figure B. 24 Initiation of diagonal cracks in the panel: joint H2

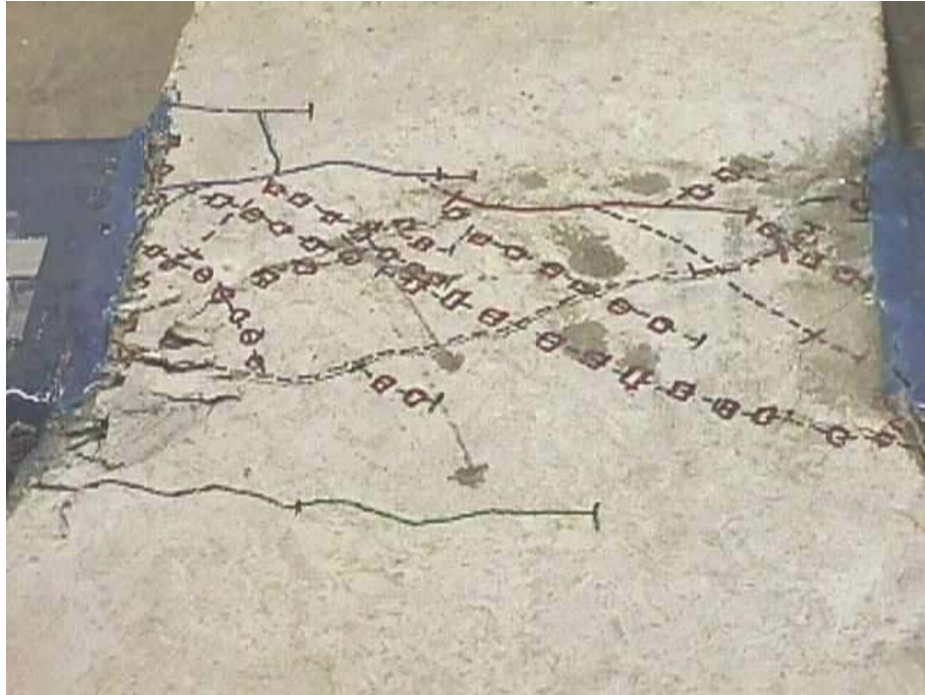
Figure B. 33 Panel damage: joint H2U

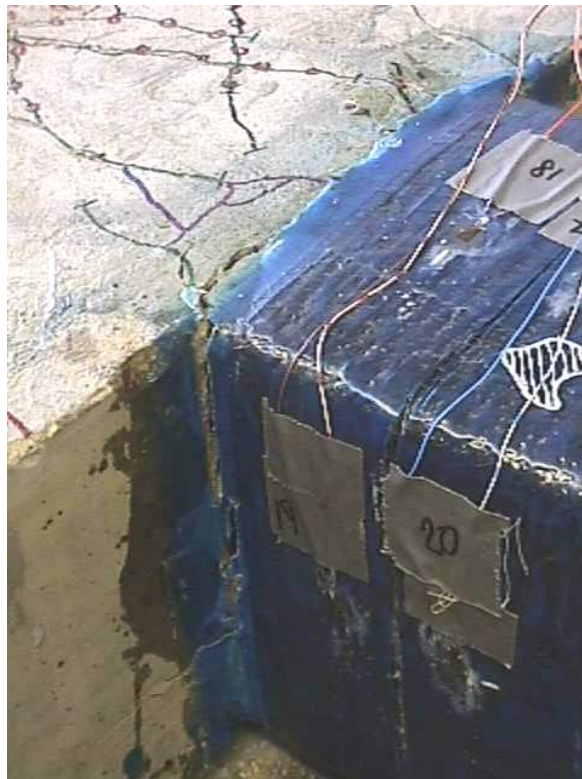
Figure B. 34 Tension failure of column: joint H2

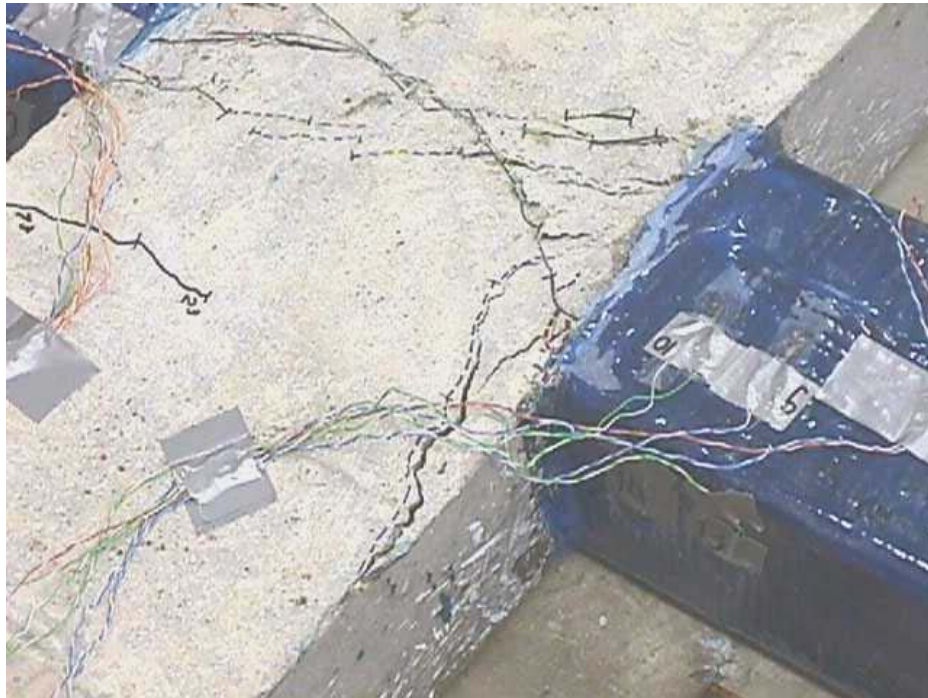
Figure B. 38 Shear failure of the panel: joint H2L

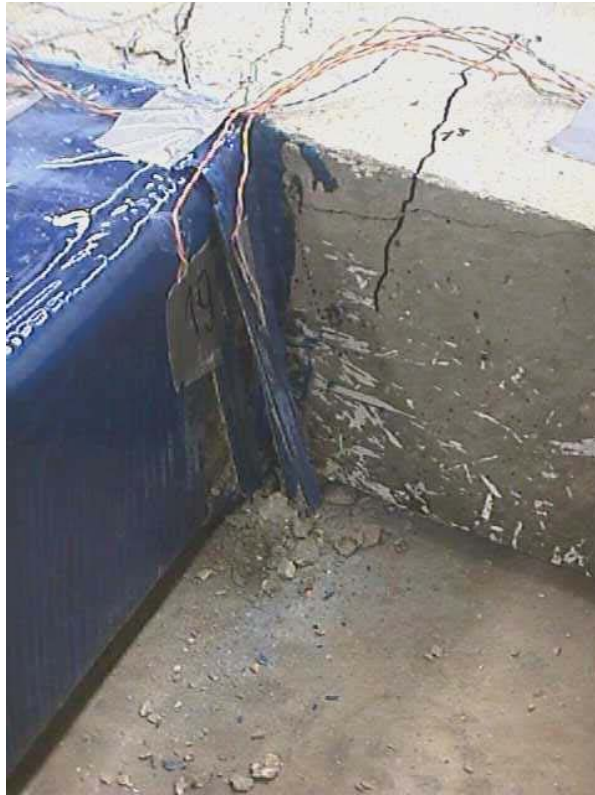
Figure B. 39 Carbon fibers breaking in compression region of column: joint H2L

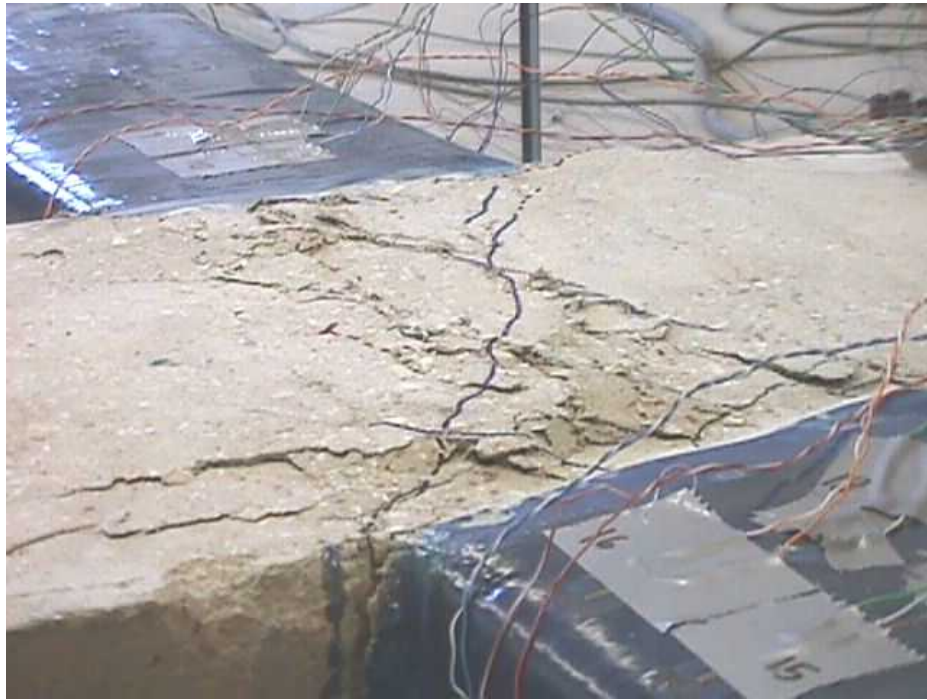
Figure B. 43 Shear failure of the panel: joint L3

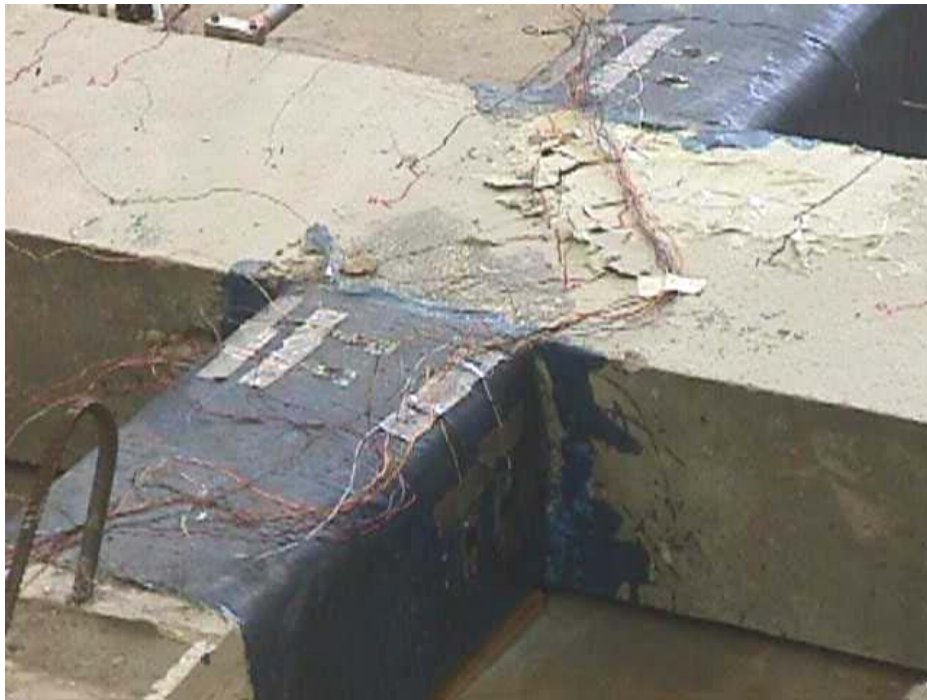
Figure B. 44 Shear failure of the panel: joint H3

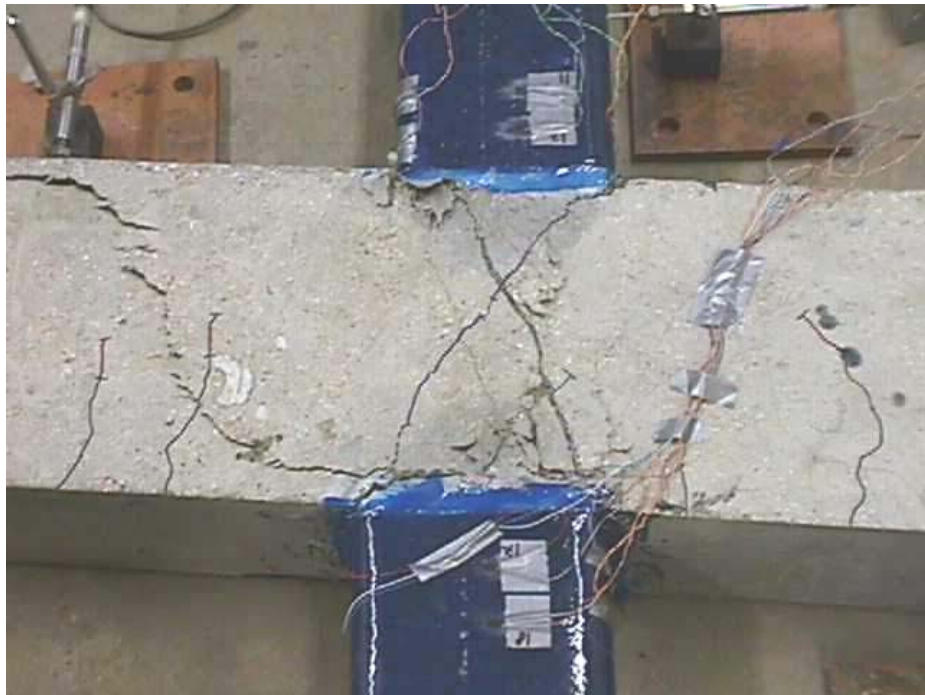
Figure B. 46 Panel shear failure: joint M3

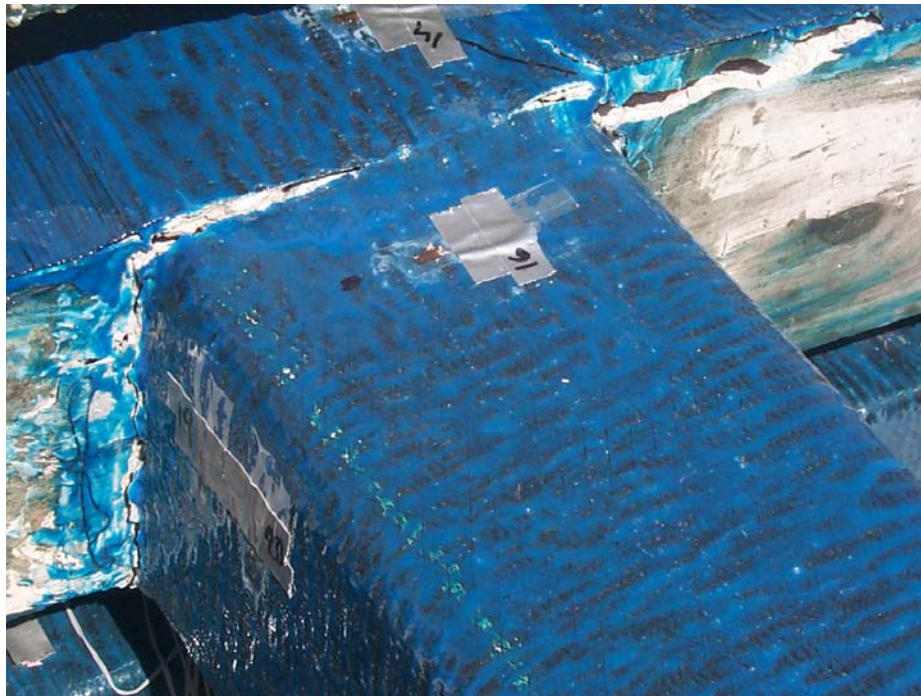
Figure B. 48 Separation at panel-superior column: joint L4

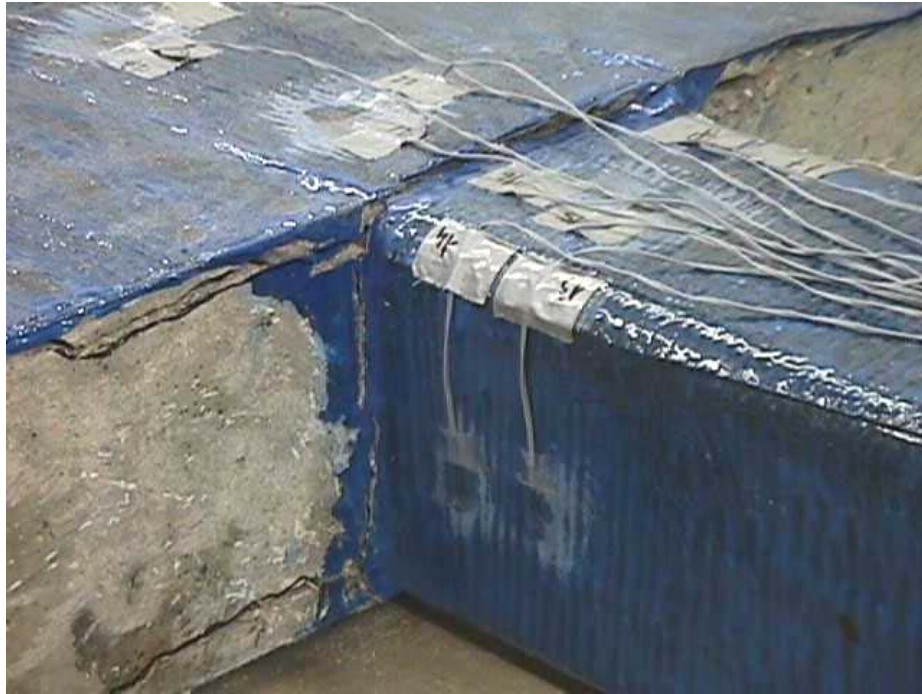
Figure B. 57 Separation at interface panel-superior column: joint H5

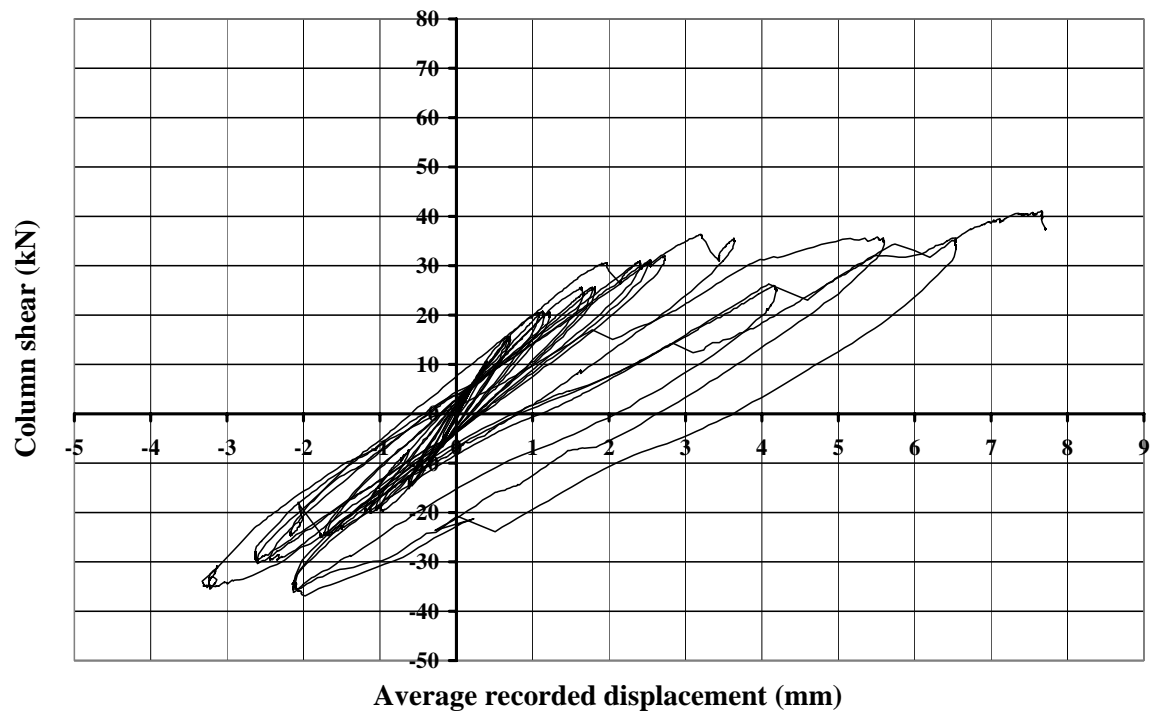
Figure C.1 Column shear-displacement: L1
