EXPERIMENTS ON TWO-WAY RC SLABS WITH OPENINGS STRENGTHENED WITH CFRP LAMINATES

**Paolo Casadei
Antonio Nanni
and
Timothy Ibell**

**CIES
03-39**

Abstract:

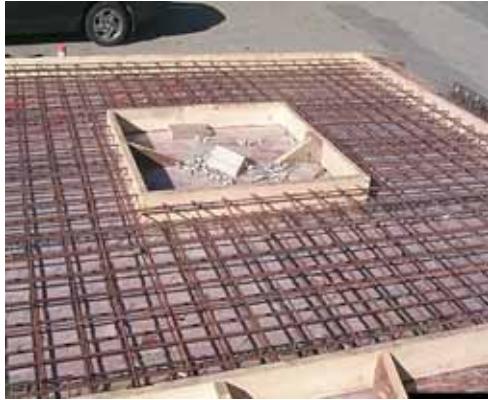
a) Layout of reinforcement

Figure 1 - Geometry

Details of the rebar arrangement and specimen geometry are given in Figure 1(a) and 1(b).

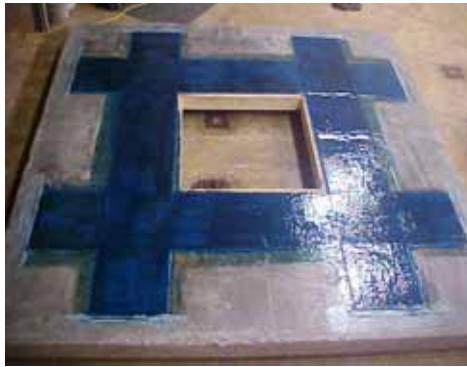
Figure 2 - CFRP Laminates application by manual wet lay-up on tension side of specimen SQ3

⁽²⁾ See Fig.3a for detailed geometry.

A total of six plies were applied: three were placed on one side of the cutout and three on the other side in each direction (see Figure 2b).

The bonding processes used for the CFRP laminates were as follows. The tension face of the RC slab was abraded by sandblasting to remove all the laitance and to expose the aggregate before bonding. At this stage, four grooves were cut as shown in Figure 2(c), each 25.4 mm deep (1 in.) and 6.35 mm wide ($\frac{1}{4}$ in.), to house the carbon tape used to anchor the first ply of the laminate. Once the grooves had been cut, the surface was thoroughly brushed to remove all loose particles, and vacuum-cleaned. Once the surfaces had been prepared, CFRP laminates were bonded to the tension face by epoxy resin, as per manufacturer recommendations. In order to avoid any concentrated unevenness in the location in which the plies overlapped on the four diagonals, the plies in the two perpendicular directions were applied one at a time in sequence (see Figure 2(a)). The laminates were bonded adjacent to the edge of the opening in order to resist the peaks of localized stress that occur near corners of openings. The mechanical characteristics of the CFRP laminates are shown in Table 3 and have been validated by tests [Yang, 2001].

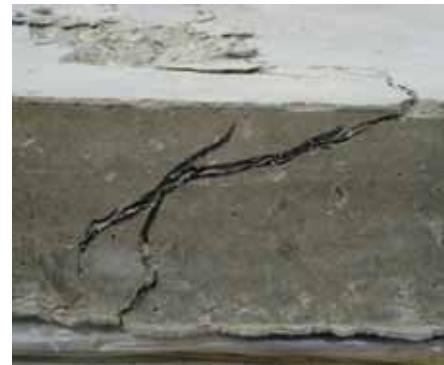
b) Shear crack along the support side

failure was caused by sudden pull-off of the anchoring system at the end of one laminate, with a considerable amount of concrete substrate. Table 4 reports the test results, while Figure 4 provides images of the failure modes.

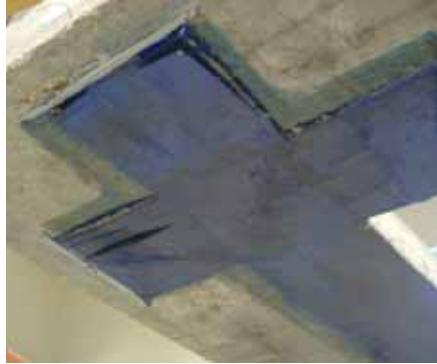
e) Delamination of the CFRP plies on one corner

Flexural cracks started either at the center of the slab (SQ1) or along the edges of the cutouts (slabs SQ2 and SQ3), developing perpendicular to the adjacent line of support. Under increasing load, these cracks developed diagonally towards the four support corners, symmetrically located across the entire tension face (see Figure 4(c)). On the top surface, crushing developed in a circular pattern around the loading points, and also linearly from the application load at roughly a 45° angle towards the lines of support, illustrated in Figure 4(a). This pattern was repeated in all three slabs and occurred more evidently at high levels of load. In all slabs, flexural-shear cracks developed along the sides at a 45° angle, connecting the bottom flexural cracks with the top-surface ones (see Figure 4 (b)); in slabs SQ2 and SQ3, similar types of crack developed on the sides of the openings, starting from the corners of the hole and moving at an angle of about 45° towards the center of the cutout (see Figure 4 (d)). Post-failure inspection showed that these cracks sliced through the plane of the slab, which may be interpreted as a form of punching shear behavior. The simply supported conditions under which these tests were performed would have helped to encourage a more flexural type of behavior at the expense of such punching shear. If the four corners of the slab had been restrained from lifting up, it is possible that punching shear would have been the definitive controlling mode of failure. Slab SQ3 experienced a very similar crack pattern to that of specimen SQ2, but in this case, failure of the specimen occurred in the anchoring device of the FRP. Debonding of the laminates started from flexural cracks at the maximum bending moment region around the hole, and particularly in the area where the two perpendicular strips overlapped on the diagonal (see Figure 4 (e)), but the anchoring prevented the laminates from debonding prematurely. At failure, the entire concrete cover was pulled off suddenly (see Figure 4 (f)).

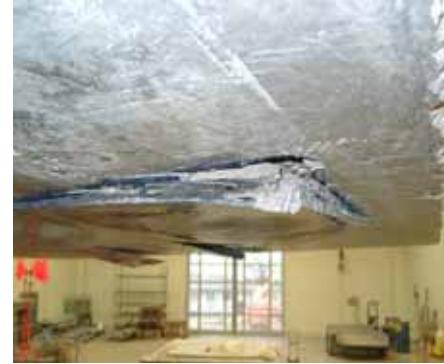
f) Failure of anchoring: pull off of the concrete cover
