FAILURE BEHAVIOR OF PRECRACKED CONCRETE BEAMS RETROFITTED WITH FRP

By Oral Buyukozturk,¹ Member, ASCE, and Brian Hearing,² Student Member, ASCE

ABSTRACT: The addition of fiber-reinforced plastic (FRP) laminates bonded to the tension face of concrete girders is becoming an attractive solution to the rehabilitation and retrofit of damaged structural systems. Flexural strength is enhanced with this method but the failure behavior of the system can become more brittle, often involving delamination of the composite and shear failure of the girder. This study first reviews failure modes including delamination with the use of FRP to rehabilitate various concrete structures and discusses methodologies used to characterize the failure processes of the system. Then, failure modes observed in an experimental program involving FRP-laminated laboratory models are reported. Physical models of reinforced concrete beams with variations in shear strengths, bonded laminate lengths, and epoxy types are precracked, then retrofitted with glass and carbon fiber-reinforced plastics and tested in an experimental program. Strengths are shown to increase with the addition of FRPs, but the specimens are ob

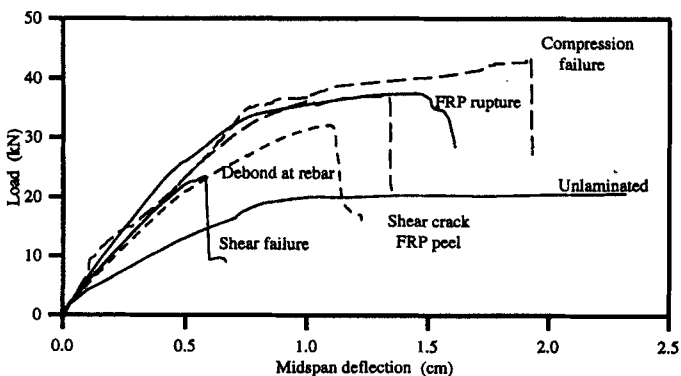
FIG. 4. Sample Load versus Deflection Curves for Specimens

mental program. The beam specimens were first precracked at a maximum deflection of $l/240$, then retrofitted with two types of laminates, a 33% glass/nylon plastic (Grade 1600) and a 70% carbon/graphite (T700) plastic, respectively. Shear reinforcement spacings were varied at 13 and 18 cm to test different shear capacities of the beam. High-modulus and low-modulus epoxies were tested with two lengths of laminate, 90 and 70 cm, to investigate effects of retrofitting configurations. The thickness of the applied epoxies ranged from 0.5 to 2 mm, due to the varying roughness of the beams. These testing variables caused the specimens to fail in a variety of modes; observed modes of failure include flexural compression of the concrete, shear failure in the concrete beam, delamination of the FRP, and debonding of a layer of concrete at the flexural steel level. Sample load-midspan deflection curves for these failures are shown in Fig. 4.

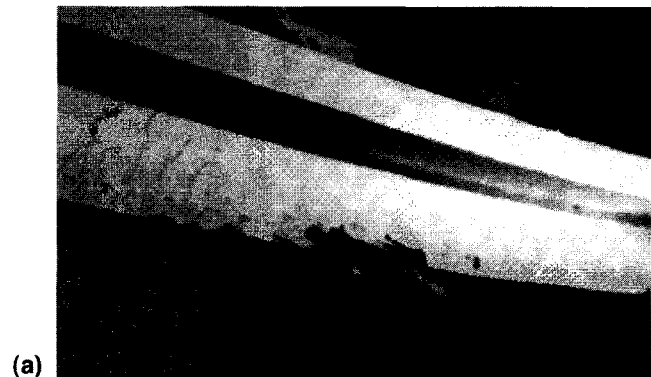
FIG. 5. Flexural Failures: (a) Laminate Tensile Failure (EMPA 1994); (b) Compression Failure

Flexural failures of the retrofitted section include tensile rupture of the laminate [Fig. 5(a)], and compression failure of the concrete [Fig. 5(b)]. Both failures occur in a brittle manner with a sharp, explosive fracture. Strengths were increased by an average 23% in this program, though theoretical increases of up to 245% have been reported (Saadatmanesh and Ehsani 1990; Meier 1992). Deflections in the beam were reduced compared to the unretrofitted section, and the beam stiffness was increased. The ultimate strengths and stiffnesses of the beams with these flexural failures can be accurately predicted using strain- or stress-compatibility theories (introduced in the next section). However, it was found that flexural failures occurred only in beams with the long (90 cm) laminate length and higher shear reinforcement (13-cm spacing).

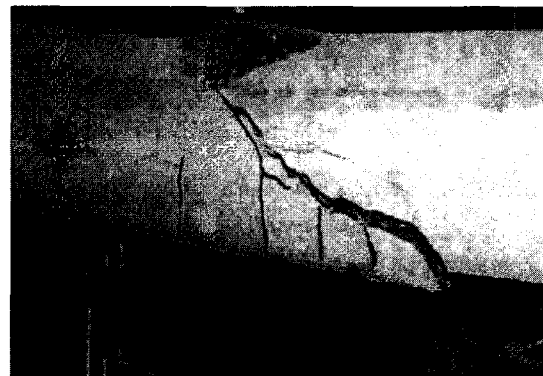
FIG. 6. Shear Failure

Shear failures of retrofit sections occur when the shear capacity of the section is exceeded prior to the load level reaching the flexural strength (Fig. 6). It is concluded that the FRP along the bottom of the beam does not significantly add to the shear strength of the section. These failures were achieved with the wider shear stirrup spacing (18 cm), which gave rise to a lower shear capacity. Shear cracks typically extended from the end of the laminate (70 and 90 cm lengths) to the point of loading. Shear failure occurred at relatively low applied loads, but these loads agreed with traditional reinforced concrete shear-strength theory. Research into improving the shear capacity of beams through innovative retrofit with FRP is increasing (Berset 1992; Sharif et al. 1994; Chajes et al. 1995b).
