In-Plane and Out-of-Plane Behavior of Masonry Walls Strengthened with FRP Systems

J. Gustavo Tumialan

Antonio Nanni

Report No. CIES 01-24

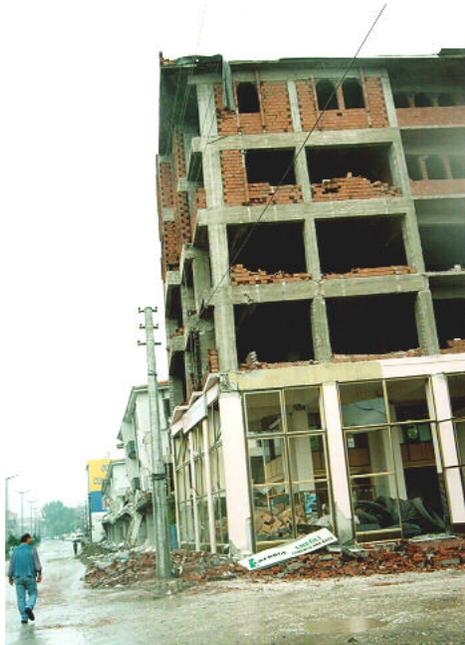
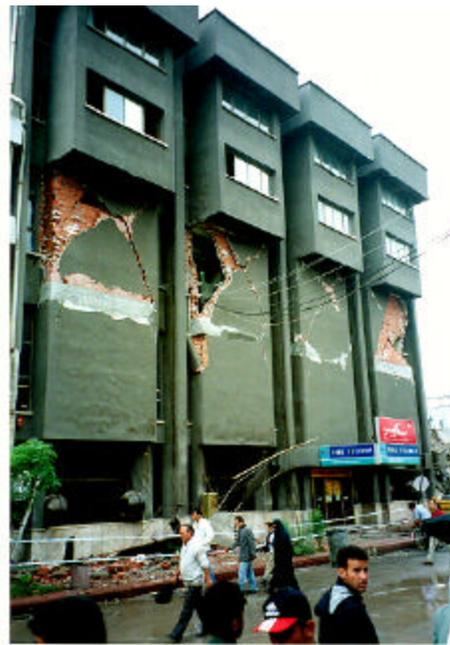
Figure 1.1. Failure of URM Walls (Turkey, 1999)

Structural weakness or overloading, dynamic vibrations, settlement, and in-plane and out-of-plane deformations can cause failure of masonry structures. Unreinforced masonry (URM) buildings represent a large portion of the buildings around the world. As a matter of fact, many of the existing buildings in the United States consists of URM buildings, especially in the Eastern part of the country. URM buildings have features that can threaten lives, which include unbraced parapets, inadequate connections to the roof, and the brittle nature of the URM elements themselves. Organizations such as The Masonry Society (TMS) and the Federal Emergency Management Agency (FEMA), have identified that failures of URM walls result in most of the material damage and loss of human life. This was evident from the post-earthquake observations in Northridge, California (1994) and Turkey (1999). Figure 1.1 illustrates the collapse of URM walls due to out-of-plane and in-plane loads after the earthquake in Turkey in 1999. Note the debris at the bottom, which during an earthquake is a potential threat to bystanders.

(a) Out-of-Plane Failure

(b) In-Plane Failure

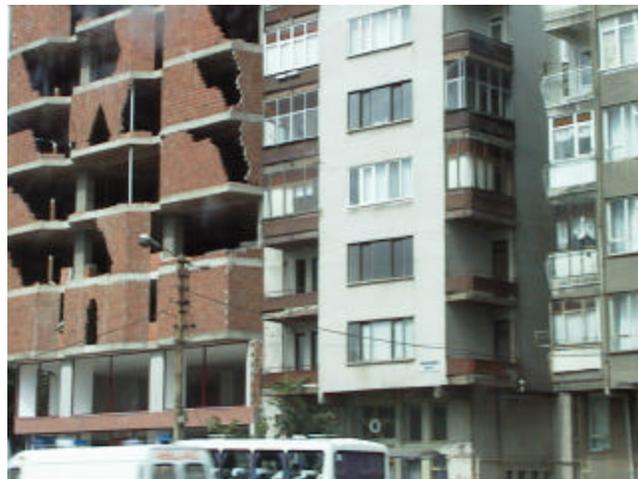
Figure 1.2. Collapse of URM Walls (Turkey, 1999)

URM walls are commonly used as interior partitions or exterior walls bound by steel or concrete frames forming the building envelope. Depending on design considerations, these walls can resist lateral and/or gravity loads. Due to weak anchorage to adjacent concrete members, or to absence of anchorage, URM walls may crack, tear and collapse under the combined effects of out-of-plane and in-plane loads generated by seismic forces, as illustrated in Figure 1.2.

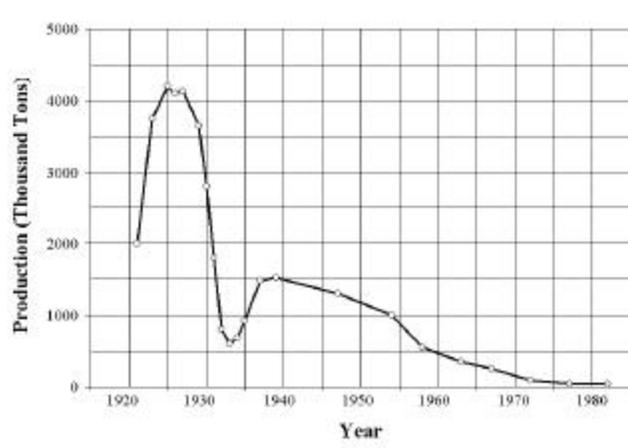
Figure 2.2. Production of Clay Tile during the 20th Century

Figure 2.2 illustrates information made available by the U.S. Department of Commerce Census of Manufacturers, on the production of clay tile in the 20th century. As can be observed, the production of clay tiles was peaked in the 1920's. As a consequence of the Great Depression, production then suffered a dramatic decrease. As World War II began, the economy was revitalized and large public works were performed. Some of military facilities built primarily with clay tiles included Fort Benning in Georgia, and the Women's Army Auxiliary Corps Barracks in Iowa. From Figure 2.2, it is observed that the production of clay tiles decreased during the 1960's, when concrete units began to be widely used.

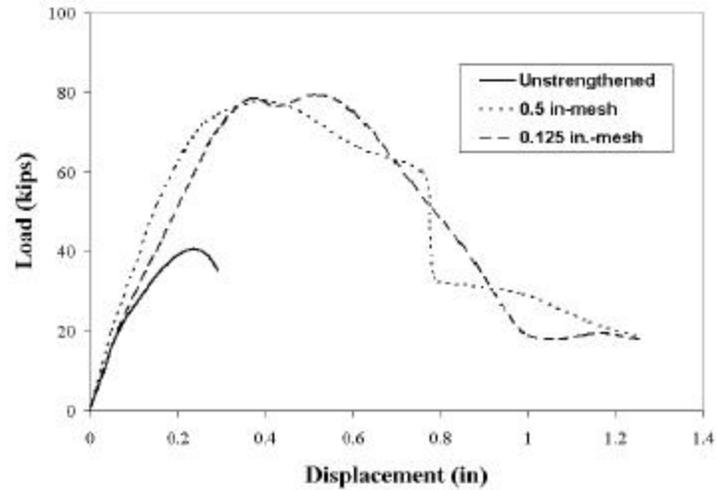
Figure 2.3. Test Results-External Reinforcing Overlay

The specimens were subjected to diagonal in-plane loading. Two modes of failure were observed, a ductile one caused by yielding of the steel wire and a brittle failure caused by debonding of the ferrocement overlay from the masonry surface. The experimental results indicated that the strength and ductility were almost doubled in the coated walls compared to the unstrengthened wall. Figure 2.3 illustrates the test results of three specimens. In the testing of panel 2, which had a 0.5-in. mesh wire spacing, it was observed that the layer of ferrocement debonded from masonry after substantial cracking. In contrast, in panel 3, with a mesh wire spacing of 0.125-in., complete yielding and tensile failure of the mesh was observed.

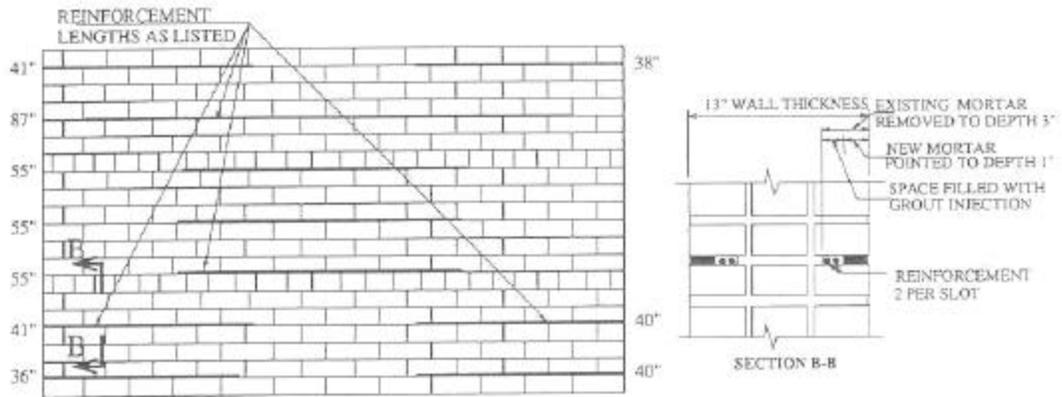
Figure 2.4. Location of Horizontal Reinforcement-Internal Steel Reinforcing

2.2.1.2. Internal Steel Reinforcing. Manzouri et.al. (1996) evaluated the efficiency of repairing URM walls by grout injection in combination with horizontal and vertical steel reinforcement. URM walls were built in three whites with clay bricks for an overall dimension of 8.5 by 5-ft. The walls were tested under in-plane loading. First, the behavior of the walls in their original condition was investigated. Then, the walls were retrofitted to be tested once again. All the retrofitted walls were injected with grout. The severely damaged areas were repaired by replacement with similar materials. Crack widths larger than 0.06 in were injected with a coarse aggregate; whereas, crack widths ranging between 0.008 to 0.06-in. were injected with a fine grout. Steel ties for use as dry-fix remedial anchor were placed as vertical reinforcement used for the pinning of the wythes in the toe area, and horizontal reinforcement (see Figure 2.4). The ties were made of Type 304 stainless steel with a helical design, similar to a self-tapping screw, which cuts a spiral groove as it is tapped into a pilot hole. The installation procedure included cutting of certain bed joints to a depth of 3-in. followed by placement of the tie in the slot and sealing with mortar.

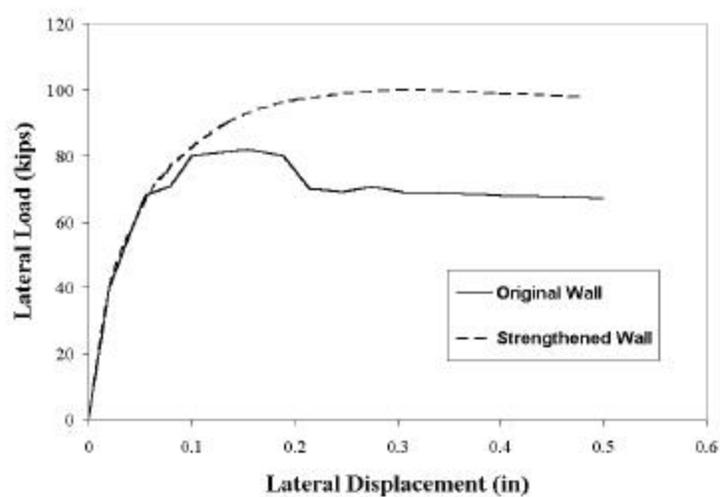
Figure 2.5. Test Results-Internal Steel Reinforcing

The test results demonstrated that the injection of grout accompanied by repair of localized damaged areas can restore the original strength and stiffness of retrofitted walls. The introduction of horizontal reinforcement increased the strength and ductility of the wall system, since shear failure was prevented. It was also observed that the vertical reinforcement increased the lateral resistance and ductility. Figure 2.5 illustrates the test results for a wall before and after being strengthened.

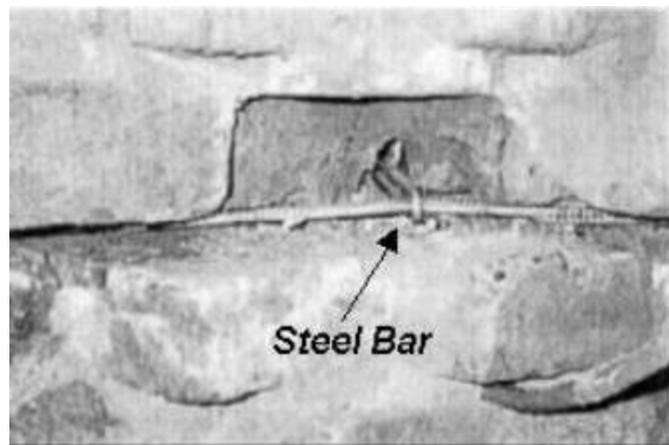
Figure 2.6. Internal Reinforcement

In old structures, load bearing masonry elements are prone to vertical cracking due to the combined effect of the gravitational sustained load and cyclic loads. This phenomenon has been observed in masonry towers and pillars throughout Europe, and can eventually lead to the collapse of the structure. Binda et.al (1999) investigated a technique to repair and strengthen masonry elements subjected to the aforementioned mechanism. This technique consisted of grooving the bed joints, placing of mortar along with the steel reinforcement (bars or plates) as shown in Figure 2.6. 10x20x 44-in. panels were built for this research program. Initially, the specimens were pre-cracked by compressive loads representing the 80% of their capacity. After this, the specimens were repaired by placing two bars with a diameter of 0.25 inch every third bed joint. The depth of the grooves was 2.5 inches. The test results of the repaired specimens showed that the strength was not improved. However, significant results in terms of deformation were attained, which was evident from the reduced cracking observed. In the repaired walls, reductions in the strains ranging between 40% to 50% were recorded. It was concluded that the structural degradation process of a masonry element can be detained; especially if the overall conditions are improved by other strengthening techniques such as injections and replacement of damaged sections.

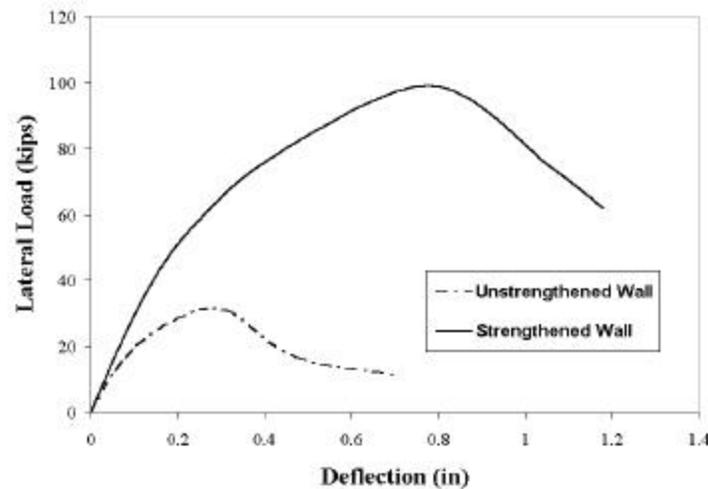
Figure 2.8. Test Results-External Steel Reinforcing

observed in the unstrengthened wall. In the strengthened wall, the diagonal steel strips delayed the crushing of masonry until excessive yielding, which led to buckling in the strips, occurred. It was observed that the vertical strips provided a ductile flexural behavior to the walls, and the steel strip system prevented the development of rigid body rotation and allowed cracks to spread.

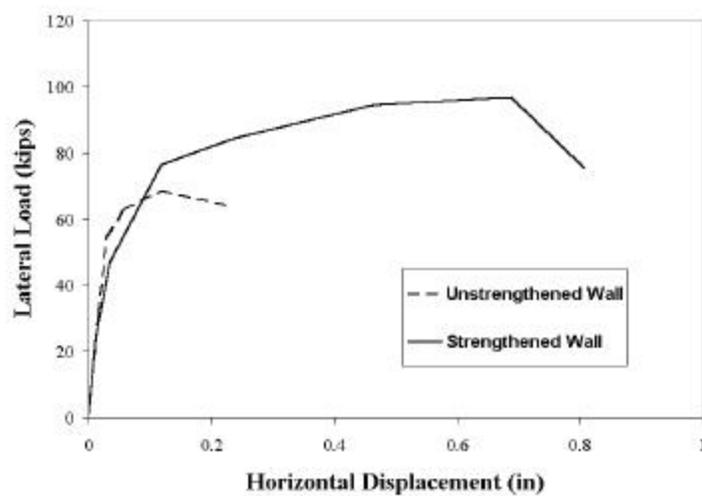
Figure 2.10. Test Results-Schwegler

As observed in Figure 2.10, the test results showed that the strengthened wall exhibited elastic behavior up to 70% of the maximum shear force. It was also observed that the carrying capacity decreased as a consequence of massive crack formation in the masonry. By comparing walls strengthened in one side and two sides, it was observed that if only one side of the masonry wall is strengthened, the capacity could be halved. In addition, the eccentricities caused by this strengthening scheme had a minimum effect on the shear carrying capacity. In all the strengthened walls fine cracks were observed perpendicular to the sheets. The crack separation was constant and the crack widths remained small.

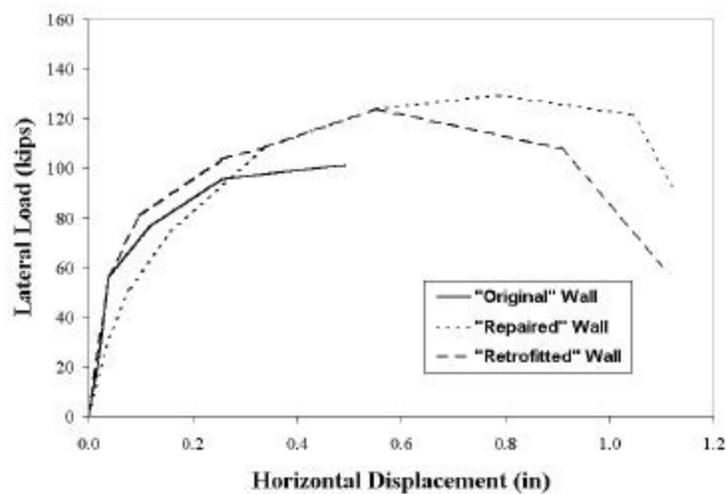
Figure 2.11. Test Results-Laursen

Laursen et al. (1995) studied the shear behavior of masonry walls strengthened with CFRP laminates. The walls were built with concrete blocks; and fully grouted. The overall dimensions were 6 by 6-ft. The walls were internally reinforced; horizontally with a low shear reinforcement ratio of 0.14%, and vertically with a ratio of 0.54%. The “original” wall failed in shear. The specimen was re-tested after being repaired. The repair was performed by closing the large diagonal shear cracks with epoxy filler and epoxy injection, and repairing the crushed compression toes with epoxy mortar. The “repaired” wall was then strengthened with CFRP laminates, which covered the two sides of the wall; an additional layer was applied in the end regions as confinement. The amount of strengthening in the “retrofitted” wall was similar to the previous wall but applied to only one side of the wall.

It was observed that the presence of the FRP laminates improved the wall performance by changing the failure from a shear-controlled failure to a flexural-controlled failure. This change caused an increase in the capability of deformation of approximately 100% by preventing a brittle failure mode. The test results of this wall, shown in Figure 2.11, also proved that even though the wall failed in shear, it could be repaired to restore the initial stiffness and strength compared to the standard of the “original” and “retrofitted” walls.

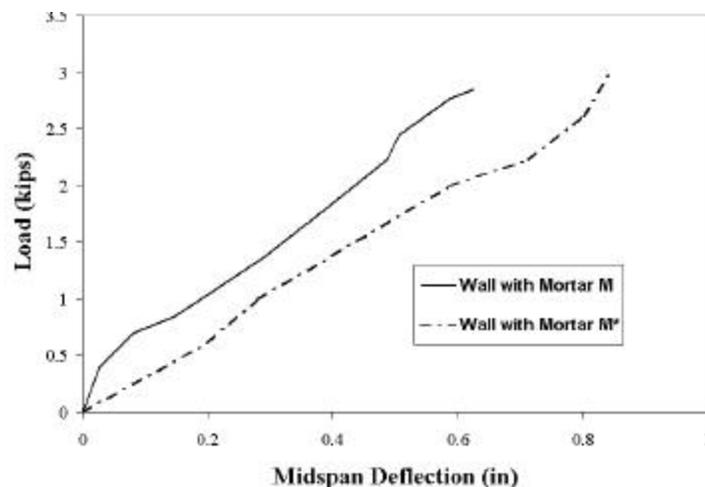
Figure 2.12. Test Results-Ehsani

Ehsani et al. (1996) investigated the flexural behavior of URM walls strengthened with GFRP sheets. Their dimensions were 8.5-in. wide, 4-in. high, and 57-in. long. Two different kinds of mortar were used for their construction, type M with cement:lime:sand ratios of 1:1/4:3 and a compressive strength of 4.65 ksi; and type M* with ratios of 1:1/4:5 and a compressive strength of 4.1 ksi. The specimens were subjected to four-point bending. The primary failure was a tension failure, which was observed when low amount of strengthening was used. When the number of plies was increased, the masonry failed in compression. It was observed that the flexural capacity was increased up to 24 times compared to the control specimen. As observed in Figure 2.12, the effect of the mortar strength appeared to be negligible, both specimens failed by crushing of the masonry.

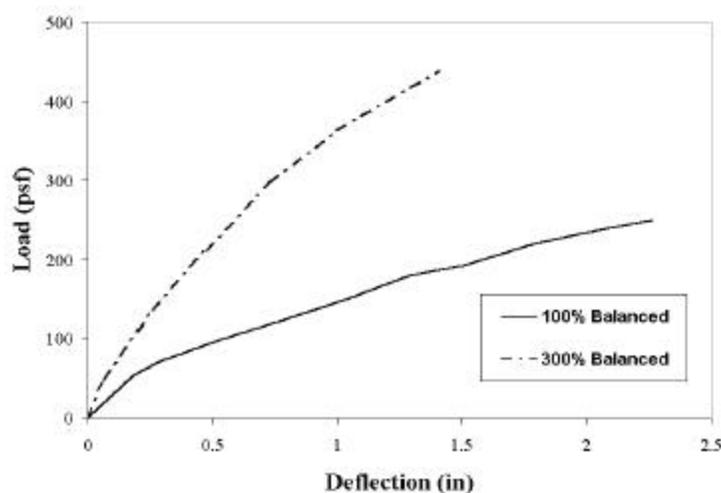
Figure 2.14. Test Results-Velazquez

Velazquez et al. (2000) reported test results of half-scale URM walls tested under out-of-plane cyclic loading. The test specimens had a width of 48-in. and a height of 56-in., with a slenderness ratio of 28. Two of the walls were strengthened on both faces with GFRP strips. By understanding that the balanced condition represents the failure of masonry and rupture of composite laminate at the same time, one wall had the reinforcement equivalent to the balanced ratio ($1.0\% \rho_b$). The other wall had three times the amount of reinforcement as compared as the first wall ($3.0\% \rho_b$). The specimen reinforced with $1.0\% \rho_b$ showed extensive delamination at failure. The first delaminated areas were observed on the central strip above the middle brick course. The specimen with $3.0\% \rho_b$ failed due to high in-plane shear stresses along the lower brick course. Substantial increases in strength and deformation capability were achieved. It was observed (see Figure 2.14) that the retrofitted walls resisted pressures up to 24 times the weight of the wall and deflected as much as 5% of the wall height. To avoid very stiff behavior and improve the hysteretic response, it was recommended to limit the reinforcement ratio to two times the balanced condition.

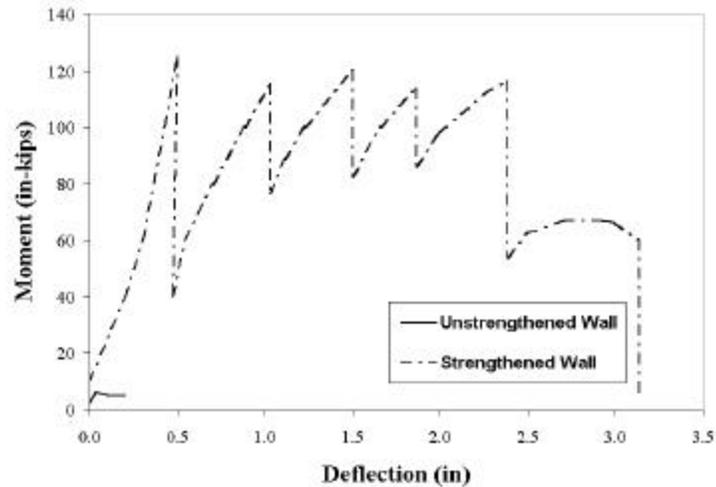
Figure 2.15. Test Results-Ahmid

The 4 by 8.5-ft. walls were simply supported and tested under out-of-plane loading. In the strengthened wall, a 22-fold increase in flexural capacity compared to the unstrengthened wall was recorded. In addition, a large deformation capability beyond the first crack was observed, as seen in Figure 2.15. This is attributed to the presence of the reinforcing bars and the high tensile strength of the grout.

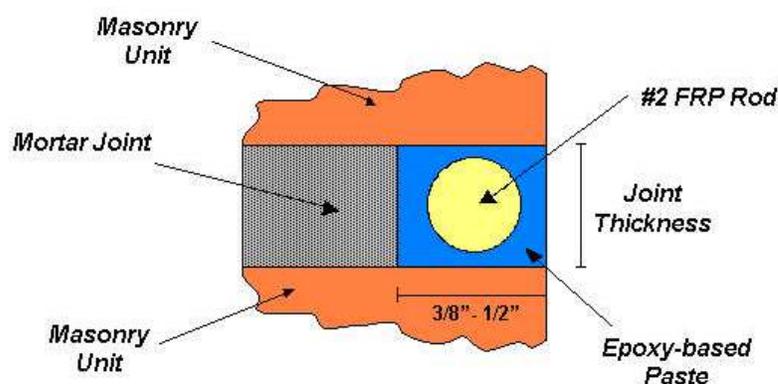
Figure 3.7. FRP Structural Repointing

When the FRP rods are installed in either the horizontal or vertical (only for stack bond patterns) masonry joints, the aforementioned technique receives the name of FRP Structural Repointing. Repointing is a traditional retrofitting technique, commonly used in the masonry industry, which consists in replacing missing mortar in the joints. The term “structural” is added to describe a strengthening method aimed at restoring the integrity and/or upgrading the capacity of walls. This is achieved by placing into the joints deformed FRP rods, which are bonded to the masonry wall by the paste (see Figure 3.12).

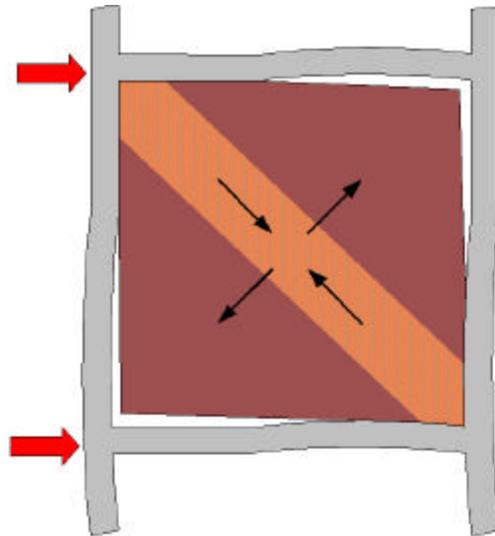
Figure 4.1. Diagonal Compression Strut

Previous investigations (Sabnis, 1976) have demonstrated that the composite action between the masonry infill and the surrounding frame is depending on the level of the in-plane load, bonding or anchorage at the interfaces, and geometry and stiffness of both the masonry infill and the structural frame. At a very low level of in-plane loading, a full composite action between the infill wall and the frame is observed. Once the load increases, the infill wall and the frame are no longer in contact, except in surrounding areas of the two corners where compression stresses are transmitted from the frame to the masonry which lead to the formation of a diagonal compression strut (see Figure 4.1).

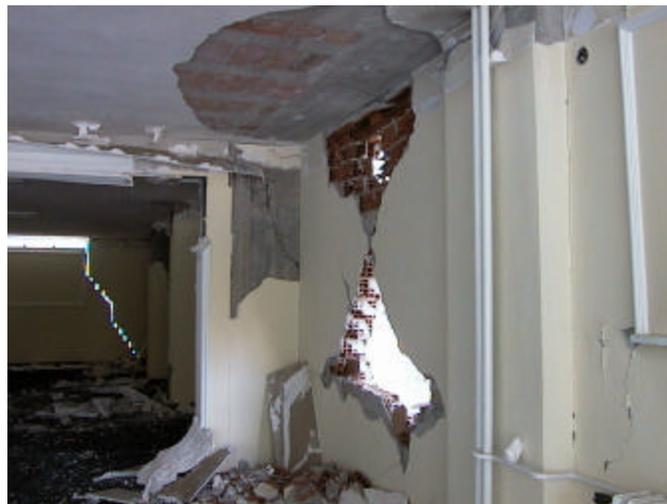
Figure 4.2. Diagonal Tension Failure (Turkey, 1999)

This resulting structural system is usually analyzed as a truss. The stiffness of the infill starts decreasing once cracking is developed. At a stage when higher in-plane loads are present, the contribution of the compressive strut begins to reduce as further cracking is developed. Also, the gap separating masonry from frame is increased, which eventually leads to shear failure (diagonal tension) of masonry as observed in Figure 4.2; and flexure (yielding) failure of the columns. Depending on the compressive strength of the masonry, the units in the corner areas may be crushed prior to developing diagonal cracking (see Figure 4.3).

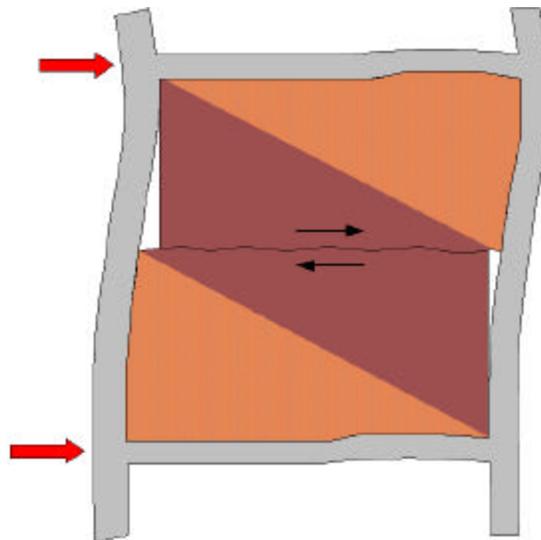
Figure 4.4. Joint-Slip Failure

Alternatively to the diagonal tension failure, a shear failure along a horizontal joint can be observed at a lower load level as compared to the load causing the latter mentioned failure. The resulting shear crack divides the infill in two parts, where the behavior is controlled by either the flexural or shear capacity of the columns. This failure mechanism is commonly known as Knee Brace or Joint-Slip (see Figure 4.4).

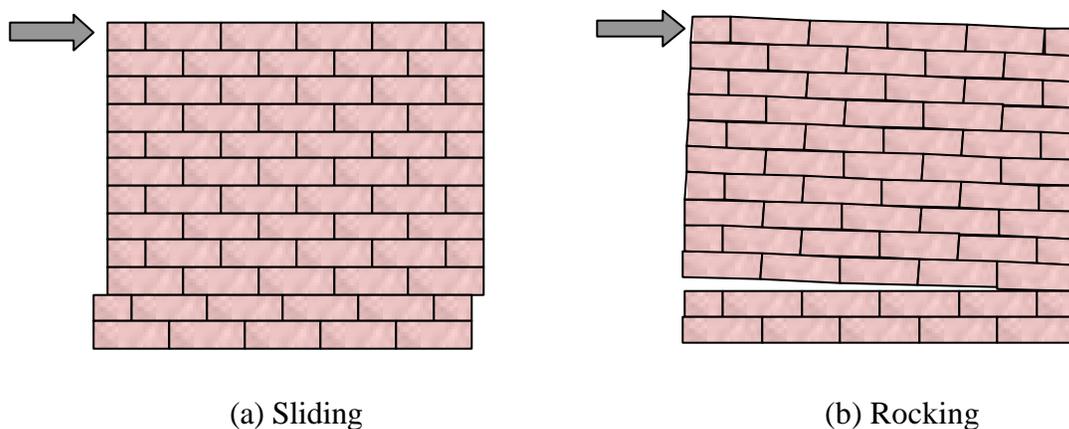
Figure 4.5. Potential Failures in Walls with No Axial Load

Single-story buildings, such as schools and shopping centers, are very common in the United States. In these buildings, vertical and horizontal loads are resisted by shear walls. These unreinforced or lightly reinforced walls are prone to failing during an earthquake. Their capacity to withstand horizontal loads is limited by the strength of the masonry units and the mortar in the bed joints. At low axial loads, two modes of failure may be observed. One is sliding of the wall along the bed joints (see Figure 4.5a). The other is rocking on a horizontal crack at the wall bottom (see Figure 4.5b). The overall stability of the building is not compromised as long as the deformations are small. If the masonry wall bears high axial loads, the bed joint friction is increased and therefore sliding or rocking will not be observed. Instead, diagonal shear cracks will be developed. In this context, the specimens belonging to series IF offer the opportunity to perform fieldwork to evaluate the behavior of this kind of masonry walls.

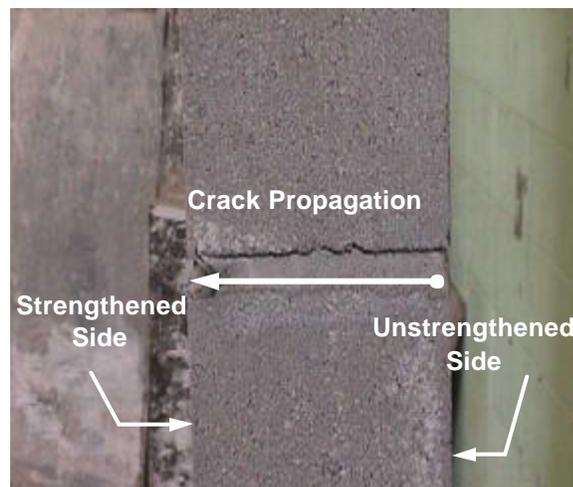
Figure 4.10. Mechanism of Failure – Series IL

4.2.4. Mechanism of Failure. In the strengthened walls, the failure was produced by the loss of bonding between the epoxy-based paste and the masonry units. Comparing the recorded crack widths in the front and back sides, the crack growth in the unstrengthened or less strengthened back side increased at a higher rate than the strengthened front side; as verified from Figure 4.7. The crack produced by debonding of the masonry units from the mortar in the back side, traveled through the wall thickness until debonding of the epoxy-based paste from the masonry units (see Figure 4.10). At this point the wall fails because the tensile stresses are not longer transferred to the rods.

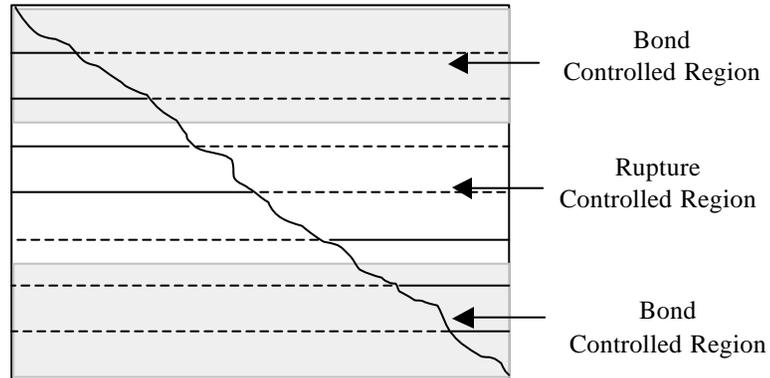
Figure 4.11. Controlling areas to estimate R_F

R_f depends on the tensile stresses developed in the rods. Depending on the magnitude of the stresses two areas can be identified in a masonry panel: bond-controlled and rupture controlled regions (see Figure 4.11)

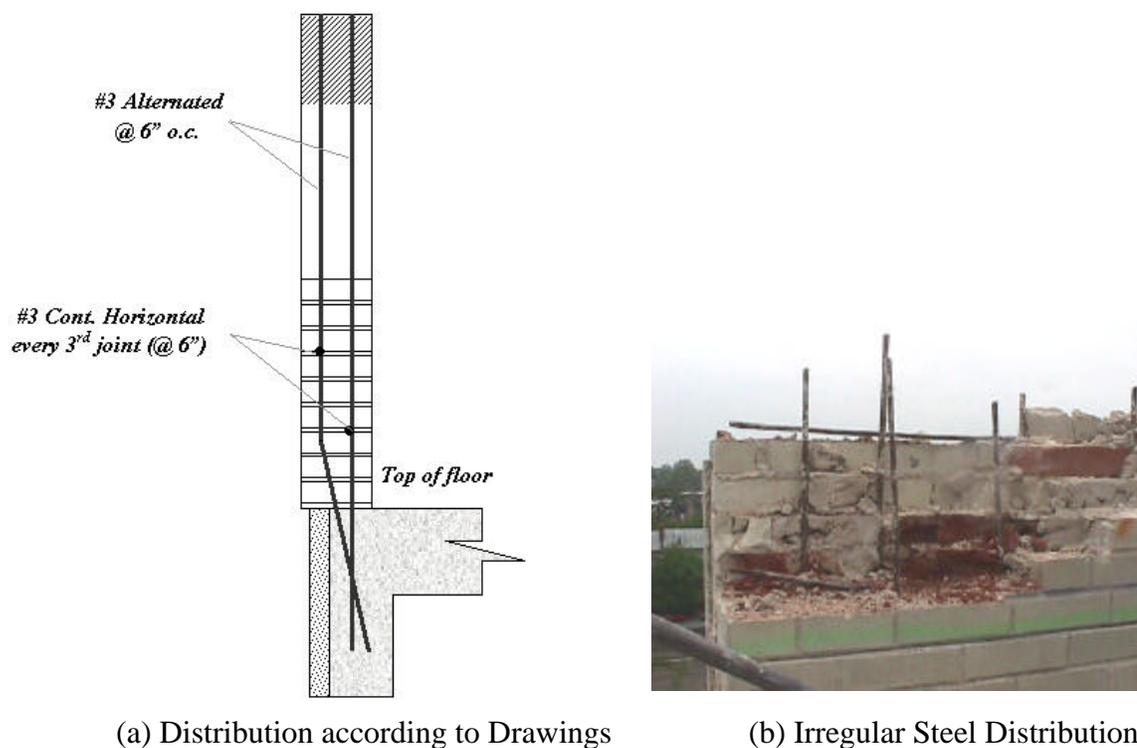
Figure 4.13. Steel Distribution – Series IF

Wall IF1 was selected as a control specimen. The remaining three specimens were strengthened with GFRP sheets and rods. Wall IF2 was strengthened with three GFRP strips with a width of 10-in. (vertically oriented), and six #3 GFRP rods spaced at 10 inches (horizontally oriented). The strengthening scheme for Wall IF3 was similar to that of Wall IF2 with regard to the FRP sheets. Conversely, ten #3 GFRP rods having a length of 36-in., two per slot, were placed in 18-in. at each wall toe. This additional reinforcement was placed with the purpose of increasing the flexural capacity of the wall and force a shear failure to occur. It would have been desirable to strengthen both sides of the walls, but since these walls were part of the parapets at the uppermost story only one side was easily accessible. Details of the strengthening schemes are presented in Appendix B.1.

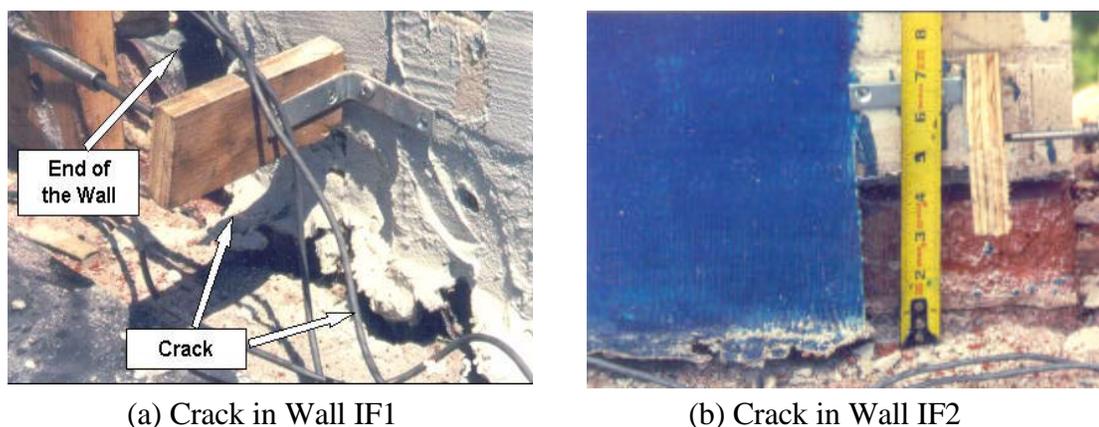
Figure 4.16. Flexural Cracks at the Bottom of Walls

some secondary cracks near to the bottom by the FRP laminates. In the same way to Wall 1, the primary flexural crack causing the failure was observed at the bottom of the wall (see Figure 4.16b).

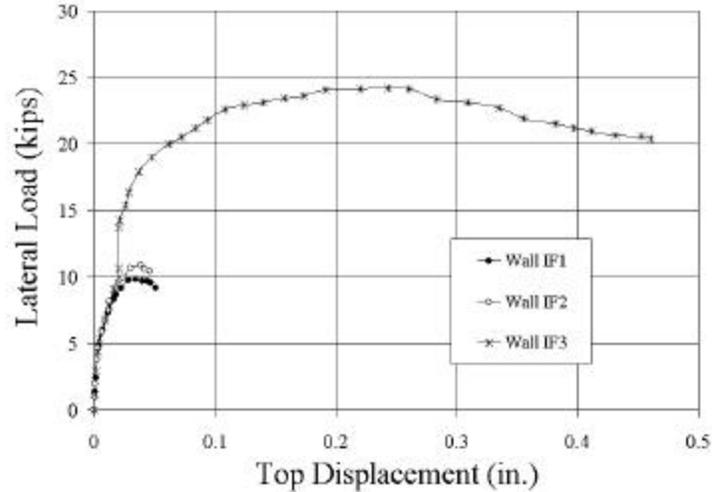
Figure 4.17. Lateral Load vs. Top Displacement – Series IF

deflection at the yielding of steel can not be applied. However, in Wall IF3, due to the contribution of the GFRP rods in the toes, a notable increase in pseudo-ductility was attained.

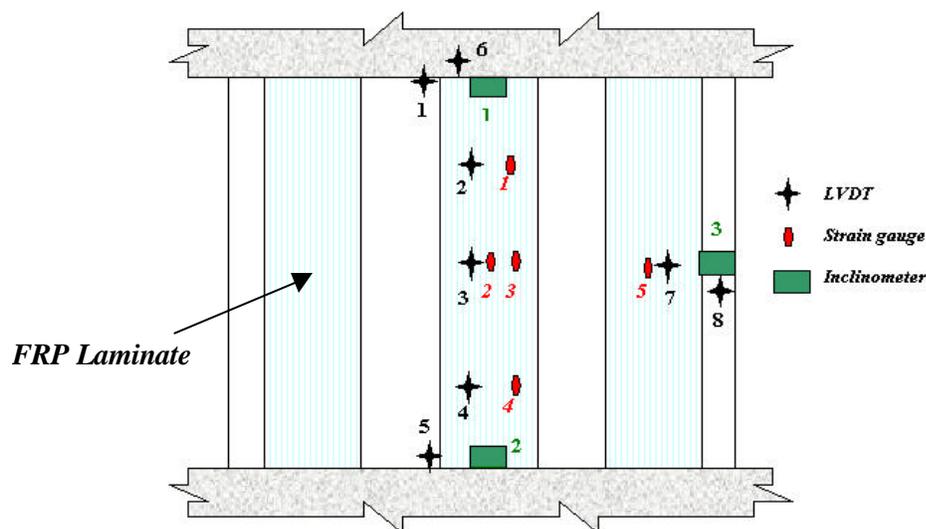
Figure 5.6. Test Instrumentation –Series OF

loading and unloading. Each URM wall was loaded to 10 kips and then unloaded prior to continuing with the test. This procedure allowed checking the instrumentation and reacting systems. The walls were loaded in increments of 10 kips, and unloaded to a low threshold of 5 kips. The data obtained from a 200 kip load cell, Linear Variable Transducer (LVDTs), strain gages, and inclinometers were collected by a data acquisition system at a frequency of 1 Hz (see Figure 5.6). For the tests carried out in this experimental program eight LVDTs were used. LVDTs 1 to 5 intended to record out-of-plane deflections along the wall height. LVDTs 1 and 5 measured the wall movement at the boundaries. LVDT 3 recorded midheight deflection, LVDT 6 monitored any movement in the upper RC beam, and LVDTs 7 and 8 intended to register the deflections along the wall length with the purpose of observing two-way action. Five channels to record strains were employed, the strain gages were placed on the FRP laminates or rods. Three inclinometers were used to record rotations in the upper and lower borders, as well as in one of the free edges.

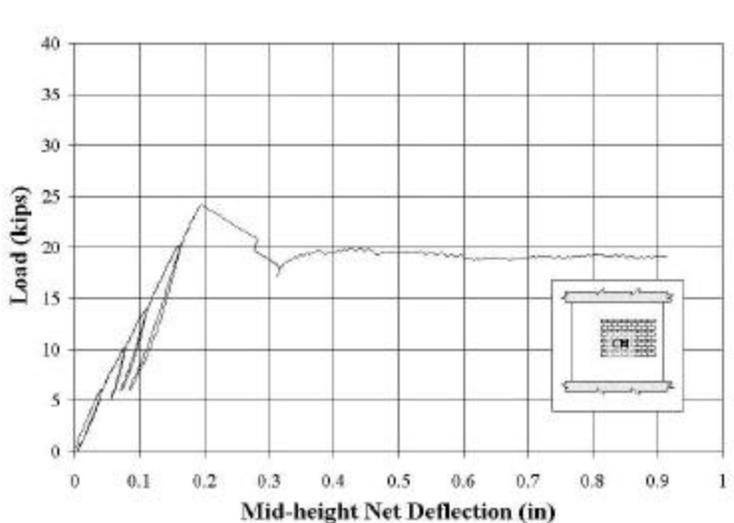
Figure 5.9. Load vs. Mid-height Net Deflection Curve – Wall OF2

This wall was also tested as control specimen; however, in this case the cementitious plaster was removed from its surface. The first visible crack was observed at a load of 10 kips, running above the central brick course, along the bed joint. The peak load was reached at 24 kips for a mid-height deflection of 0.16-in., the failure, similar to that observed in Wall OF1, was caused by a shear-compression combination effect at the upper region of the wall. Once its peak was reached the load decreased to 20 kips and only the deflection increased. In comparison to Wall OF1, this wall was less stiff, and it had pseudo elasto-plastic behavior up to failure (see Figure 5.9).

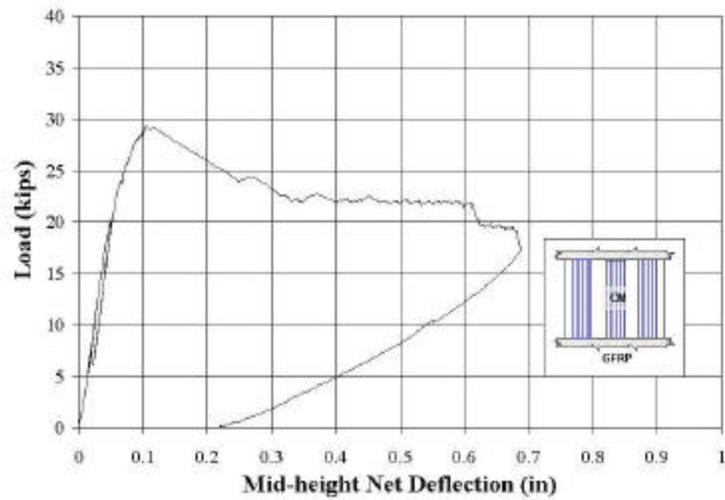
Figure 5.10. Load vs. Mid-height Net Deflection Curve – Wall OF3

This wall was strengthened with three strips 20-in. wide of GFRP laminates. The first visible crack was observed at a load of 20 kips; at this stage the stiffness is slightly reduced. Two horizontal cracks are observed above the mid-height course. As shown in Figure 5.10, the wall failed at a load of 29 kips with a mid-height deflection of 0.1-in. at that stage. Delamination of the plaster at the lower area of the wall could be observed due to the loss of bonding between the plaster and the adjacent bricks and tiles, which were fractured by a shear-compression combination effect. In comparison with Wall OF1, the presence of glass fibers delayed the first cracking, reduced the crack width but did not increase the ultimate capacity.

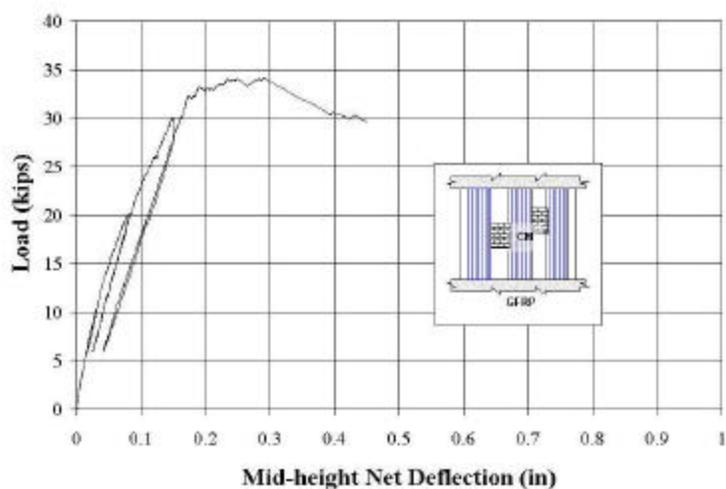
Figure 5.12. Load vs. Mid-height Net Deflection Curve – Wall OF4

This wall had a similar strengthening scheme to Wall OF3. The significant difference was that the GFRP laminates were applied directly on the masonry. It was observed that the FRP reinforcement performed in a better fashion than in the previous wall. The failure was caused by fracture of the masonry units located at the top of the wall (see Figure 5.11). For this case, the load drop was less pronounced and more gradual after reaching the peak. The maximum load recorded was 34 kips with a corresponding mid-height deflection of 0.2 in (see Figure 5.12)

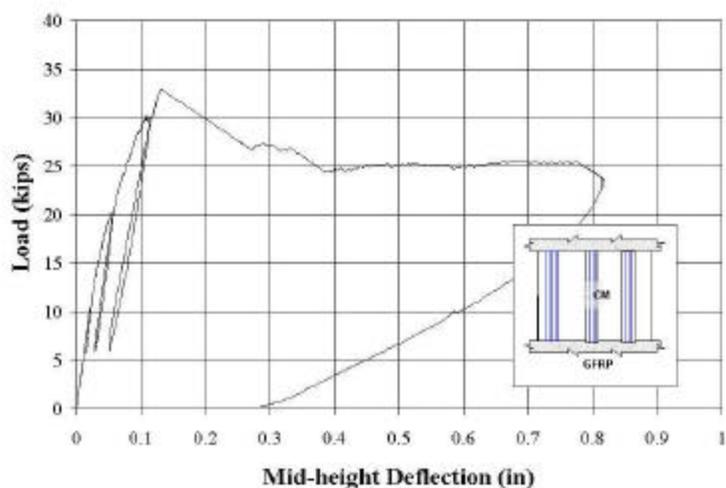
Figure 5.13. Load vs. Mid-height Net Deflection Curve – Wall OF5

This wall was strengthened with half of the reinforcement used in Walls OF3 and OF4, meaning three strips 10-in. wide of GFRP fibers were attached to the wall surface. A horizontal crack above the mid-height course was observed at a load of 13 kips. Similarly to the previous walls, the failure was caused by a shear-compression combination effect at the lower region of the wall. The failure occurred at a load of 33 kips for a corresponding mid-height deflection of 0.12 in (see Figure 5.13). By comparing this wall to Wall OF3, a larger presence of cracks spread for almost 50% of the area was observed (see Figure 5.14).

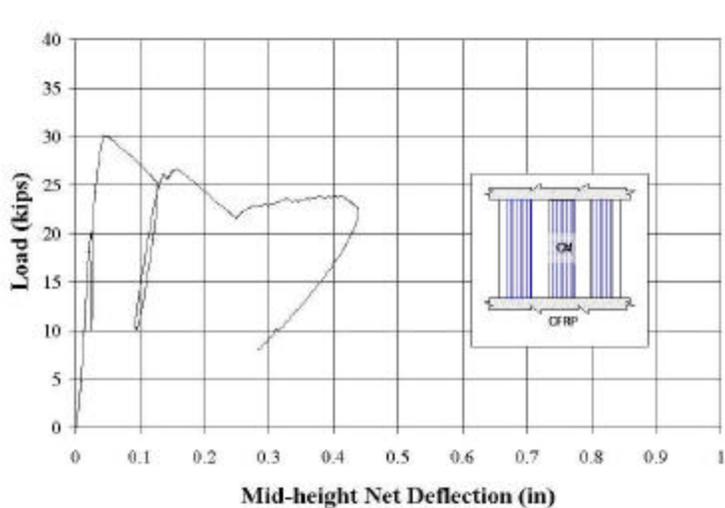
Figure 5.15. Load vs. Mid-height Net Deflection Curve – Wall OF6

This wall was strengthened with three strips 20-in. wide of CFRP laminates. A major horizontal crack was observed at a load of 24 kips, running along the bed joint located above the mid-height course. The maximum registered load was 30 kips, for 0.06 in mid-height deflection, as observed in Figure 5.15. The failure was caused by a shear-compression combination effect, which fractured some tile units located at the bottom of the wall. As a consequence, with the deflection increasing the plaster layer delaminated from the adjacent tiles as can be observed in Figure 5.16. This wall showed an atypical behavior compared to the other walls. As can be observed in the corresponding Height vs. Displacement curve in Appendix C.2-21, the upper region of the wall displaced in opposite direction to the applied load.

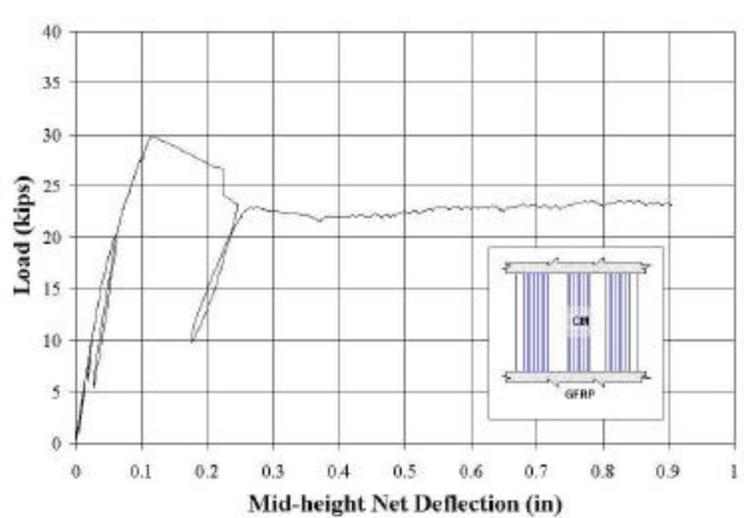
Figure 5.19. Load vs. Mid-height Net Deflection Curve – Wall OF8

The strengthening geometry of Walls OF3 and OF8 were similar. The only difference was the employment of GFRP rods in Wall OF8 in order to give continuity to the GFRP laminates into the RC beams. Since the controlling factor was the fracture of the tiles located at the bottom region of the wall, the results were identical to those found in Wall OF3. The peak load was 29 kips with 0.1 in mid-height deflection, as observed in Figure 5.19.
