# **Seismic Retrofit of Reinforced Concrete Beam-Column T-Joints in Bridge Piers with FRP Composite Jackets**

**by C.P. Pantelides and J. Gergely**

Synopsis: The research described encompasses laboratory as well as in-situ testing of reinforced concrete beam-column joints and multicolumn bridge piers rehabilitated with FRP composite jackets. Fourteen RC beam-column joint tests were performed and a design equation was developed which determines the thickness of the FRP composite jacket and the orientation of the fibers for maximum effectiveness in enhancing shear capacity and ductility. Several in-situ tests were conducted at the South Temple Bridge in Salt Lake City, which included a three-column bridge pier without an FRP composite seismic retrofit, a pier retrofitted with FRP composite jackets, and a pier retrofitted with FRP composite jackets and a reinforced concrete grade beam. The design of the seismic retrofit was based on rational criteria, which included the design of the foundation and column retrofit, and the design equation for retrofitting reinforced concrete beam-column joints, developed in the laboratory tests. The performance target for the seismic retrofit was a

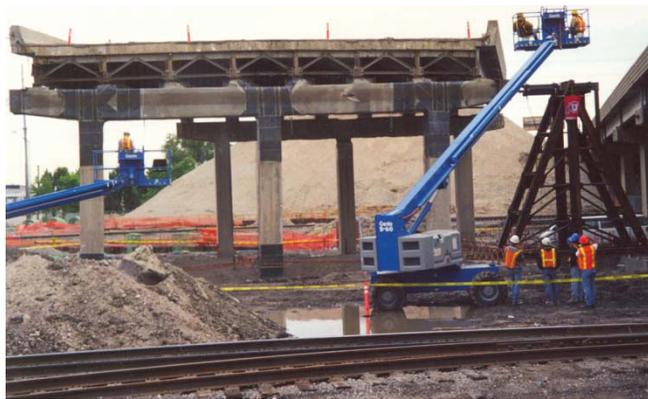
Figure 7 - In-situ lateral load test of bridge pier – 1998 tests.

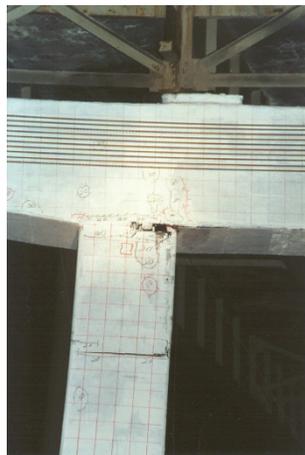
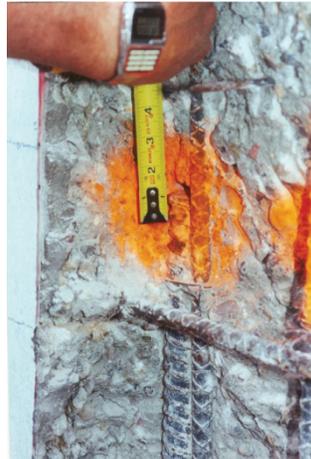
Figure 17 - Damage of retrofitted bridge pier in 2000 tests: (a) CFRP U-Strap rupture at 4% drift ratio at East column T-joint, (b) 16 mm (5/8 in.) slip of West column longitudinal steel at 5.5% drift ratio.

Degradation of the lateral load capacity of the bridge pier started once the CFRP U-straps ruptured in the T-joints of the two exterior columns at a 4% drift ratio, as shown in Fig. 17(a). Subsequently, the vertical column steel started slipping at the East and West column T-joints near a drift ratio of 5.5%, as shown in Fig. 17 (b). A flexure/shear crack formed starting at the top of the cap beam, 1.73 m (68 in.) east of the West column, as shown in Fig. 18; this is the termination point of the four 32-mm (#10) negative moment steel bars, as shown in Fig. 5(a). The crack started as a flexural crack at a 4.0% drift ratio, continued to propagate diagonally and had completely developed at a drift ratio of 6%, reaching a crack width of 1.3 mm (0.05 in.). The crack occurred because of the high negative moment and insufficient tensile steel and vertical stirrups at this location; there were no FRP composite layers parallel to the cap beam axis near this joint, which were provided for the East and Middle columns, as shown in Fig. 15(a), which did not develop any cracks. It should be stressed that the retrofit was successful, the pier dissipated a large amount of energy and reached a drift ratio of 6.8%. A more extensive treatment of the 2000 bridge pier tests is given in Pantelides et al. (2002), Pantelides et al. (2004), and Duffin (2004).
