Paterson, N.J.

CIPP of Leaking High-Pressure Gas Main

Sharon M. Bueno — Oct 27, 2011

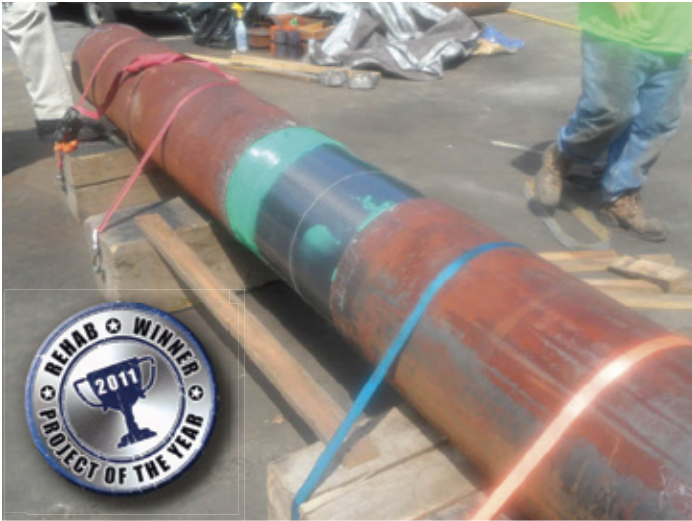
The simulated test of what the **PipeMedic™** carbon laminate sleeve would look like once installed.

The process of cutting the standpipe and installation of the PipeMedic™ laminate was simulated and tested at PPM under the watchful eye of GTI. The GTI test results indicated that the simulated drip pot pipe section met the pressure requirements of industry standards for cured-in-place liners. During the actual project, it took just a few minutes for the robotics system, which had an Aries camera attached, to travel down the main and an hour to cut away the standpipe in several cuts with the cut pipe sections dropping into the bottom of the pot. Using the robotic device, the PipeMedic™ laminate coated with epoxy resins was inserted into the pipe. After the resin cured, the CIPP process for the entire 700-foot pipe was pretty straightforward.
