Paterson, N.J.

CIPP of Leaking High-Pressure Gas Main

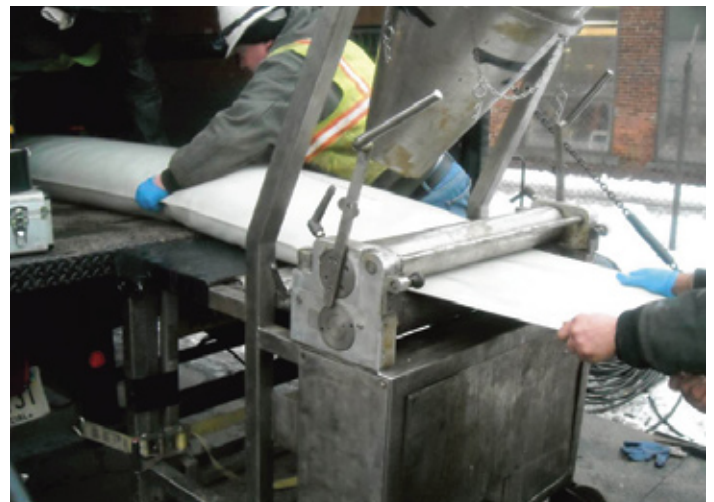
PPM overcame several obstacles before the most routine part of the project could happen: the CIPL work.
