October 2020, Vol. 247, No. 10

# How to Repair Large Pipes at Break Point Using FRP Laminates

By V. Firat Sever, Pipeline Division Manager, QuakeWrap Inc.

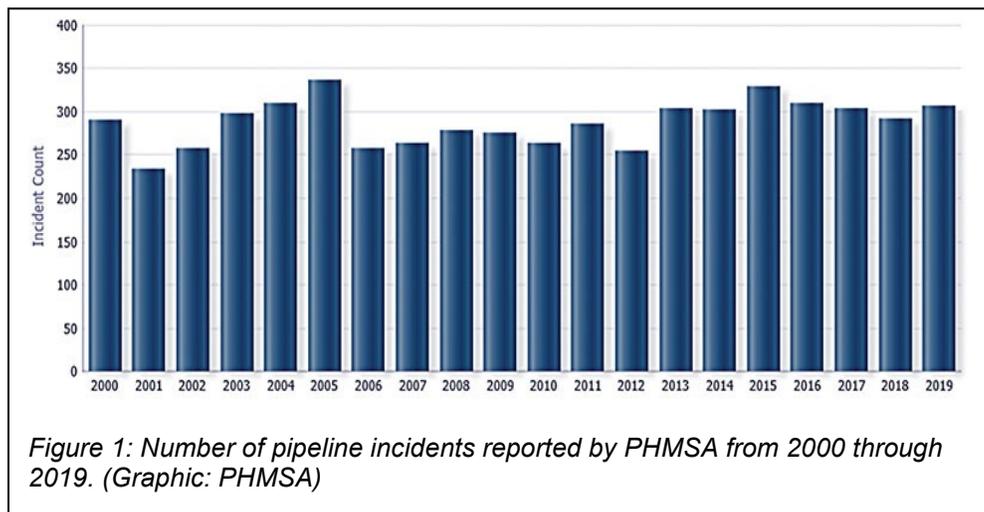
PHMSA reports a total of 5,745 pipeline incidents with

282 deaths and 1,193 injuries in the 20-year period from 2000 through 2019. Moreover, these incidents cost \$10.4 billion in damages, a huge sum to absorb by any industry. (Figure 1).

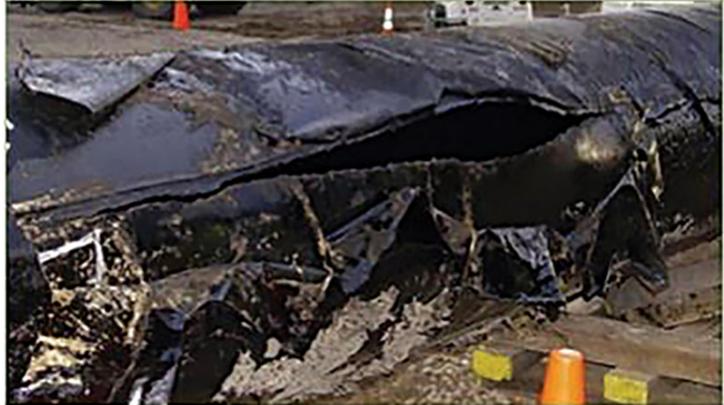
*Figure 2: A steel transmission line failure due to corrosion and internal pressure.*

**Internal corrosion:** Internal corrosion occurs due to environmental conditions on the inside of the pipeline. In most cases, the corrosive materials are contaminants naturally contained within the transported commodity, such as hydrogen sulfide, carbon dioxide, other chemicals, or even water.

Internal corrosion results in metal loss in the pipe. Over time and if left unmitigated, internal corrosion can cause the steel to lose its strength and possibly render it unable to contain the fluid in the pipeline at its operating pressure (Figure 2).

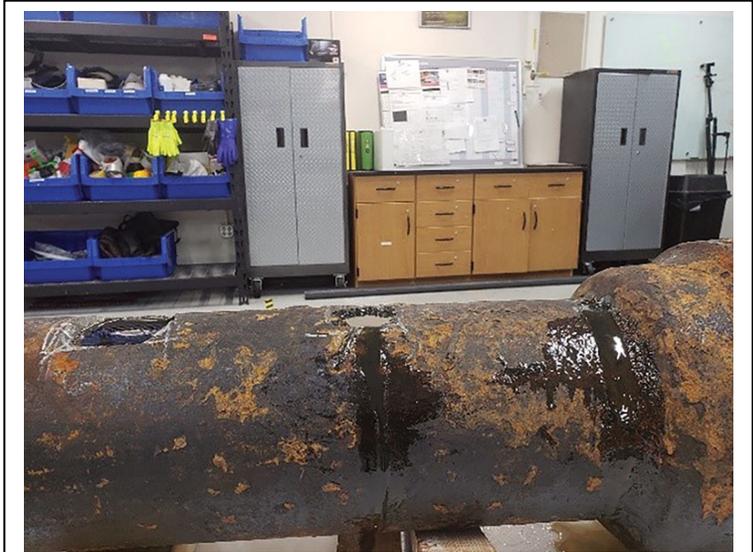
*Figure 3: An unearthed cast-iron pipe repaired with SuperLaminate™ in the QuakeWrap Research and Development (R&D) Lab. Note the excess resin filling the holes cored on the pipe. (Photo: QuakeWrap)*

The initial version of SuperLaminate™ as a precured, hard CFRP lining was successfully applied in many gas distribution pipe repairs by PSE&G over the last eight years without any significant issues reported. It can span gaps of up to 2 feet (0.6 meters) (and possibly larger) along pipelines.

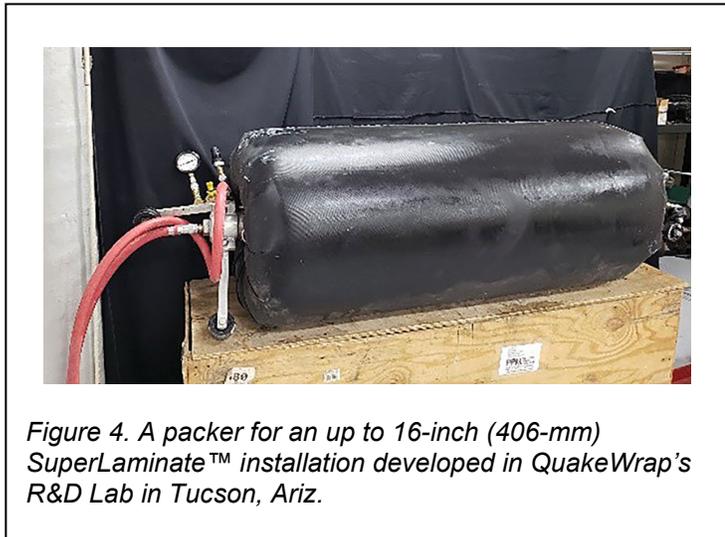
*Figure 4. A packer for an up to 16-inch (406-mm) SuperLaminate™ installation developed in QuakeWrap's R&D Lab in Tucson, Ariz.*

The system is a proprietary design with essentially carbon and glass fiber-reinforced polymers (FRP) as a segmental pipe lining solution deployed by an inflatable packer (Figure 4). The main material used is carbon-fiber reinforced polymer (CFRP), which is a very high-strength (tensile modulus of elasticity up to  $20 \times 10^6$  psi) and lightweight material.
