Field Evaluation of Masonry Walls Strengthened with

FRP Composites at the Malcolm Bliss Hospital

Department of Civil Engineering

CIES 99-12

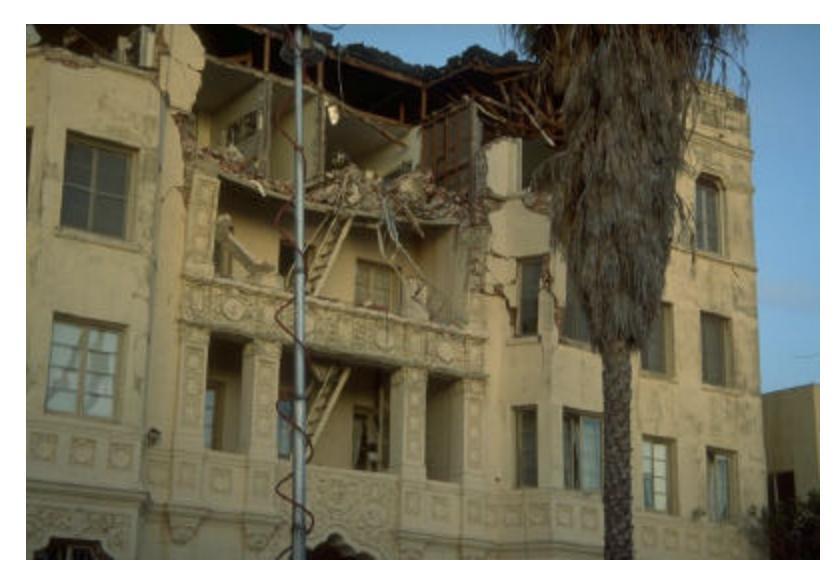
Unreinforced masonry (URM) walls can be either load bearing or infill walls, which are primarily constructed with solid and hollow clay brick. Due to weak anchorage to adjacent concrete members, for the case of load bearing walls, or due to absence of anchorage for the case of infill walls, URM walls may tear and collapse under out-of-plane loads generated by seismic forces, as illustrated in Figure 1.2. According to organizations such as The Masonry Society (TMS) and the Federal Emergency Management Agency (FEMA), failures due to out-of-plane bending in URM walls result in most of the material damage and loss of human life. Thereby, the development of effective strengthening techniques to address out-of-plane bending is of interest.

Figure 1.2. Out-of-Plane Failure Source: Northridge Collection, Earthquake Engineering Research Center, University of California, Berkeley

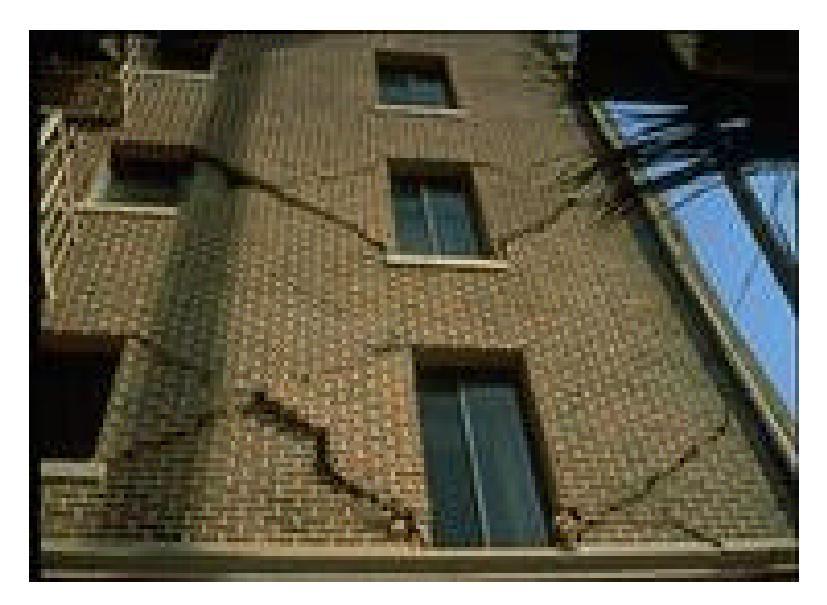
Reinforced masonry walls are usually part of "box system" structures, in which walls resist gravity load, and in-plane loads. The latter caused by either a seismic event or high wind load. Depending on the structural configuration of these members, such as effective aspect ratio of the wall components, and amount of vertical and horizontal reinforcement, two mechanisms of failure can be observed. One is an in-plane flexural failure, which is characterized by tensile yielding of vertical reinforcement and/or crushing of masonry in the area of the toe wall. The second mechanism is a shear failure, characterized by diagonal tensile cracking, which is illustrated in Figure 1.3.

Figure 1.3. Diagonal Tensile Cracking Source: Northridge Collection, Earthquake Engineering Research Center, University of California, Berkeley

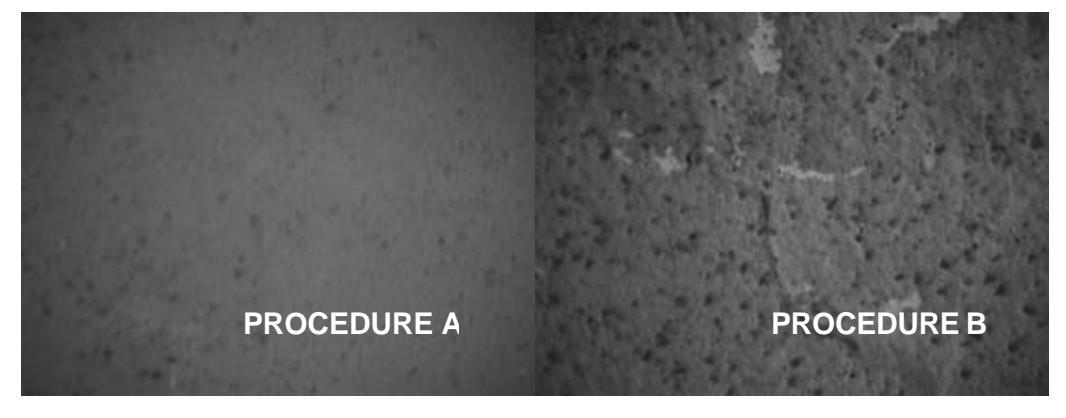
Figure 3.1. Aggregates Exposure

Procedure B: The surface was prepared by means of sandblasting, which was performed using an abrasive blast machine with a 300 lbs. sand capacity. This procedure was less labor intensive than the previous; however, due to the lack of control to measure the aggregate exposure during the sandblasting, the aggregates were excessively exposed, requiring a larger amount of putty to level the surface (see Figure 3.1).

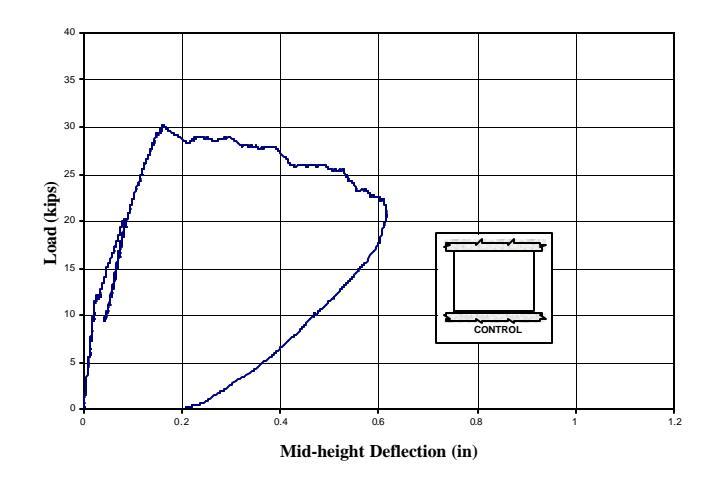
Figure 5.2. Load vs. Mid-height Deflection Curve – Wall 1

This wall was tested as a control specimen to determine the load-carrying capacity with the inclusion of the cementitious plaster. At 12 kips a first major horizontal crack was visible at mid-height, along the full bed joint (see Figure 5.1). At an applied load of 26 kips a second horizontal crack is formed, measured at a quarter height from the top of the wall. The peak load was reached at 30 kips for a mid-height deflection of 0.16 in as can be observed in Figure 5.2. The final failure is produced by a shear-compression combination effect, which ended with the fracture of the tiles placed at the bottom region of the wall. At the final stage part of the plaster, located at the bottom region of the wall is delaminated. It is important to highlight that in this specimen as well as in the remaining ones, no damage was observed on the exterior face of the veneer wall.

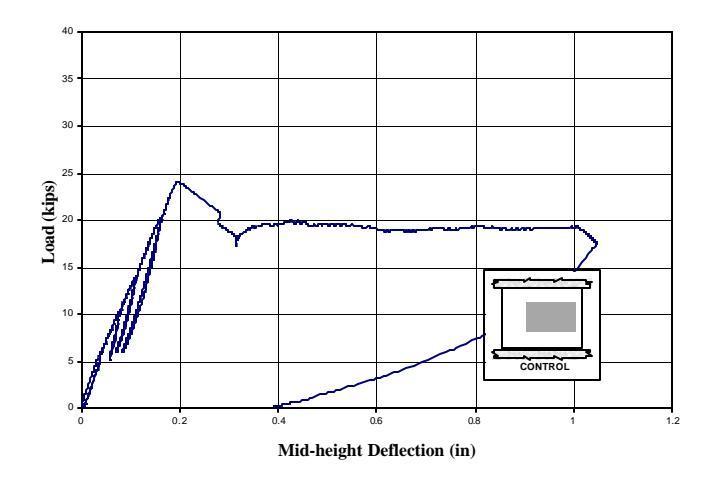
Figure 5.3. Load vs. Mid-height Deflection Curve – Wall 2

This wall was also tested as control specimen; however, in this case the cementitious plaster was removed from its surface with the objective of observing its influence on the overall wall behavior. The first visible crack was observed at a load of 10 kips, running above the central brick course, along the bed joint. The peak load was reached at 24 kips for a mid-height deflection of 0.16 in., the failure, similar to that observed in Wall 1, was caused by a shear-compression combination effect at the upper region of the wall. Once its peak was reached the load decreased to 20 kips and only the deflection increased. In comparison to Wall 1, this wall was less stiff, and it had quasielastic behavior up to failure, and can be observed from Figure 5.3.

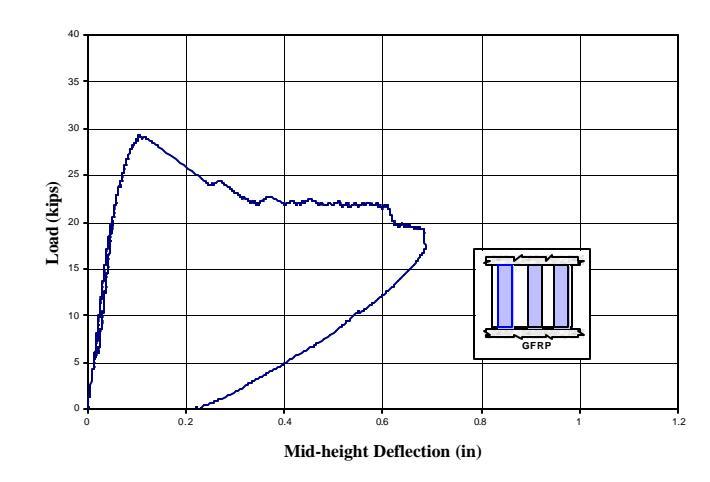
Figure 5.4. Load vs. Mid-height Deflection Curve – Wall 3

This wall was strengthened with three strips 20 in. wide of GFRP sheets. The first visible crack was observed at a load of 20 kips; at this stage the stiffness is slightly reduced. Two horizontal cracks are observed above the mid-height course. As shown in Figure 5.4, the wall failed at a load of 29 kips with a mid-height deflection of 0.1 in. at that stage. Delamination of the plaster at the lower area of the wall could be observed due to the loss of bonding between the plaster and the adjacent bricks and tiles, which were fractured by a shear-compression combination effect. In comparison with Wall 1, the presence of glass fibers delayed the first cracking, also, the crack width was thinner.

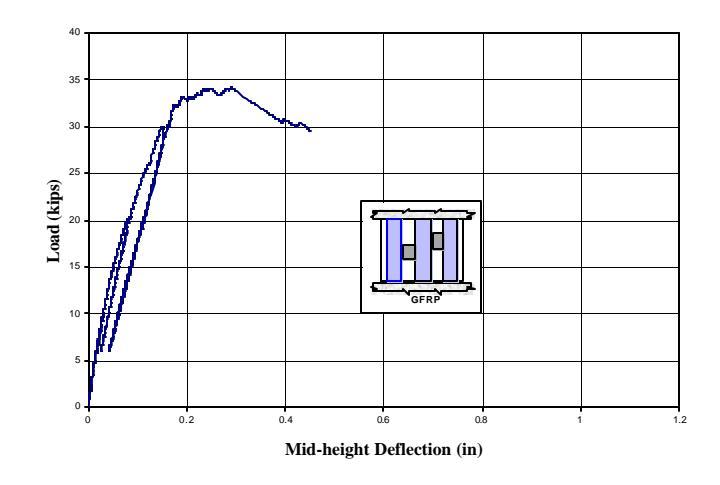
Figure 5.6. Load vs. Mid-height Deflection Curve – Wall 4

This wall had a similar strengthening scheme to Wall 3. The significant difference was that the glass fibers were applied directly on the masonry, meaning the plaster was previously removed. It was observed that the FRP reinforcement performed in a better fashion than the previous wall due to this alteration in the FRP installation procedure. The failure was caused by fracture of the masonry units located at the to of the wall (see Figure 5.5). However, the fact that the FRP was attached to the masonry made possible to observe a behavior more ductile than that observed in the previous wall, as can be observed in Figure 5.6. The maximum load recorded was 34 kips with a corresponding mid-height deflection of 0.2 in.

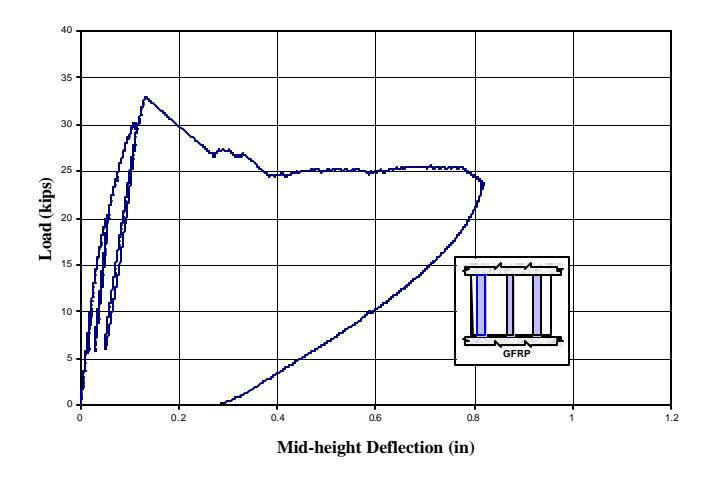
Figure 5.7. Load vs. Mid-height Deflection Curve – Wall 5

This wall was strengthened with half of the reinforcement used in Walls 3 and 4, meaning three strips 10 in. wide of GFRP fibers were attached to the wall surface. A horizontal crack above the mid-height course was observed at a load of 13 kips. Similarly to the previous walls, the failure was caused by a shear-compression combination effect at the lower region of the wall. The failure occurred at a load of 33 kips for a corresponding mid-height deflection of 0.12 in (see Figure 5.7). By comparing this wall to Wall 3, a larger presence of cracks spread for almost 50% of the area was observed (see Figure 5.8).

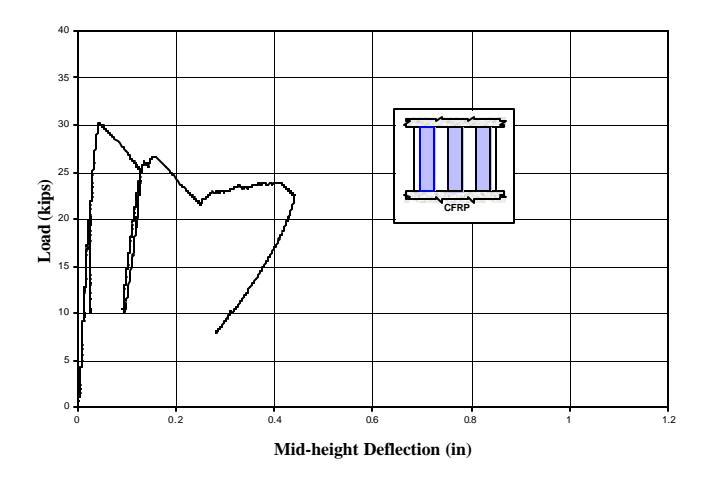
Figure 5.9. Load vs. Mid-height Deflection Curve – Wall 6

This wall was strengthened with three strips 20 in. wide of CFRP sheets. A major horizontal crack was observed at a load of 24 kips, running along the bed joint located above the mid-height course. The maximum registered load was 30 kips, for 0.06 in mid-height deflection, as observed in Figure 5.9. The failure, brittle and without warning, was caused by a shear-compression combination effect, which fractured some tile units located at the bottom of the wall. As a consequence, with the deflection increasing the plaster layer delaminated from the adjacent tiles as can be observed in Figure 5.10. This wall showed an atypical behavior compared to the other walls. As can be observed in the corresponding Height vs. Displacement curve in Appendix 2, the upper region of the wall displaced in opposite direction to the applied load.

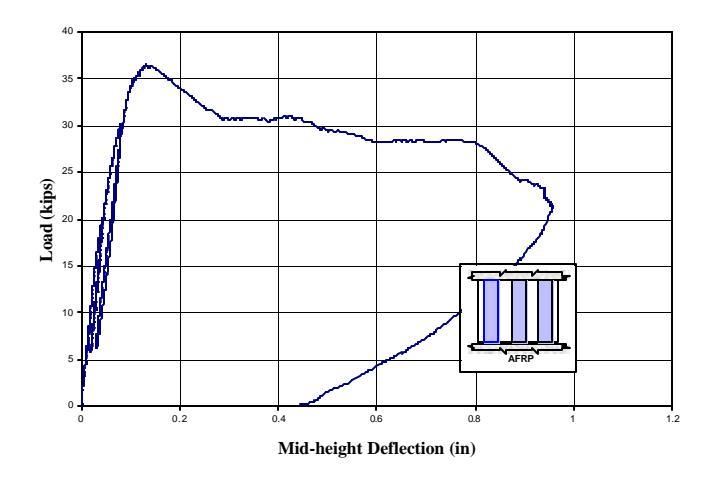
Figure 5.11. Load vs. Mid-height Deflection Curve – Wall 7

The strengthening geometry of this wall was similar to the previous wall, only that in this case AFRP sheets were used. This wall did not show large areas of cracking, only a major horizontal crack running along the mid-height was detected at a load of 24 kips. The peak load was 36 kips with a corresponding mid-height deflection of 0.12 in. (see Figure 5.11). Delamination of the plaster on the top region of the wall was observed as a consequence of the fracture of the tiles, as shown in Figure 5.12

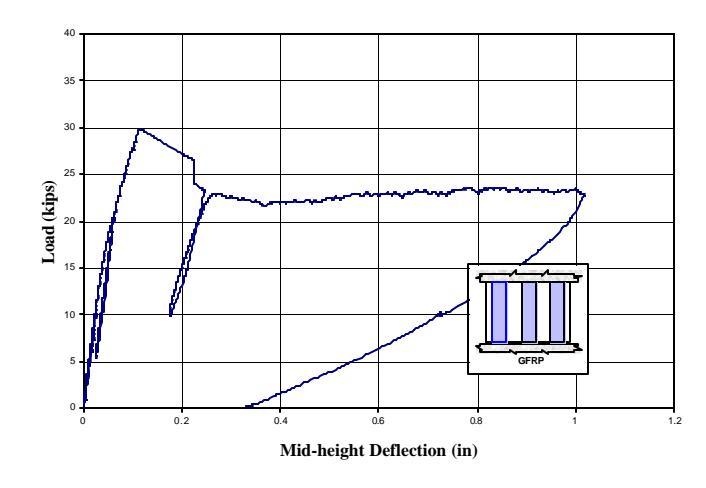
Figure 5.13. Load vs. Mid-height Deflection Curve – Wall 8

The strengthening geometry of Walls 3 and 8 were similar. The only difference was the employment of glass rods in Wall 8 in order to give continuity to the GFRP sheets into the RC beams. Since the controlling factor was the fracture of the tiles located at the bottom region of the wall, the results were identical to those found in Wall 3. The peak load was 29 kips with 0.1 in mid-height deflection, as observed in Figure 5.13.

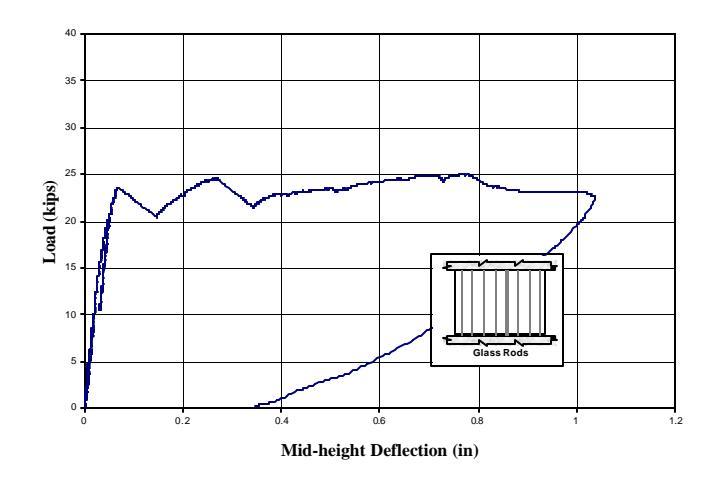
Figure 5.15. Load vs. Mid-height Deflection Curve - Wall 9

This wall was strengthened with eight #3 glass rods. The first visible crack was observed at 22 kips running along the upper joint of the mid-height course (see Figure 5.14). The wall failed at 24 kips for a mid-height displacement of 0.06 in (see Figure 5.15). The lower capacity may be caused by pre-existing cracking formed during the installation of the rods. The installation procedure weakened the by themselves already fragile clay tiles facilitating the failure. The failure was originated by a shear-compression combination effect, which fractured some tiles at the lower part of the wall.

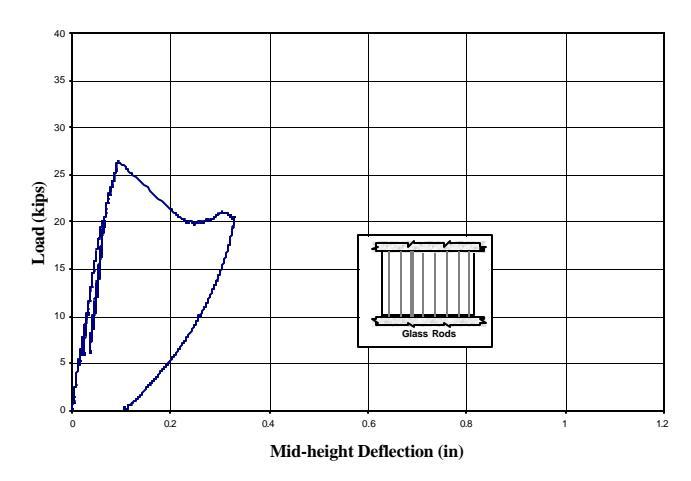
Figure 5.16. Load vs. Mid-height Deflection Curve - Wall 10

This specimen was also strengthened with eight #3 glass rods. As mentioned in Section 4, the near-surface-mounted rods were anchored to the upper and lower beams. The first visible crack, at mid-height course, was observed at 20 kips for a corresponding displacement of 0.09 in. As observed in Figure 5.16, the wall failed at 26 kips, in similar way to the previous one. The cause of the failure was also attributed to the presence of cracking prior to testing.

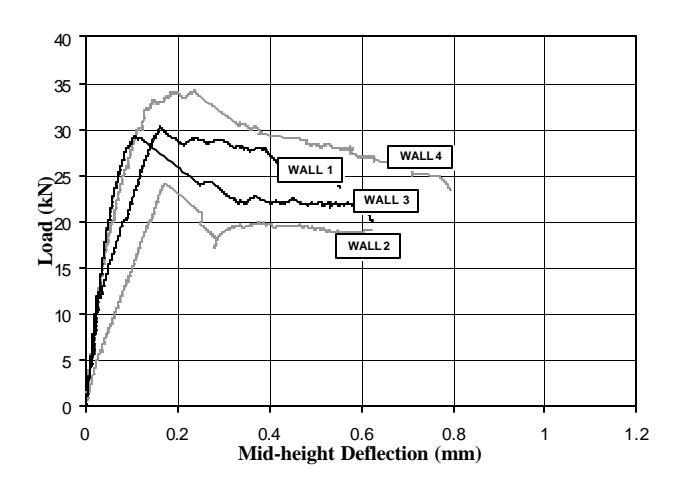
Figure 5.17. Behavior Comparison of Walls 1, 2, 3 and 4

5.1.2. Comparisons. By observing Figure 5.17, Control Wall 1, with plaster, showed a capacity 25% larger than that found in Control Wall 2, without plaster. After reaching 12 kips, point where the first horizontal cracks occurred in Wall 1, a substantial difference in the stiffness K ($K \ a \ EI$) is observed. This difference is attributed to an increment in the

overall moment of inertia of the wall due to the extra inch of the plaster thickness, and due to the different modulus of elasticity in the masonry and cementitious plaster. From the same figure it is observed that FRP sheets do not perform adequately when they are attached to the plaster surface, as can be concluded from the corresponding tests performed on Wall 1 and Wall 3, where no increment in capacity was registered. In contrast, when the FRP was attached directly on the masonry by removing the plaster, an increment of 40% in capacity was observed by comparing Wall 4 to the Control Wall 2.

The aforementioned increment in capacity is attributed to a better engagement of the FRP sheets to the surface when the out-of-plane bending increases. This can be corroborated from Figure 5.18, where up to a load of 20 kips the strains developed in the FRP sheets attached to Wall 4 doubled those of Wall 3.

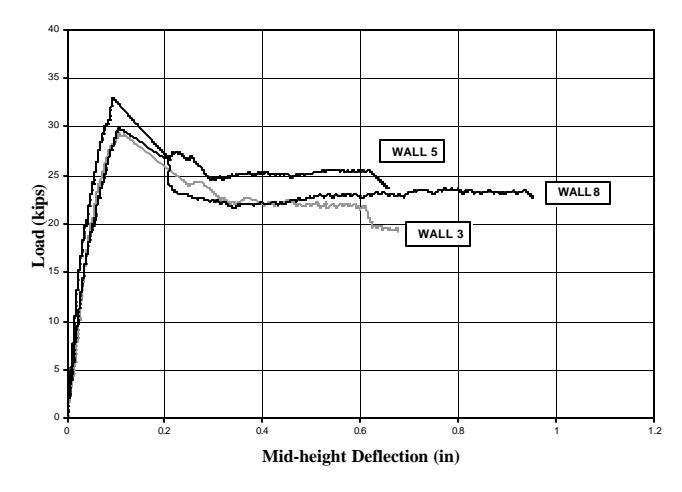
Figure 5.19. Behavior Comparison of Walls 3, 5 and 8

From Figure 5.19, it is observed that Wall 3 and Wall 8 had the same behavior. The rods placed in Wall 8 did not have influence since the failure was controlled by a shear- compression effect, which fractured the tiles in the upper region of the wall. Also, it can be observed that Wall 5, with half amount of reinforcement respect to the other Walls, showed a slightly higher capacity.

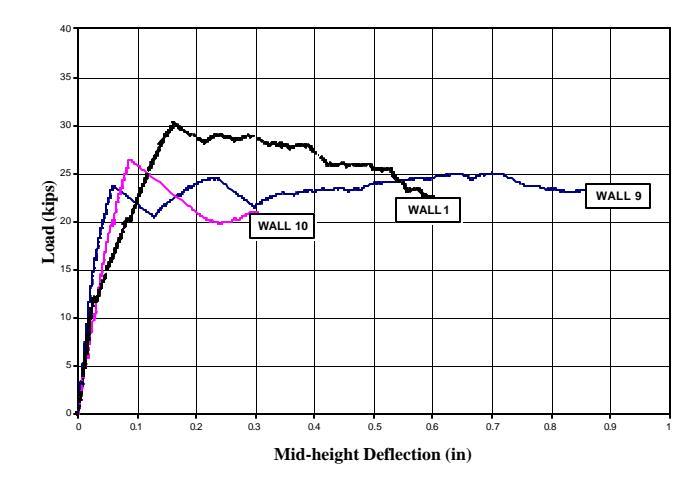
Figure 5.20. Behavior Comparison of Walls 9 and 10

As observed in Figure 5.20, Wall 9 and Wall 10 showed lower capacities than the Control Wall 1, which may be attributed to a weakening of the masonry units during the installation of the rods. As it was mentioned in Section 3, FRP rods were mounted into slots grooved on the masonry surface using a grinder and chisel. This procedure may have pre-cracked the wall. The use of near-surface-mounted rods is attractive since the removal of plaster is not required; however, their installation should be limited to strengthening of walls built of solid brick units or grouted concrete walls.

The use of near-surface-mounted rods is attractive since the removal of plaster is not required; however, due to the technique used for their installation, which can create local damage in the masonry, their use should be limited for strengthening of walls built of solid brick units or grouted concrete walls.

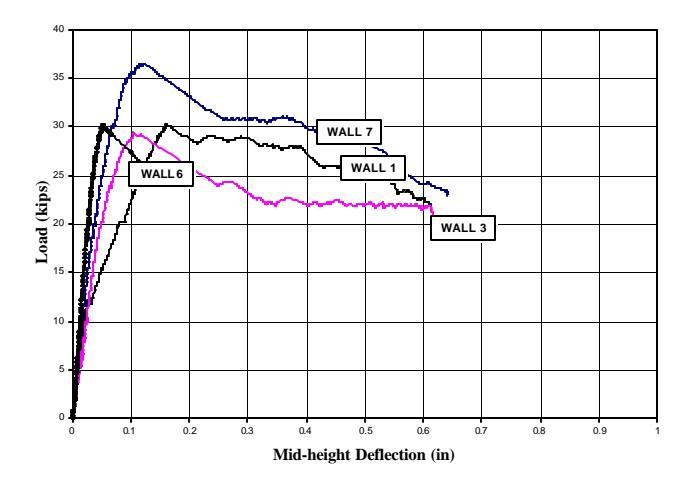
Figure 5.21. Behavior Comparison of Walls 1, 3, 6 and 7

In Figure 5.21 can be observed the increment of stiffness, from smaller to larger, when GFRP, AFRP and CFRP sheets were used. The higher capacity of Wall 7 compared to the other walls is not statistically significant since its value is within the variability of the capacity values and because the fracture of tiles is controlling its behavior. During the tests, it was observed that the employment of FRP sheets delayed the presence of the first visible cracks, and also, that the crack widths were reduced.

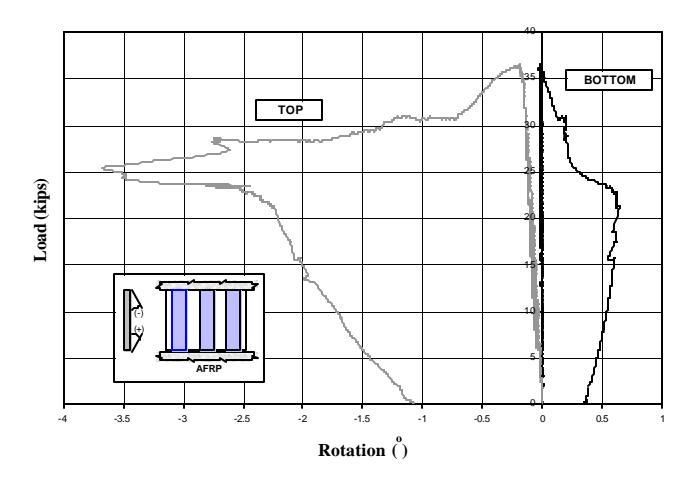
Figure 5.22. Rotations in Wall 7

The walls suffered more rotations in the zone where the main fracture occurred. Their values were small, averaging 0.25° , they produced angular distortion, which is critical in a masonry unit composed of thin walls such as the case of the clay tiles. The

angular distortion along with a shear-compression combination effect caused the fracture of the units located either at the top or bottom of the wall. Larger rotations were accompanied, most of the times, by larger displacements at that zone due to either starting of plaster delamination or spalling of the tile shell, which were caused by the fracture of the tiles. As example the Load vs. Rotation curve corresponding to Wall 7 is presented in Figure 5.22, in this case fracture of tiles was observed at the top of the wall.

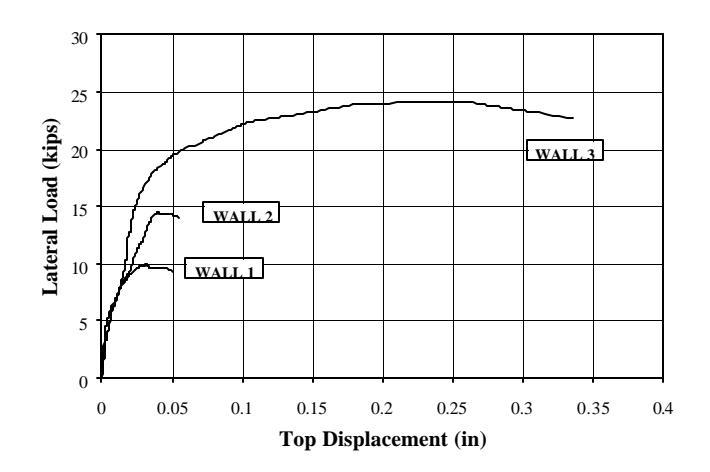
Figure 5.24. Lateral Load vs. Top Displacement – Walls 1, 2 and 3

Due to the low load applied during the tests only two cycles were applied, an envelope of the load vs. top displacement curves is illustrated in Figure 5.24. This envelope includes the cycle where the failure occurred, either positive or negative cycle. The curves showing the positive and negative cycles, as defined in Section 4 (see Figure 4.11), are shown in Appendix D.

Since the steel reinforcement was pulled out, the concept of ductility defined as the ratio between the deflection at the ultimate state of failure and the deflection at the yielding of steel can not be applied. However, in Wall 3, due to the contribution of the GFRP rods in the toes, a notable increase in pseudo-ductility was attained, as illustrated in Figure 5.24.

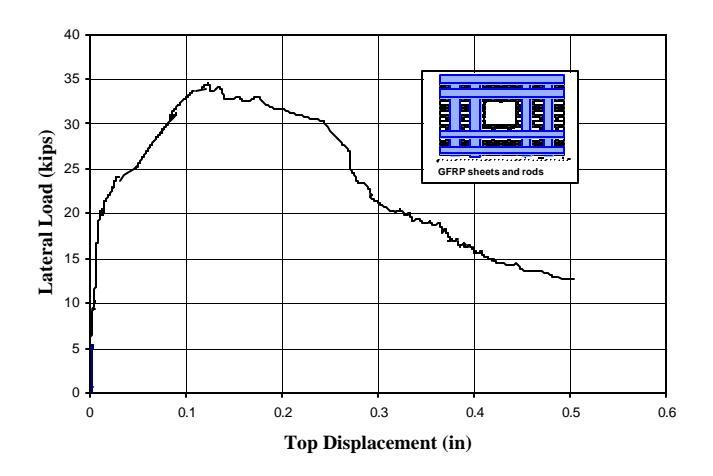
Figure 5.27. Lateral Load vs. Top Displacement – Wall 4

Wall 4 was also strengthened with GFRP sheets and near surface mounted GFRP rods. The purpose of testing this wall was to observe the influence of openings in the wall behavior. Two main flexural cracks were observed; one along the base of the wall, and the other at a height of 2.5 ft., at the cut point of the GFRP rods. The latter flexural crack ended up in the border of the opening, as observed in Figure 5.27.
