Durability of GFRP Reinforced Concrete in Field Structures

by **A. Mufti, M. Onofrei, B. Benmokrane, N. Banthia, M. Boulfiza, J. Newhook, B. Bakht, G. Tadros, and P. Brett**

Synopsis: Recently, ISIS Canada studied the durability of GFRP in concrete in several field structures across Canada. The objective of the study was to provide the engineering community with the results of the performance of GFRP materials that have been exposed to the concrete environment in built structures. Cores of GFRP-reinforced concrete were removed from five field structures. Analytical methods, namely optical microscopy, scanning electron microscopy and energy dispersive x-ray, differential scanning calorimetry and infrared spectroscopy, were used to determine the composition of GFRP after being subjected to the alkaline environment of concrete for five to eight years. Three research teams from four Canadian universities performed microanalyses of the GFRP and surrounding concrete independently. Results indicate that no deterioration of GFRP took place in any of the field structures. No chemical degradation processes occurred within the GFRP due to the alkalinity of the concrete. The overall conclusi

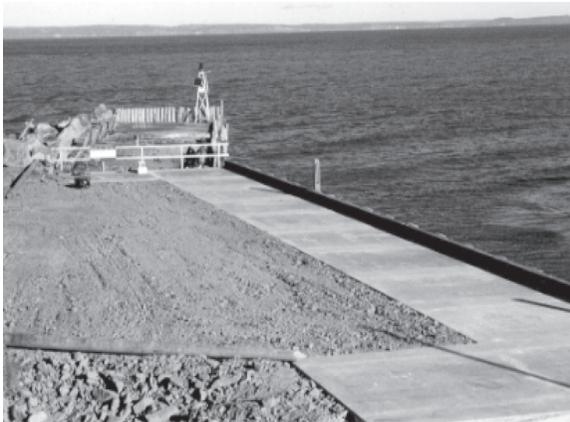
Figure 1 – Hall's Harbor Wharf.

The Hall's Harbor Wharf (Fig. 1) was the first marine structure in Canada to be built using ISIS Canada technology and design concepts¹³. The wharf, located on the Bay of Fundy shore in Nova Scotia, comprises steel-free precast concrete panels with GFRP bars and concrete pile cap beams reinforced with a hybrid GFRP-steel bar system. Concrete with a compressive strength of 45 MPa was used in the panels and beams. The structure is 5 years old and operates under the following environmental conditions: thermal range +35 to -35°C; wet and dry cycles, splash and tidal salt water; frequent freeze-thaw cycles.

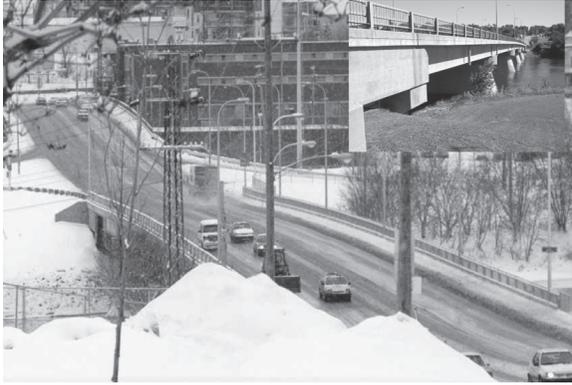
Figure 2 - Joffre Bridge.

The Joffre Bridge (Fig. 2), located in Sherbrooke, Québec, over the St-Francois River, contains GFRP bars as reinforcement in the 45 MPa concrete in the sidewalks and the traffic barriers¹⁴. In this structure, the GFRP material is a ribbed-deformed GFRP C-Bar. The structure is 7 years old and operates under the following environmental conditions: thermal range +35 to -35°C; wet and dry cycles; freeze-thaw cycles; de-icing salt.

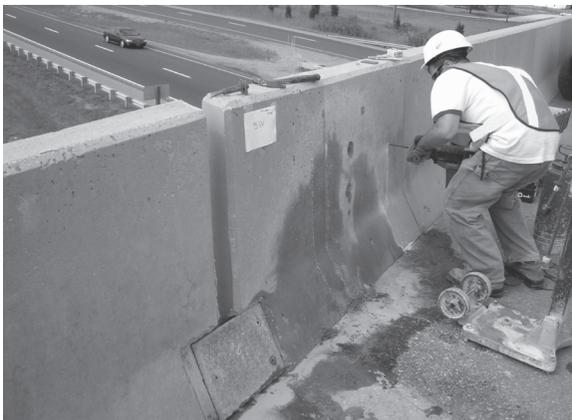
Figure 3 – Barrier wall of Chatham Bridge.

From each of the five structures, at least 10 cores of GFRP reinforced concrete were removed at various locations in the structure. Figure 3 shows a barrier wall of the Chatham Bridge, from which cores were removed. The cores had a diameter of 75 mm and a length varying between 140 and 180 mm. All cores removed from one structure can be seen in Fig. 4.
