FRP Application in Underwater Repair of Corroded Piles

by R. Sen, G. Mullins, K. Suh, and D. Winters

Keywords: corrosion; FRP; instrumentation; piles; repair; underwater

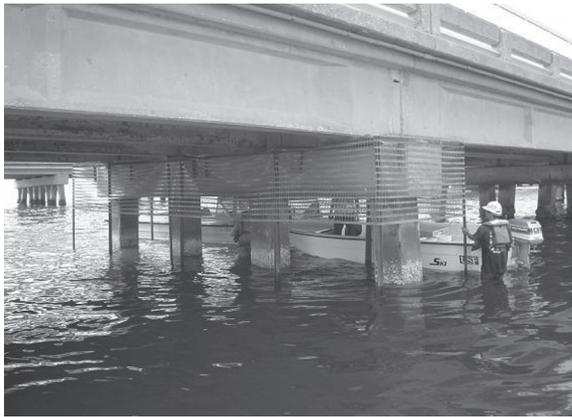
Figure 4 — Scaffolding System, Friendship Trails Bridge, Tampa, FL

yet sufficiently rigid when assembled to support 4-6 people. The scaffolding was suspended from the pile cap and extended 2.74 m (9 ft) below. Its mesh flooring provided a secure platform around the pile that allowed the wrap to be carried out unimpeded in knee deep waters (Fig. 4).

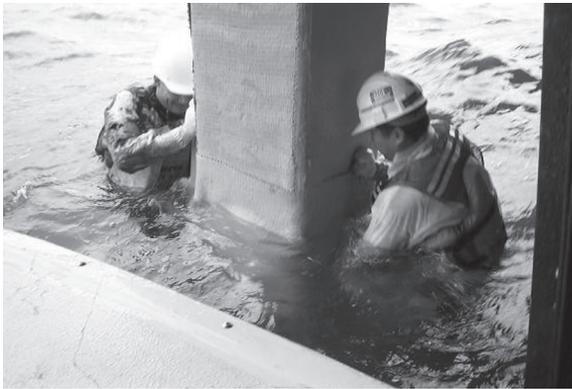
Figure 6 — Underwater Wrapping, Friendship Trails Bridge, Tampa

FRP wrapping -- Two different FRP systems were used. One was the same pre-preg system with a water-activated resin used in the Allen Creek Bridge. The other was Fyfe's system that used resins that cure in water. The pre-preg system was used to wrap four piles – two using carbon and two using glass. The wet-lay up system from Fyfe required on-site saturation of the fibers. Two piles were wrapped with fiberglass using this system. Of the two, one was an experimental FRP system that combined wrapping with a sacrificial cathodic protection system. Two other unwrapped piles in a similar initial state of disrepair were used as controls to evaluate the performance of the wrapped piles. Application was facilitated through the use of a scaffolding system mentioned earlier (Fig. 6).

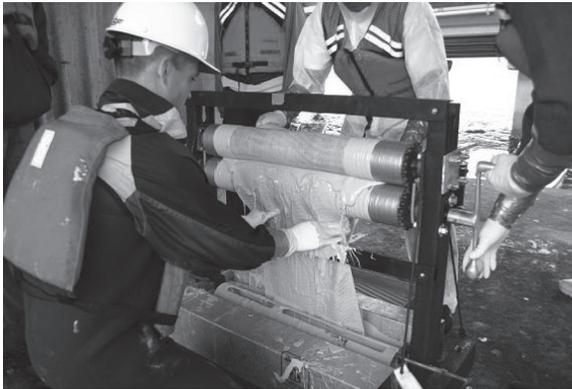
Figure 7 — On-Site Saturation, Friendship Trails Bridge, Tampa

The pre-preg system was applied as in the Allen Creek Bridge and posed no problems. The Fyfe system was more challenging since the FRP material had to be saturated on-site. Access to foundations of an adjacent bridge provided a convenient staging post for the on-site impregnation (Fig. 7). On an average the operation took 90 minutes to complete.

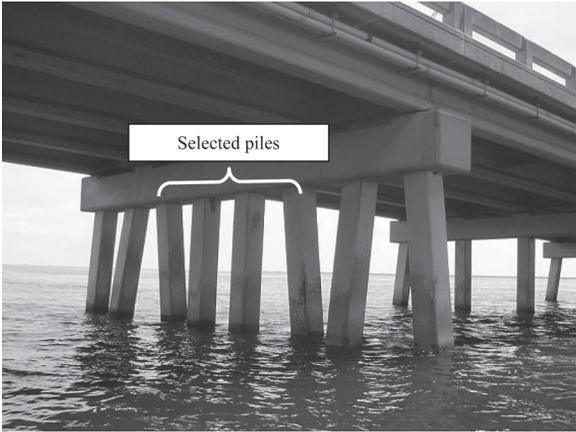
Figure 9 — Selected Piles, Gandy Bridge, Tampa

The Gandy Bridge built in 1970's connects St. Petersburg to Tampa. The bridge has approximately 300 piers comprising five or eight prestressed concrete piles with 50.8 cm x 50.8 cm (20 in x 20 in.) cross section. The original plan was to just wrap one heavily corroded pile (Fig. 8). Later, the scheme was revised to include three piles. An additional unwrapped but instrumented pile served as control (Fig. 9).

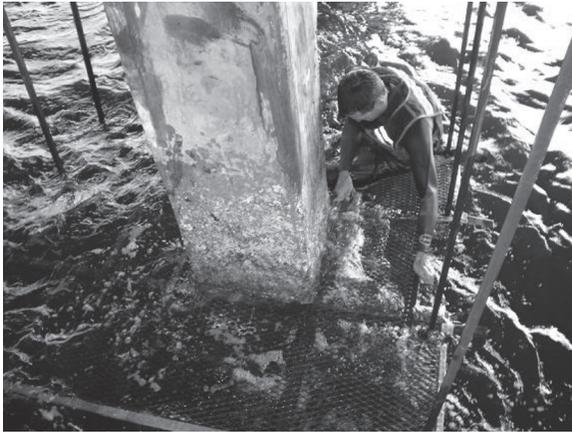
Figure 10 — Scaffolding System, Gandy Bridge, Tampa

two parts that were readily assembled in the field and suspended from the pile cap using steel chains rather than welded angles used earlier. The system could be installed by 2-3 people easily and quickly, and provided a good working space for 3 people (Fig. 10). Prior to applying the wrap, the severely damaged pile (Fig. 8) was repaired. The surface of the exposed concrete and steel was cleaned by sand blasting and the damaged section restored using an underwater patch material, Tyfo® PUWECC, manufactured by FYFE Co. LLC. All procedures recommended by the manufacturer were followed.
