BEHAVIOR OF RETROFITTED URM WALLS UNDER SIMULATED EARTHQUAKE LOADING

By M. R. Ehsani,¹ Fellow, ASCE, H. Saadatmanesh,² Member, ASCE, and J. I. Velazquez-Dimas³

ABSTRACT: Unreinforced masonry (URM) buildings perform poorly under seismic forces and have been identified as the main cause of loss of life in recent earthquakes. Many of these structures fail in out-of-plane bending due to the lack of reinforcement. In this study, the experimental results from three half-scale unreinforced brick walls retrofitted with vertical composite strips are presented. The specimens were subjected to cyclic out-of-plane loading. Five reinforcement ratios and two different glass fabric composite densities were investigated. The mode of failure is controlled by tensile failure when wider and lighter composite fabrics are used and by delamination when stronger ones are used. The tested specimens were capable of supporting a lateral load up to 32 times the weight of the wall. A deflection as much as 2% of the wall height was measured. Although both URM walls and composite strips behave in a brittle manner, the combination resulted in a system capable of dissipating some energy. Retrofitting URM walls

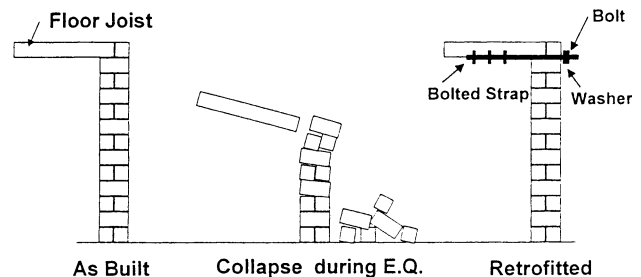
FIG. 1. Failure and Retrofit of URM Walls

As shown in Fig. 1, in most older buildings, the floor joists simply rest on the masonry wall. During the earthquake, the wall movement would result in loss of support for the beam. One method to fix this problem is to bolt some of the floor joists through the wall. This retrofitting technique has been applied to many buildings in California since the mid 1980s. The retrofitted buildings can be easily identified from the washers that are used on the exterior face of the wall. The intent is to force the wall to span between floors. However, because most of these walls do not contain any reinforcement, they cannot resist the imposed loads and displacements. The result is that many of these retrofitted buildings are subject to severe damage in future earthquakes (Fig. 2); in essence, the weakest link in the chain that used to be the connection between the wall and the floor has been replaced with the unreinforced wall itself. These continuing challenges have resulted in URM buildings being identified as the primary cause of injuries and loss of life (Tobriner 1984; Deppe 1988; *Expected* 1994; Kehoe 1996; Tomazevic 1996).

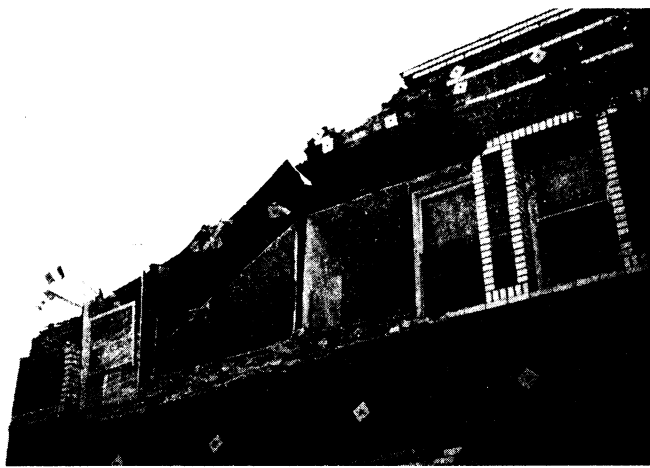
FIG. 2. Failure of URM Wall That Was Retrofitted by Tying Floor Beams to Wall

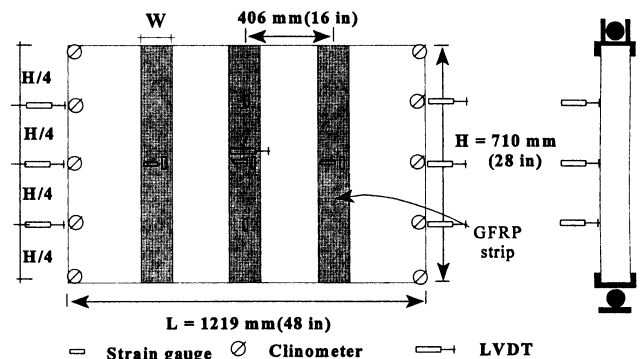
FIG. 3. Overall View of Test Specimens and Instrumentation

Three half-scale unreinforced masonry walls were constructed with solid clay brick. As shown in Fig. 3, the specimens were 0.710 m (28 in.) high and 1.22 m (48 in.) long. They were constructed in a single wythe of 49 × 38 × 102 mm (1.92 × 1.5 × 4 in.) reduced-scale solid clay bricks with cement-lime type N mortar. As illustrated in Table 1, each wall is designated with the letter “S” followed by two numbers. The letter S refers to single wythe; the following two numbers refer to the percentage of composite reinforcement with respect to the balanced condition used on the south and the north faces of the wall, respectively. A balanced condition is assumed to occur when the compressive capacity of brickwork is reached at the same time that the composite material reaches its tensile capacity. All specimens were retrofitted with vertical E-glass fabric composite strips bonded on both faces of the walls with a two-component epoxy resin.

were to be attached was coated with a thin layer of a two-component water-based primer. Second, composite fabric strips were cut and laid on a plastic sheet, and the mixed epoxy was poured on the fabric and spread over the whole fabric using a trowel, ensuring that the fabric was saturated with epoxy. Next, the saturated composite strips were bonded to the wall surface by hand pressure and pressed with a roller. Finally, a small layer of epoxy was put on the fabric for protection and instrumentation purposes. This retrofitting process was followed for the three walls. As depicted in Fig. 3, the

center-to-center space between vertical strips was kept constant at 406 mm (16 in.) for all specimens. The fabric width varied for different reinforcement ratios. These values can be observed in Table 1.

The three walls were instrumented identically. As shown in Fig. 3, 10 strain gauges (SG1–SG10) were used to monitor longitudinal and transverse strains on the north and the south faces of the wall at five points in the composite strips. Ten clinometers (C1–C10) were also attached along the height of the wall on the east and west wall edges to measure rotations. Seven points were instrumented with linear variable displacement transducer (LVDTs) to measure out-of-plane displacements. In addition, a pressure sensor capable of measurements with an accuracy of 0.35 kPa (0.05 psi) was connected to the airbag for measuring the applied pressure. Data from all devices were recorded through a computer-controlled data-acquisition system.

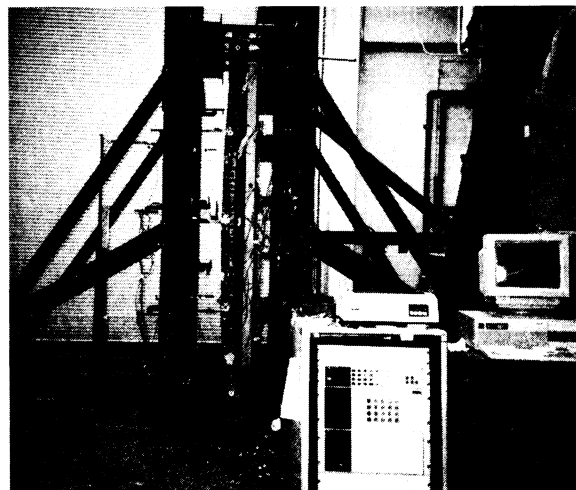
FIG. 4. Test Frame

A steel test frame capable of accommodating specimens up to 3,060 mm (120 in.) high was constructed. The testing frame consisted of two identical reaction frames, one in the north and one in the south. These reaction frames were spaced 920 mm (36 in.) apart to provide space for the placement of the wall specimen and the airbag. Each reaction frame consisted of three W8 × 31 columns, nine W8 × 31 cross beams, and three bracing elements built with C3 × 8 channels. An airbag confined in a plywood box was used for applying the out-of-plane pressure to the wall surfaces. The test frame is shown in Fig. 4. However, the wall shown in the photograph is a taller wall that is not discussed in the present paper.

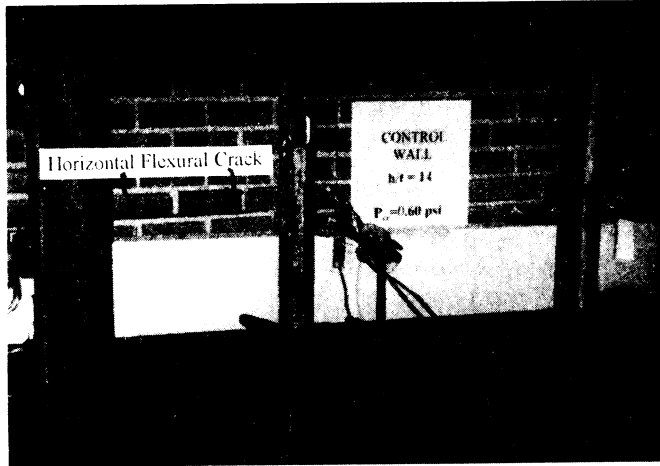
FIG. 5. Failure of Control Specimen

To determine the load-carrying capacity of plane brickwork, this wall was first tested as a control specimen (without any composite strips). Under these conditions, the wall failed at an applied pressure of 4.13 kPa (0.6 psi) by splitting in two pieces, as depicted in Fig. 5. The wall was later retrofitted and tested again. This specimen had reinforcement ratios of 25% and 75% of the balanced condition for the south and the north faces, respectively. The south face was subjected to 21 cycles of loading, while the north face supported 23 cycles. The behavior on both faces was characterized by progressive bed joint cracking and gradual delamination of the composite strips

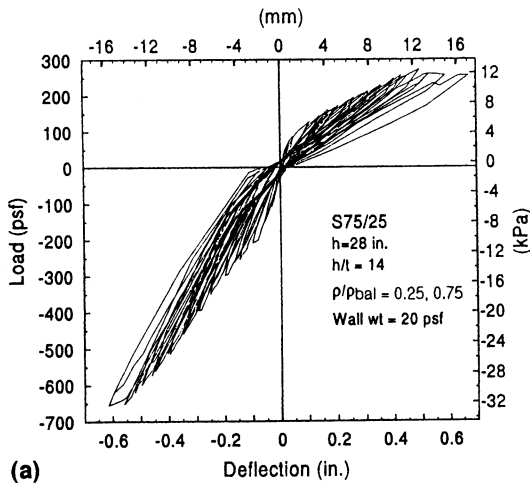
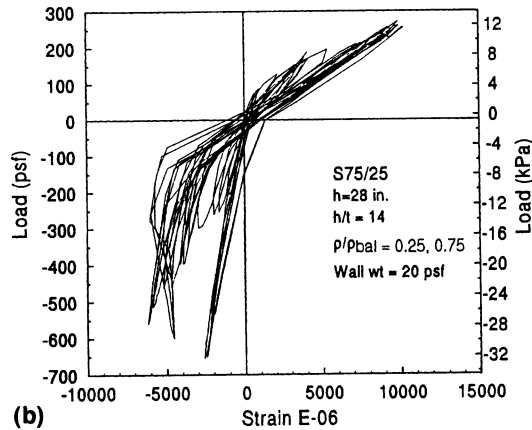
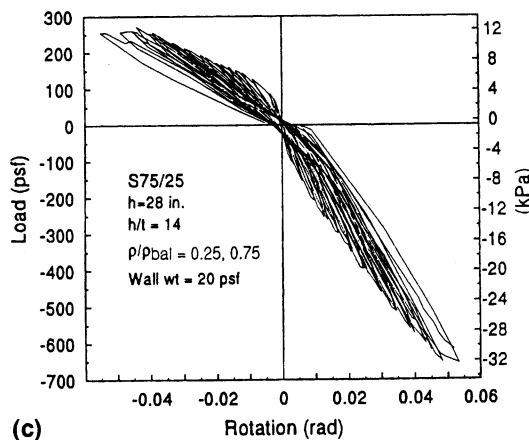
FIG. 6. Specimen S75/25: (a) Load versus Deflection at Midheight; (b) Load versus Longitudinal Strain in GFRP Strip; (c) Load versus Rotation at Top Support; (d) Delamination and Crack Patterns Just before Failure

as the applied pressure increased. Wider cracks were observed on the south face of the wall, where a 2 mm crack width was measured. Cracks spread for almost 75% of the wall area on both faces. Essentially, linear elastic behavior was observed before major crack development on both faces. This resulted in a stiffness degradation, as shown in Fig. 6(a).

Longitudinal tensile strain of 1% in the composite strips was measured on the south face of the wall. A compressive strain of 0.25% was also recorded for the same face. Maximum strains of 1.2% in tension and 0.3% in compression were measured in the composite strips of the north face. In Fig. 6(b), a typical load versus strain curve is shown.

top and bottom ends. Rotations as much as 3.24° and 3.06° were recorded at the top support for both reinforcement ratios, as depicted in Fig. 6(c). Although the north face had three times more reinforcement than did the south face, the last values are fairly close. This is attributed to the excessive delamination suffered by the composite strips on both faces. Thus, the stiffness of the wall degrades to similar values for both faces once excessive delamination begins to control the wall behavior.

Very stiff behavior was observed for the north face. The failure occurred by a sudden peeling of the three strips at the top support. On this face, delaminated areas were located mostly above the middle brick course, as shown in Fig. 6(d). This failure took place at a maximum pressure of 31.03 kPa (4.5 psi) and for an ultimate deflection of 15.5 mm (0.61 in.). Peeling controlled the mode of failure for both faces, although a tensile failure of the fabric was expected due to the relatively

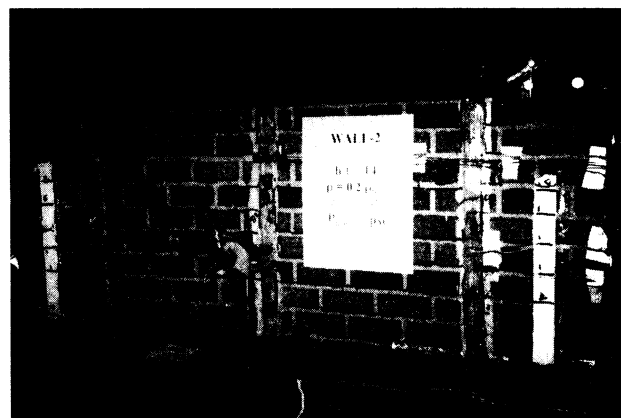
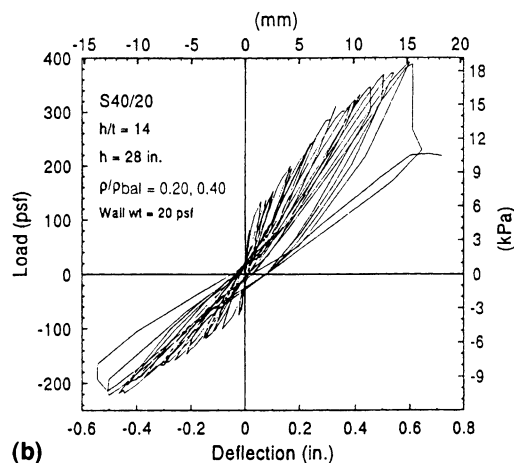
FIG. 7. Specimen S40/20: (a) Cracking and Delamination Pattern at Failure on South Face; (b) Load versus Deflection at Midheight

The modes of failure were as follows: For the north face, during the 16th cycle, a large delaminated area occurred on the east strip from the center to the top steel channel. The central and the west strips delaminated almost 50% of their own areas. Most of these delaminated areas were located above the middle brick course. Failure occurred on the south face during the 18th cycle on the three strips, which experienced peeling from the steel channel. The west and the east strips peeled off at the bottom support, and the central one at the top. No tensile failure on the fabric was observed. However, a wide longitudinal mortar joint crack developed along the bottom bed joint of the central brick course, as shown in Fig. 7(a). Fig. 7(b) shows the load versus deflection curve, where the failure on both faces is denoted by a sudden loss of wall stiffness at the corresponding hysteretic loop. Details about the overall behavior of both faces of this wall are summarized in Table 4.

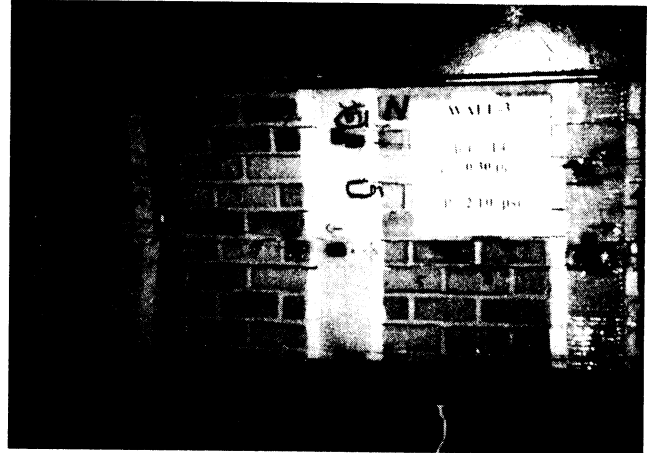
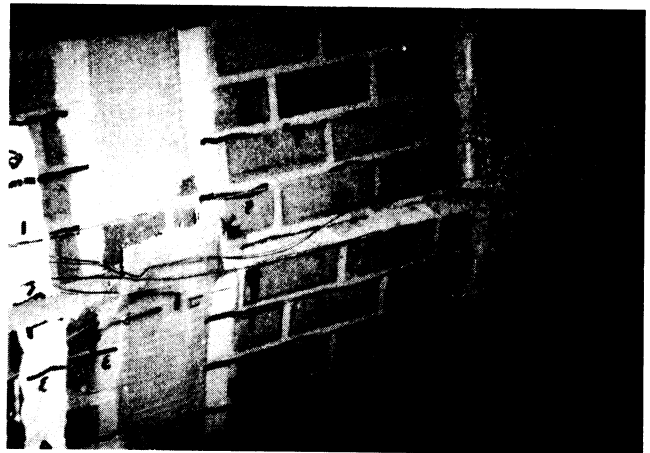
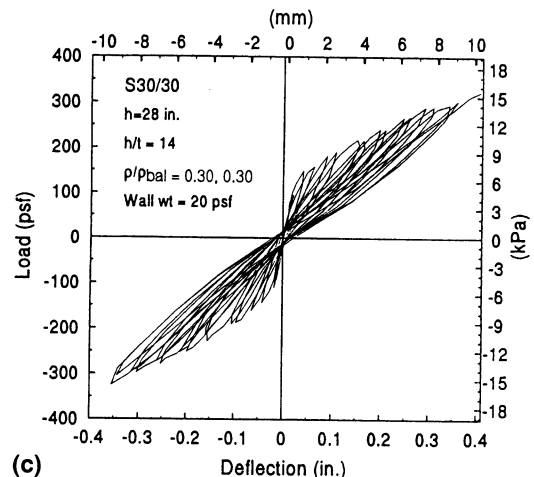
FIG. 8. Specimen S30/30: (a) Cracking and Delamination Pattern at Failure on North Face; (b) Tensile Failure of GFRP Strips on South Face; (c) Load versus Deflection at Midheight

Fairly symmetrical behavior was experienced for this wall. Due to the good interface behavior observed on both wall faces, few delaminated areas developed, as shown in Fig. 8(a). Those were marked away from the center brick course and were caused either by an uneven brick surface or by a wide flexural crack. Cracks penetrated through the bed joint as much as 75% of the wall thickness. Tensile failure occurred during the 17th cycle on the south face on the three composite strips at midheight. At failure, this wall spilt into two pieces due to the wide horizontal crack that developed along the central bed joint just below the middle brick course [Fig. 8(b)]. Failure points were at the center for the central and east strips where the big crack developed. However, the west strip showed the largest delaminated area and broke below the central brick course where an uneven brick was located. The symmetrical behavior of this specimen can be seen in the load versus deflection curve shown in Fig. 8(c).

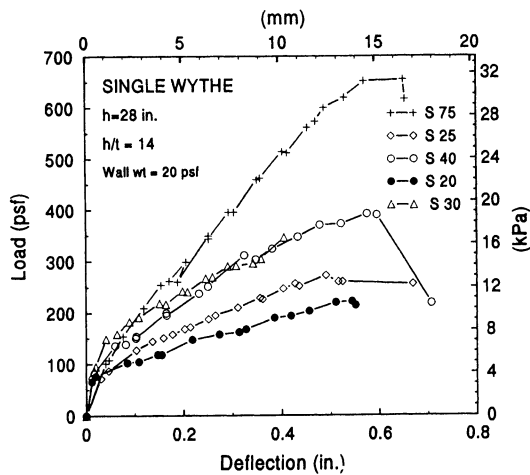
FIG. 9. Maximum Load Envelopes for All Test Specimens

The three URM walls tested had the same height-to-thickness ratio ($h/t = 14$), and were retrofitted using the same epoxy and primer. Two different glass fabric densities and five reinforcement ratios were investigated. The load-deflection envelopes for the three walls are presented in Fig. 9. For nonsymmetrically retrofitted walls, the ultimate deflection was practically the same. However, within the range of reinforcement ratios investigated in the present study, the ratio of the

maximum supported lateral pressure by each face of a given wall was proportional to the amount of reinforcement. For specimens retrofitted with unidirectional fabric, i.e., S75/25 and S20/40, the ultimate deflection appears to be independent of the reinforcement ratio. The longitudinal tensile strains on the composite fabrics were similar in all specimens; i.e., about 1%–1.2% for most cases.
