RP2C
*repair of buildings & bridges
with composites*

IDENTIFICATION OF PERFORMANCE CHARACTERISTICS OF CONCRETE RAILINGS WITH PULTRUDED FRP REINFORCEMENT

PROJECT NO. II.5

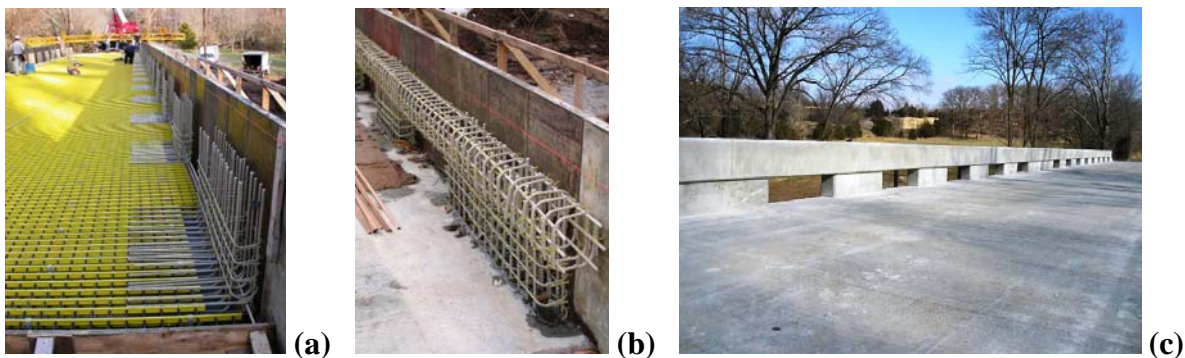
Figure 1. GFRP RC open post railing: reinforcement configuration (a), (b); and finished rail on Bridge 14802301, Greene County, MO (c).

As part of this project, a new version of the open post Federal Lands Modified Kansas Corral Bridge Rail reinforced with pultruded Glass FRP (GFRP) rebars was designed, in order to contribute in developing a truly steel-free deck and rail system (Figure 1). The technology has been recently showcased in the accelerated construction of a bridge deck in Greene County, MO, using innovative prefabricated GFRP stay-in-place reinforcing panels.
