Out-of-Plane Behavior of Brick Masonry Walls Strengthened with Fiber Composites

Juan I. Velazquez-Dimas, Mohammad R. Ehsani, and Hamid Saadatmanesh

ACI Structural Journal, V. 97, No. 5, May/June 2000.

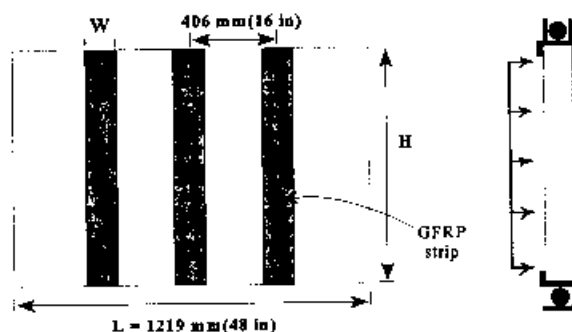
Fig. 1—Overall view of the test specimen.

The first course of bricks for the four walls was laid in a machined steel channel that formed part of the support during the test. As can be observed in Fig. 1, all walls were simply supported at the top and bottom, and the other two sides remained free. With these boundary conditions, it was intended to simulate the portion of the masonry walls found in low-rise buildings free of corner and wall-to-wall joint interference.

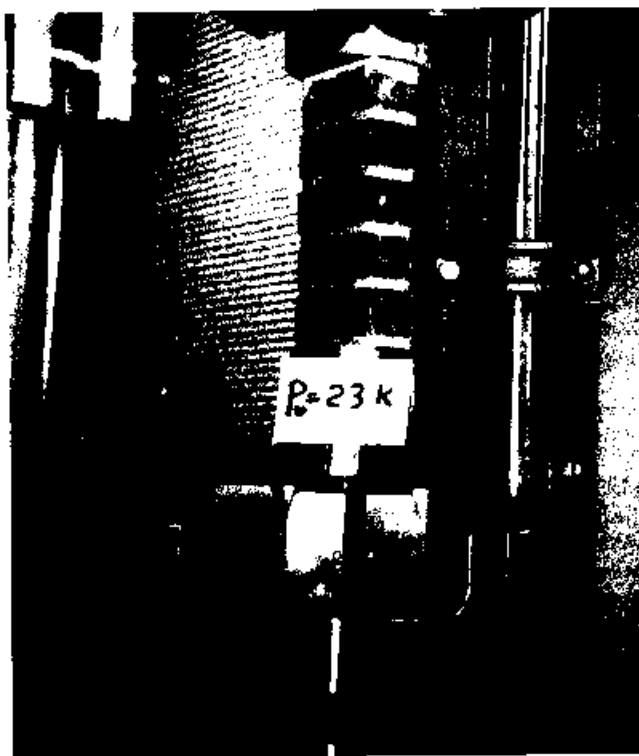
Fig. 2—Test of brick prisms for determination of compression capacity of brickwork.

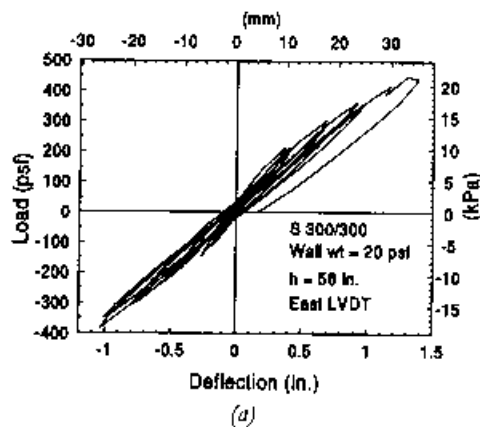
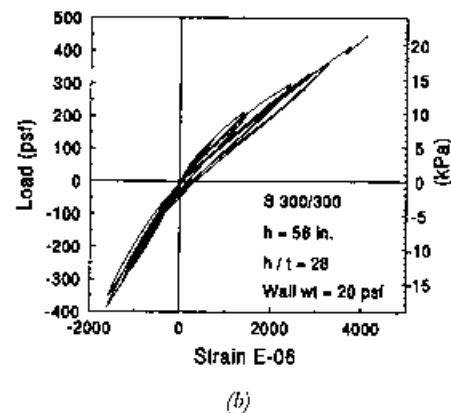
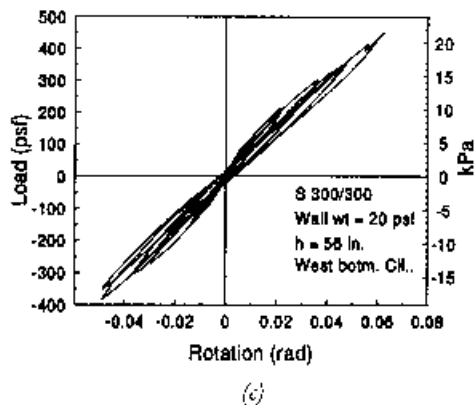
Fig. 7—Typical measurements for Specimen S300/300: (a) load versus deflection at midheight; (b) load versus the longitudinal strain in the composite strip; and (c) load versus rotation at the bottom support.

Based on the observed results of the previous wall, it was decided to test the next wall with a higher reinforcement ratio. The wall surfaces on both faces were fully covered with the same fabric, i.e., an 18 oz per yd² unidirectional glass fabric. This resulted in a reinforcement ratio equivalent to three times the balanced condition. As expected, very stiff behavior was observed for this wall. Almost linear elastic behavior was observed because of the high reinforcement ratio used. This behavior can be seen in Fig. 7, where typical curves for deflection, strain, and rotations are depicted. Little damage was observed for this wall. The few delaminated areas that were marked on either faces of the wall were initiated by the presence of air bubbles that were introduced by entrapped air during the bonding of the fabric. The measured compressive strains in the composite fabric were very close to the calculated values for the brick; this indicates that good interface bond existed between the two materials. Very small bed-joint cracks also developed. Since the fabric covered the entire wall surface, it was very difficult to detect bed-joint cracks. These were marked only at the vertical edges. Initial cracks were detected on vertical strips of gypsum that were bonded to the fabric surfaces on both faces. Because the wall suffered little damage, very narrow hysteretic loops were observed, and hence, little energy was dissipated.

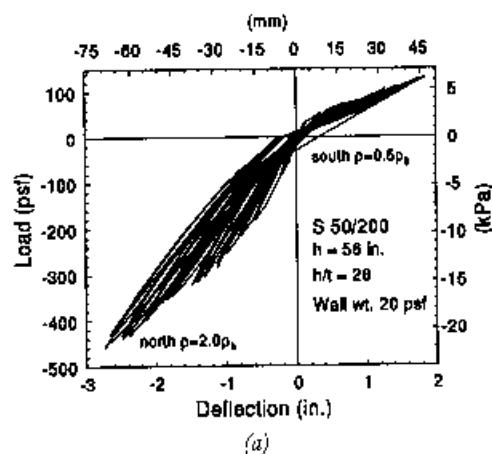
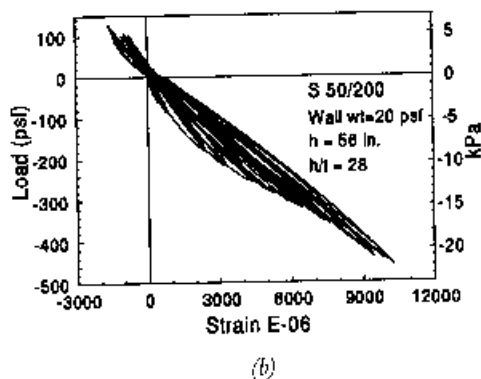
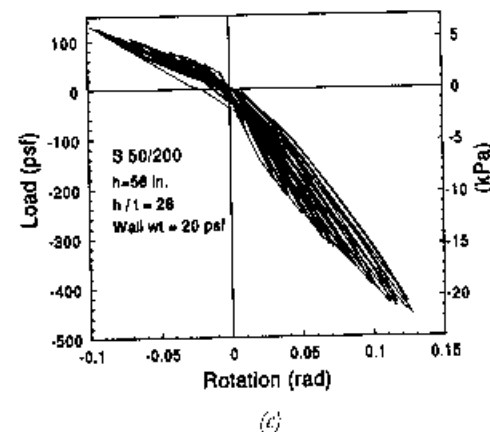
Fig. 9—Typical measurements for Specimen S 50/200; (a) load versus deflection at midheight; (b) load versus the longitudinal strain in the composite strip; and (c) load versus rotation at the top support.

Delaminated areas reached more than 75% of the area of the composite strips by the end of the test. Longitudinal strain in excess of 1.1% was measured on composite fabric on both wall faces. It is important to remark that the ratios of the applied pressure on both faces for the first major crack, first delamination, and the ultimate load were proportional to the reinforcement ratios. Figure 9 shows typical curves for all measured parameters. The general information is described in Table 3.

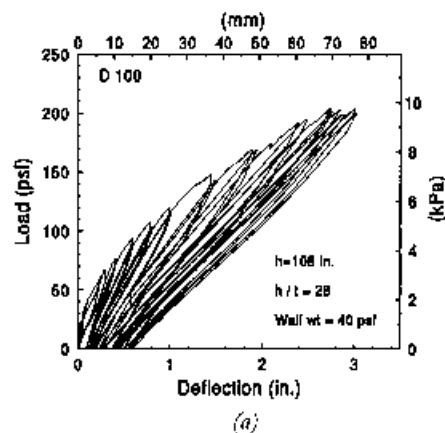
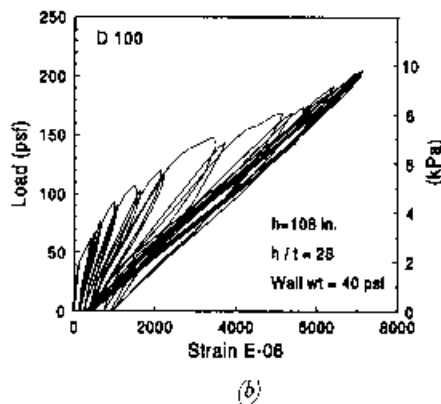
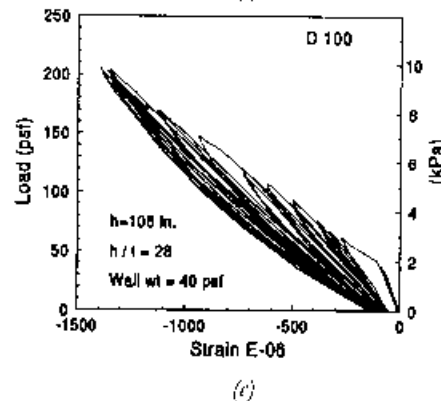
Fig. 11—Typical measurements for Specimen D100: (a) load versus deflection at mid-height; (b) load versus the longitudinal strain in the composite strip; and (c) load versus compressive strain in brick.

The lack of full composite action between the two wythes of this wall is attributed to two factors: a) the weak interface between the wythes due to the low area represented by headers; and b) because of the partially-filled gap between the wythes. Figure 11 shows typical curves for strain and deflections. The predicted behavior by beam theory was in agreement with experimental results for deflections up to 25 mm (1.0 in.); little agreement exists for points corresponding to higher deflection levels. This deflection level is close to the first major stiffness degradation due to early delamination.

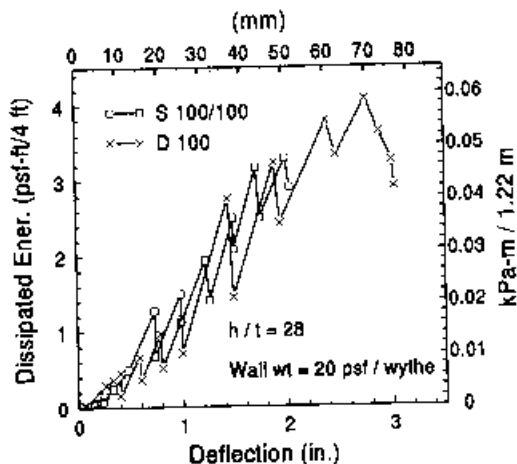
Fig. 13— Dissipated energy versus midheight deflection for Specimens S100/100 and D100.

Two failure modes were detected on Wall D100. Excessive delamination took place on all composite strips, peeling off more than 80% of the areas by the end of the test. An interface shear failure, i.e., splitting of the wythes, also occurred at the lower half part along the east and the west sides. The latter was attributed to the low shear capacity of the poorly compacted mortar between the two wythes. According to the ACI/ASCE/TMS specifications and following the beam theory approach, the shear stresses caused by the applied pressure were in excess of the allowable values. No interface failure was detected along the header courses, however, since the shear capacity of the brick units was much higher than that caused by the applied pressure. The dissipated energy at different displacement levels for Walls S100/100 and D100 are compared in Fig. 13. In spite of their differences in terms of the number of wythes and the presence of a partial gap in Specimen D100, both of these specimens dissipated similar amounts of energy for displacements up to 50 mm (2.0 in.).

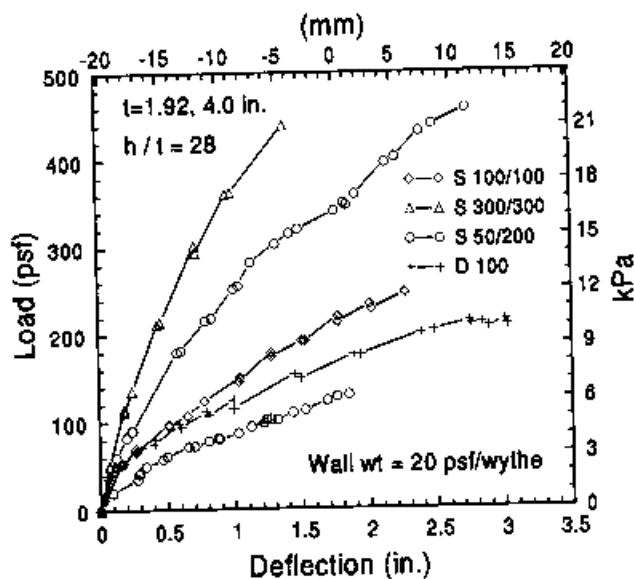
Fig. 14— Maximum load envelopes for all test specimens.

From Fig. 14, where the load-versus-deflection envelopes for all walls is presented, it can be observed that the maximum measured deflection did not depend too much on the amount of reinforcement. The maximum supported pressures, however, showed to be linearly dependent on the amount of reinforcement. The same trend was also observed for pressures at first visible crack, as well as for the first delaminated area. From Table 3, it can also be observed that the ultimate strain on composite strips was not dependent on the reinforcement ratio. Vertical cracks crossing the brick courses were detected on Walls S100/100 and S50/200. These failures occurred since the flexural capacity perpendicular to the bed-joint was reached. To avoid such failures in field applications, precautions must be taken by providing some reinforcement in the horizontal direction.
