TYRONE MINES

Location: Tyrone, New Mexico
Completed: November 2005

CONCRETE ELECTROLYTIC CELLS

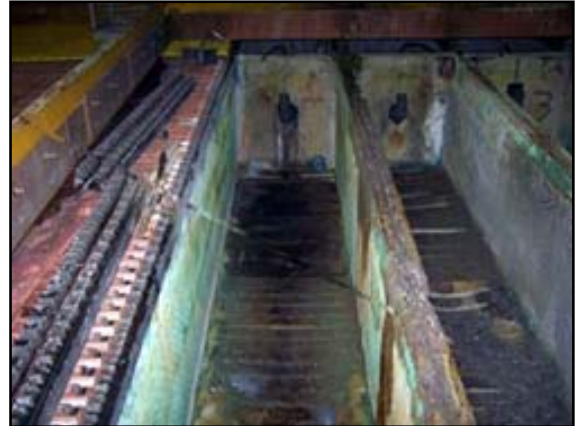
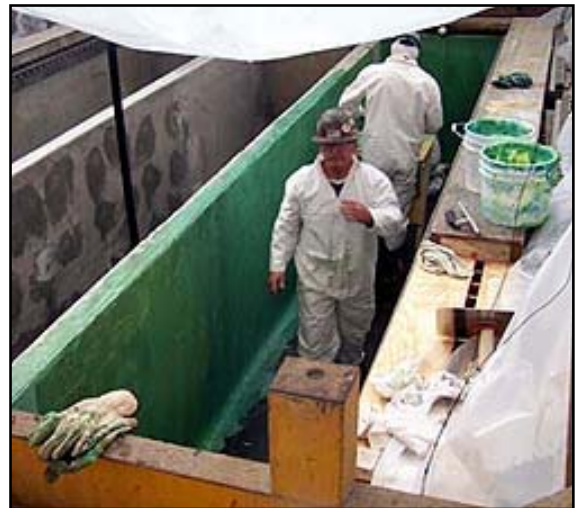
Severe corrosion of the tanks had caused the existing buffer sheets and paraliners to crack and leak. Acidic solution was able to contact the concrete walls eroding the concrete and corroding the internal rebar significantly reducing the walls strength. Also solution saturated cedar board flooring allowing it to warp. Solution also reached tankhouse floor causing damage and safety issues.

QuakeWrap developed a unique resin and fiber system to line the concrete cell walls, which increased the wall strength while containing the acidic solution within the fiberglass system. A polymer concrete floor replaced the existing wood panel floor. System has eliminated the use of paraliners and the maintenance work associated with this older system.

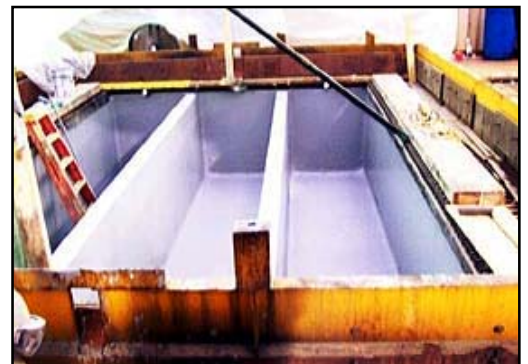
- Tanks containing 15% sulfuric acid @ 140°F
- Damaged tanks were weakened and solutions leaked
- Patent-Pending system was installed with a 5-year warranty
- Quick repair with little downtime
- Tanks are stronger than original "as-built" condition
- Long-lasting repair reduced maintenance costs
