## FRP REPAIR OF REINFORCED CONCRETE SLAB IN HOSPITAL

**Name:** Holy Cross Hospital  
**Type:** Health Care Facility  
**Location:** Silver Spring, Maryland  
**Completed:** April 2009

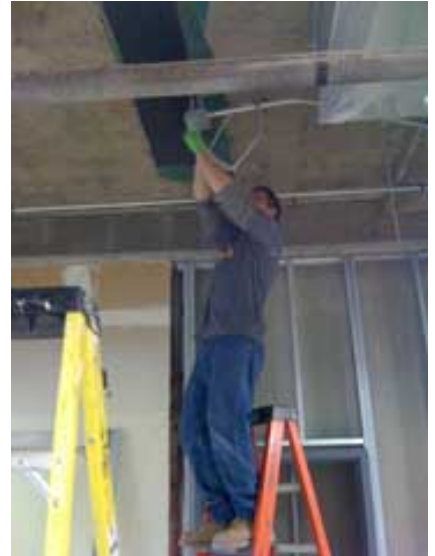
QuakeWrap® FRP Repair System was selected to strengthen the slab next to the openings. Four 1-ft wide carbon FRP strips around the rectangular opening were stronger than the loss in strength due to the slab opening. The flexibility of the material allowed the installation despite of the conduits and installations on the bottom of the slab.

- A required slab opening needed strengthening of the remaining slab around the opening.
- QuakeWrap® unidirectional carbon fabric was used in four 1-ft wide strips around the future opening
- The fabric was applied before cutting the slab to avoid extensive deflections of the slab prior to the installation.
- The installation could be completed in 1 day.
