Project Overview

FRP REPAIR OF CONCRETE SLAB IN HIGH RISE BUILDING

Name: Trump Grande Condominiums
Type: Condominium Building
Location: Sunny Isles Beach (Miami), Florida
Completed: February, 2007

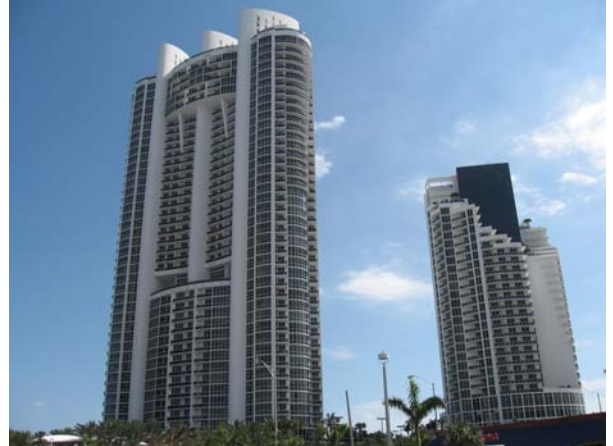
A high rise condominium tower overlooking the Atlantic Ocean was occupied and a condominium unit located below spa facilities presented leakage problems due to water seeping through cracks in the slab.

Crack repair had to be undertaken in an occupied luxury condominium unit. Since the residents were relocated to a nearby hotel, the job had to be completed in a day.
