## FRP REPAIR OF PRESTRESSED CONCRETE BEAMS IN PARKING STRUCTURE

**Name:** Panorama Condominiums  
**Type:** Parking Structure  
**Location:** Las Vegas, Nevada  
**Completed:** January, 2007

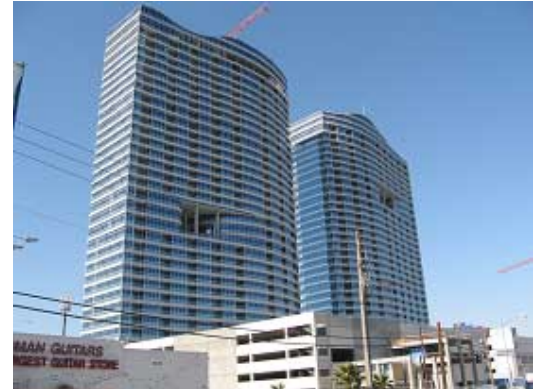
The twin tower luxury condominium complex overlooks the Las Vegas Strip. One tower was under construction and the other was occupied. The parking garages were constructed with prestressed double tee beams. Due to a manufacturing problem, several prestressed beam stems had little or no concrete cover over the steel reinforcement and corrosion of the steel reinforcement was a mayor concern.

The double tee stems had to be repaired with minimum disturbance to the tower residents using the parking structure and to the electrical and fire protection hardware already in place.
